Expertise

Protocol number: 46338681
Order No. / Reference: 26185451
Inspection date: 30 Jun 2026

Model: Vito 116 CDI Lang HA Aut. PRO

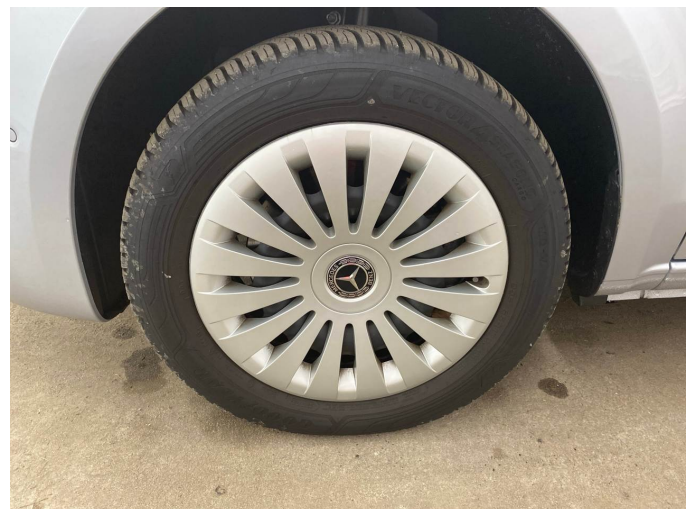
Figure 12: Mounted tyres

#	Tyre size	Type of tyre	Manufacturer	Tread depth
1)	225/55 R17 109H	All-season tyres on Steel rim with wheel cover	Goodyear	7mm / 7mm
2)	225/55 R17 109H	All-season tyres on Steel rim with wheel cover	Goodyear	7mm / 7mm
