Expertise

Protocol number: 46095203
Order No. / Reference: 26490256
Inspection date: 22 Jun 2026

Manufacturer: Volvo

Model: XC90 T8 AWD Recharge Geartronic R-Design Edition

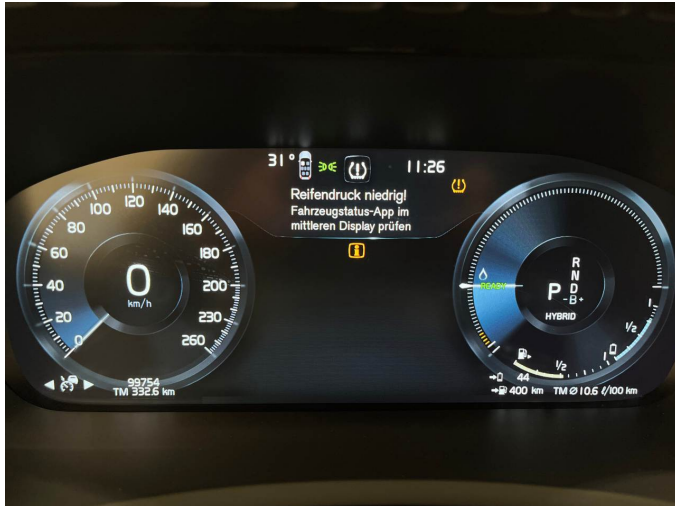
Figure 7: Instrument cluster

No.	Component group	Description
1	Equipment	Tirefit filler - Expired - Replace
2	Instrument panel	Indicator light (Reifendruck) - on - Perform diagnosis
3	Door - front left side	Door edge - Scratch(es) - Smart repair
4	Side panel - rear left side	Wheel well extension - Scratch(es) - Smart repair
5	2nd wheel set	1 tyre (Sommerreifen) - Damaged - Replace
6	2nd wheel set	1 tyre (Sommerreifen) - Damaged - Replace
7	2nd wheel set	1 alloy rim - Scratched - Loss in value
8	2nd wheel set	1 alloy rim - Scratched - Loss in value
9	Misc.	Inspection / maintenance - Due - Perform
10	Door - rear right side	Door - Dent / paintcoat damage - Paint
11	Rear bumper	Rear bumper - Scratch(es) - Paint

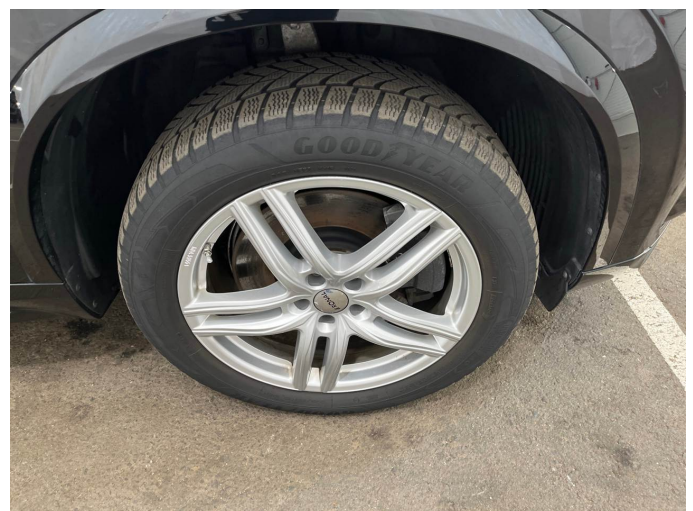
Figure 12: Mounted tyres

Mounted tyres				
#	Tyre size	Type of tyre	Manufacturer	Tread depth
1)	235/55 R19 105H	Winter tyres on Light alloy	Goodyear	3mm / 3mm
2)	235/55 R19 105H	Winter tyres on Light alloy	Goodyear	6mm / 6mm

Der montierte Winterradsatz ist kein Bestandteil der Ausstattung.

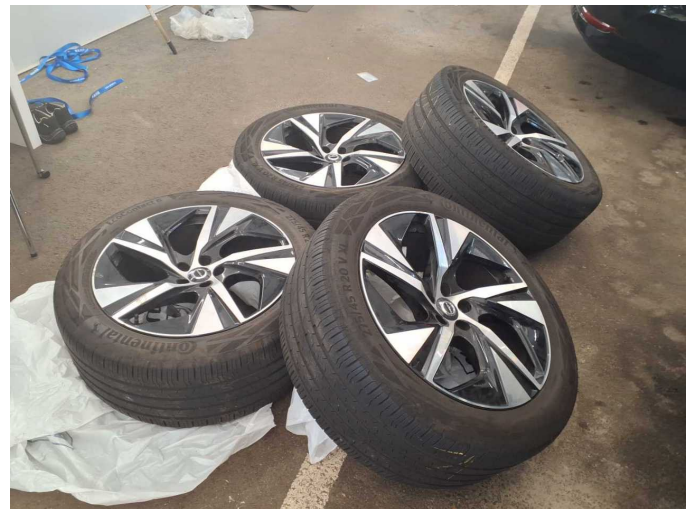
Figure 16: Additional tyres

Additional tyres				
#	Tyre size	Type of tyre	Manufacturer	Tread depth
1)	275/45 R20 110V	Summer tyres on Light alloy	Continental	4mm / 4mm
2)	275/45 R20 110V	Summer tyres on Light alloy	Continental	5mm / 5mm
