Expertise

Protocol number: 46132590
Order No. / Reference: 26501171
Inspection date: 22 Jun 2026

Manufacturer: Volkswagen

Model: ID.4 4Motion GTX

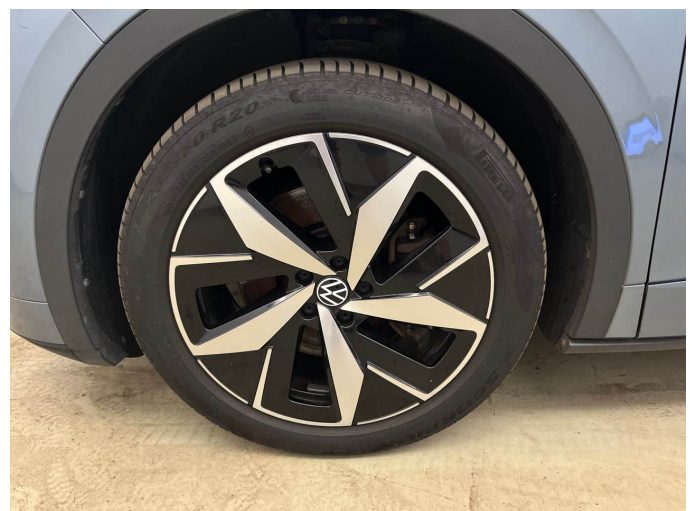
Figure 12: Mounted tyres

#	Tyre size	Type of tyre	Manufacturer	Tread depth
1)	235/50 R20 100T	Summer tyres on Light alloy	Pirelli	4mm / 4mm
2)	255/45 R20 101T	Summer tyres on Light alloy	Pirelli	4mm / 4mm

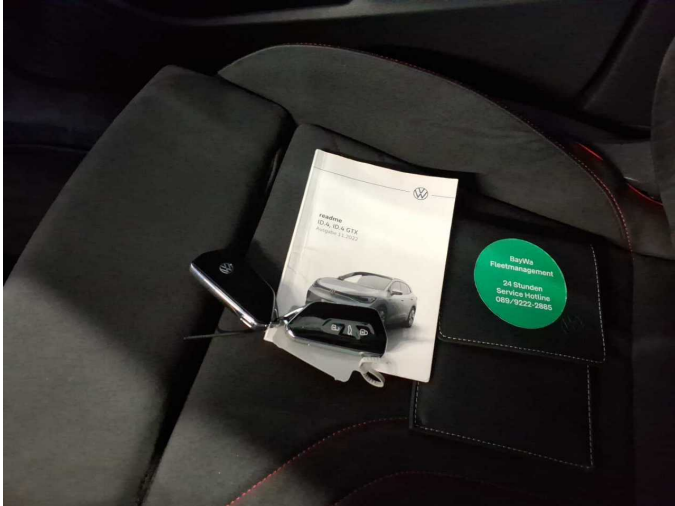
Figure 13: Documents

Documents submitted	At the time of the inspection, the vehicle registration certificate Part 2 (title) was available, but the vehicle registration certificate Part 1 (document) was not. (Copy)
VIN comparison	The vehicle identification number (VIN) was read from the vehicle and its conformity with the submitted documents was confirmed by the undersigned during the inspection.
Inspection	The inspection conditions were sufficient for the assessment of the vehicle. Lifting equipment and/or a pit were available for examining the vehicle.
Test drive	No test drive/shunting maneuver was carried out during the inspection of the vehicle.
Engine function test	An engine test run was performed.

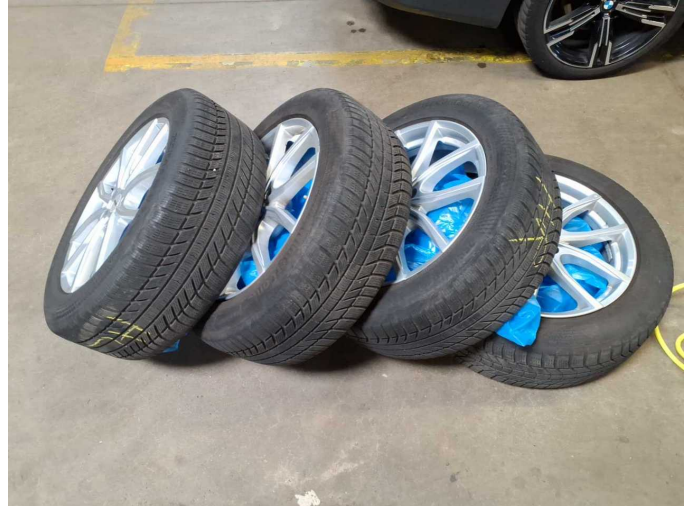
Figure 14: Additional tyres

#	Tyre size	Type of tyre	Manufacturer	Tread depth
1)	235/55 R19 105V	Winter tyres on Light alloy	Continental	5mm / 5mm
2)	255/50 R19 107V	Winter tyres on Light alloy	Continental	4mm / 4mm

Die zusätzlichen Winterreifen sind kein Bestandteil der Ausstattung.
