Expertise

Protocol number: 46602773  
Order No. / Reference: 26719983  
Inspection date: 14 Jul 2026

Manufacturer: Skoda  
VIN: TMBLN7NSXP8052121

Model: Kodiaq 2.0 TDI 4x4 DSG Style

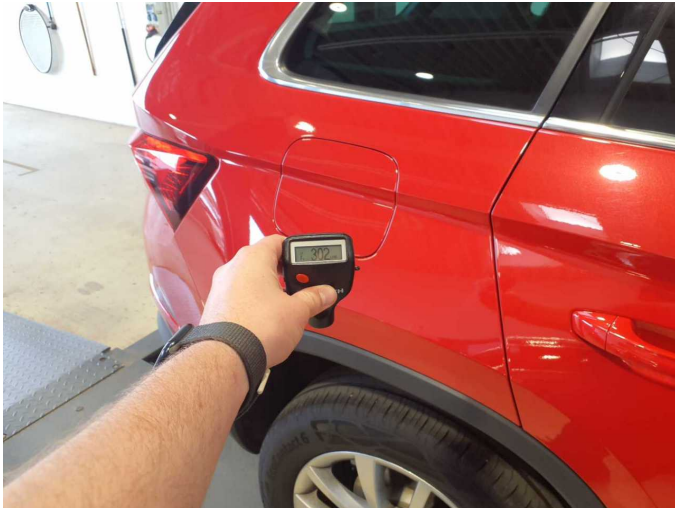
**Repainting 6:** Side panel - rear right side

| No. | Component group | Description |
|---|---|---|
| 8 | Side panel - rear right side | Side panel (Einschlüsse) - Unprofessionally repaired - Repair and paint |
