Expertise

Protocol number: 46867776  
Order No. / Reference: 26715258  
Inspection date: 3 Aug 2026

Model: Arona 1.0 TSI OPF Style

VIN: VSSZZKJZNR043302

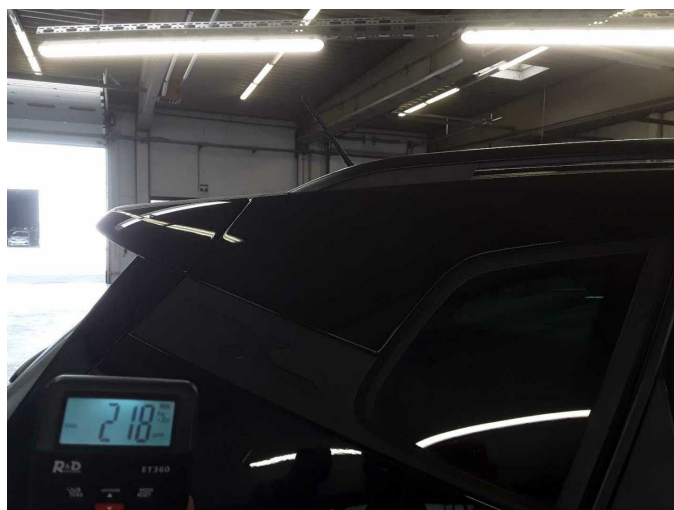
**Roof rail - right side:** 218 µm
