Expertise

Protocol number: 46714293  
Order No. / Reference: 26733811  
Inspection date: 25 Jul 2026

Manufacturer: Ford

Model: Kuga 2.5 Duratec PHEV VIGNALE

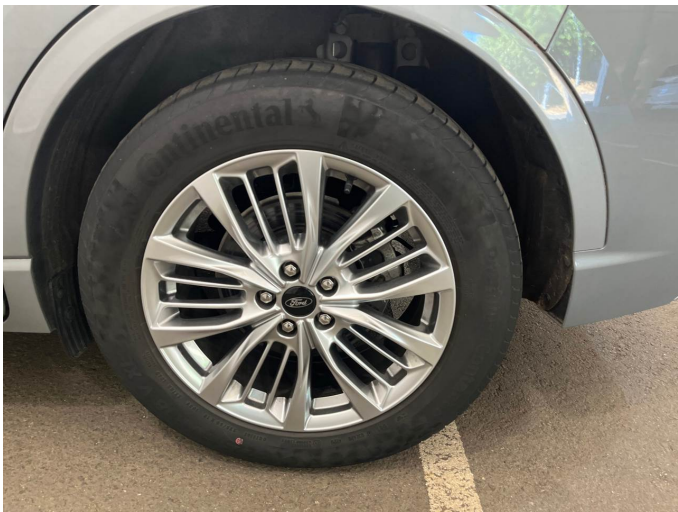
Figure 12: Mounted tyres

| # | Tyre size | Type of tyre | Manufacturer | Tread depth |
|---|---|---|---|---|
| 1) | 225/60 R18 104V | Summer tyres on Light alloy | Continental | 4mm / 4mm |
| 2) | 225/60 R18 104V | Summer tyres on Light alloy | Continental | 5mm / 5mm |
