Expertise

Protocol number: 46079554
Order No. / Reference: 26501269
Inspection date: 18 Jun 2026

Manufacturer: Skoda

Model: Enyaq iV 80x

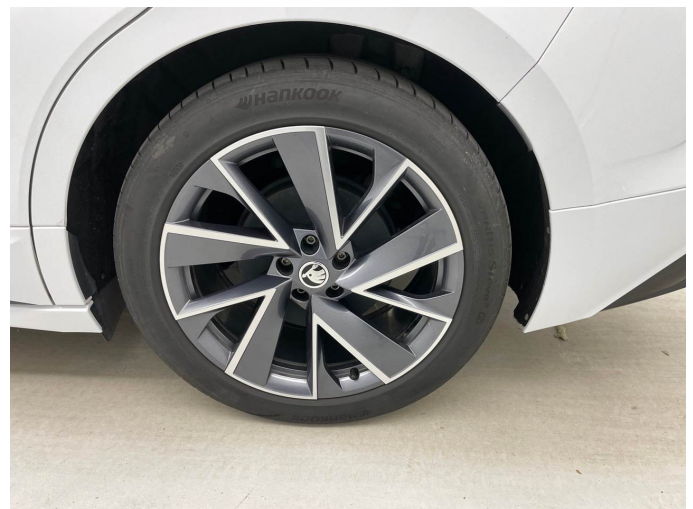
Figure 12: Mounted tyres

#	Tyre size	Type of tyre	Manufacturer	Tread depth
1)	235/50 R20 100T	Summer tyres on Light alloy	Hankook	6mm / 6mm
2)	255/45 R20 101T	Summer tyres on Light alloy	Hankook	6mm / 6mm
