Expertise

Protocol number: 46232497
Order No. / Reference: 26311361
Inspection date: 29 Jun 2026

Manufacturer: Opel

Model: Astra Sports Tourer 1.2 Turbo Automatik GS

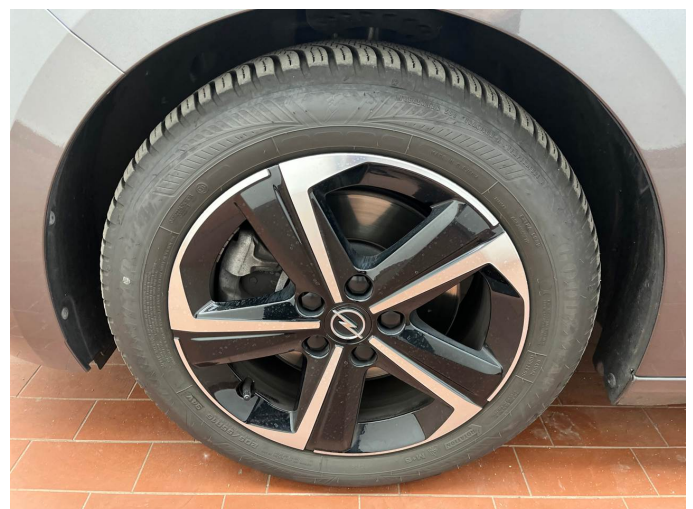
Figure 12: Mounted tyres

#	Tyre size	Type of tyre	Manufacturer	Tread depth
1)	205/55 R16 94V	All-season tyres on Light alloy	Goodyear	6mm / 6mm
2)	205/55 R16 94V	All-season tyres on Light alloy	Goodyear	6mm / 6mm
