## Expertise

Protocol number: 46186727  
Order No. / Reference: 26153548  
Inspection date: 16 Jun 2026

Model: 319 CDI Sprinter 4x4 Standard 9G-TRONIC PRO

VIN: W1V3MBTZ1TP849548

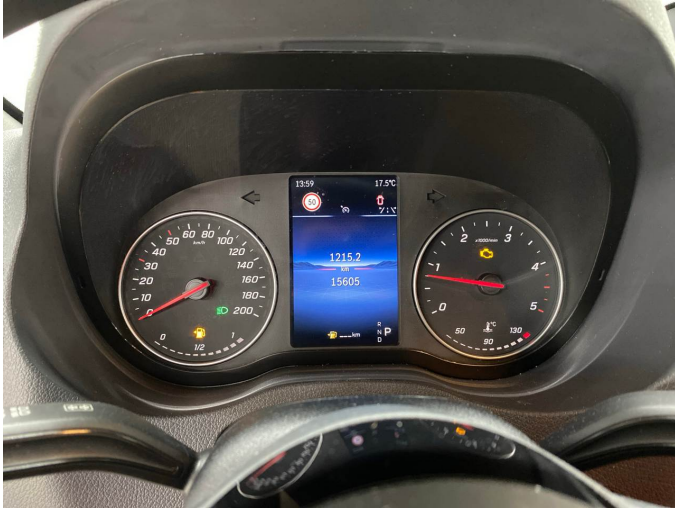
Figure 7: Instrument cluster

**Damage 2:** Instrument panel: Indicator light (Motorkontrolleuchte) - on - Perform diagnosis
