## Expertise

Protocol number: 46153462  
Order No. / Reference: 26522381  
Inspection date: 23 Jun 2026

Model: XCeed 1.5 T-GDI OPF DCT7 VISION

VIN: U5YH5F15GPL155163

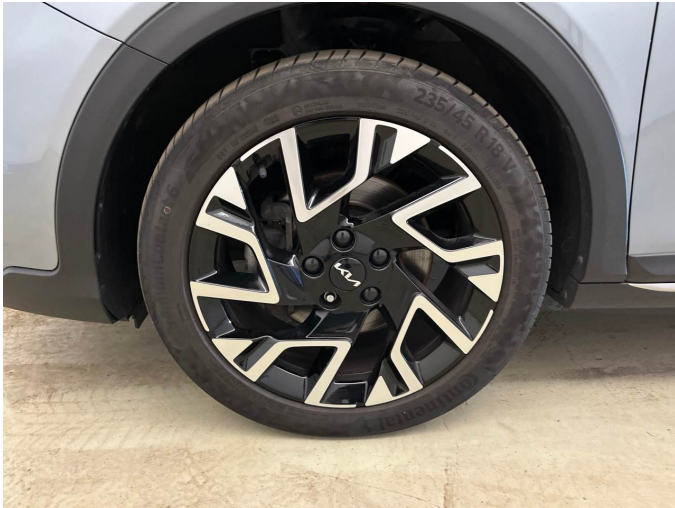
Figure 13: Mounted tyres

Mounted tyres				
#	Tyre size	Type of tyre	Manufacturer	Tread depth
1)	235/45 R18 94V	Summer tyres on Light alloy	Continental	4mm / 4mm
2)	235/45 R18 94V	Summer tyres on Light alloy	Continental	5mm / 5mm
Replacement				
Typ	Tyre size	Type of tyre	Manufacturer	Tread depth
	Tirefit	Expiration date 07/2028
