Expertise

Protocol number: 46303645  
Order No. / Reference: 26508860  
Inspection date: 29 Jun 2026

Manufacturer: Volkswagen

Model: Caddy Cargo 2.0 TDI BMT DSG

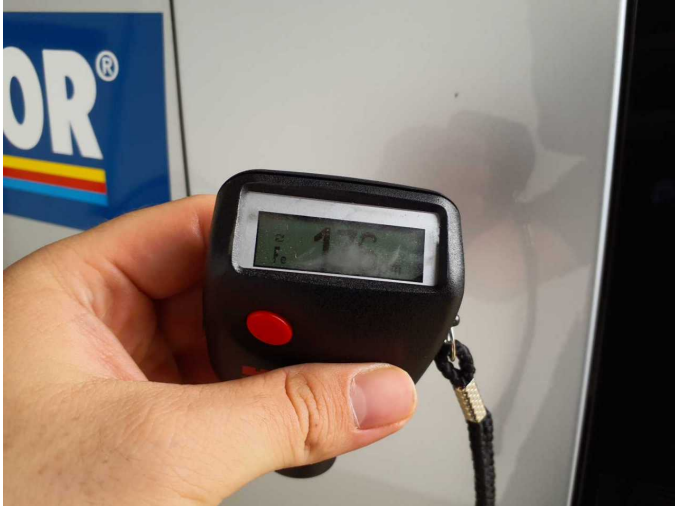
| 1 | Roof, Mudguard - left side, Mudguard - right side, Side panel - rear left side, Side panel - rear right side, Door - front left side, Door - front right side, Professionally carried out, Invoice of repair done Non-existent |

**Repainting 1:** Roof, Mudguard - left side, Mudguard - right side, Side panel - rear left side, Side panel - rear right side, Door - front left side, Door - front right side
