## Expertise

Protocol number: 46076527  
Order No. / Reference: 26474739  
Inspection date: 19 Jun 2026

Manufacturer: Mazda

Model: 2 SKYACTIV G 90 M HYBRID Homura

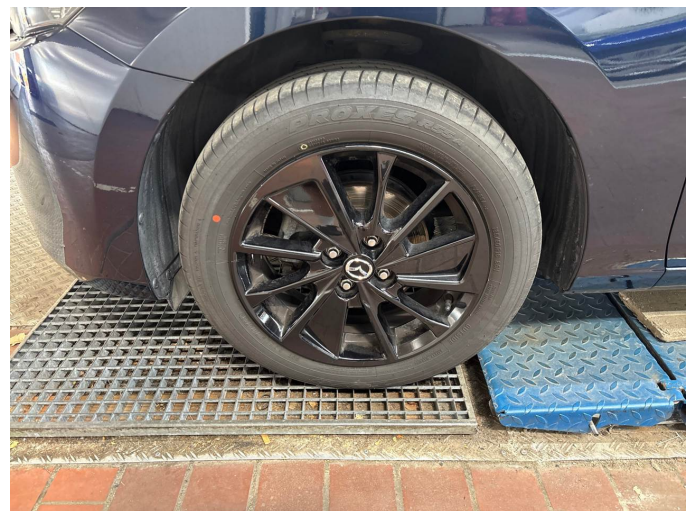
Figure 12: Mounted tyres

#	Tyre size	Type of tyre	Manufacturer	Tread depth
1)	185/60 R16 86H	Summer tyres on Light alloy	Toyo	6mm / 6mm
2)	185/60 R16 86H	Summer tyres on Light alloy	Toyo	6mm / 6mm

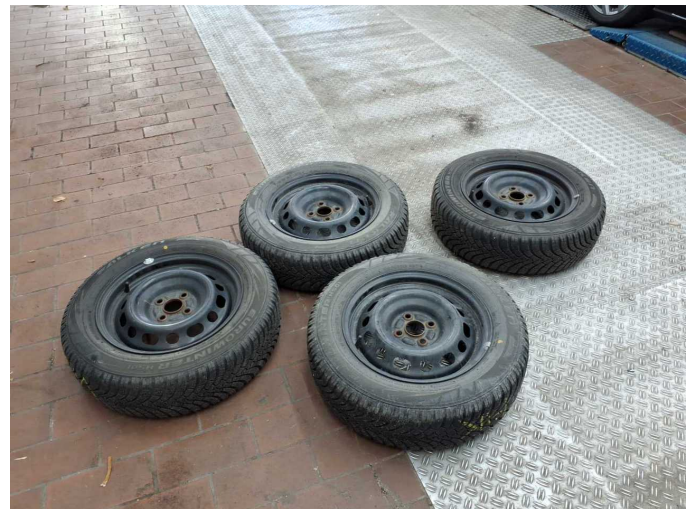
Figure 16: Additional tyres

#	Tyre size	Type of tyre	Manufacturer	Tread depth
1)	185/65 R15 88T	Winter tyres on Steel	Falken	7mm / 7mm
2)	185/65 R15 88T	Winter tyres on Steel	Falken	7mm / 7mm
