## Expertise

Protocol number: 45948116  
Order No. / Reference: 26360219  
Inspection date: 10 Jun 2026

Model: Focus Turnier 1.5 EcoBlue Start-Stopp-System Aut. TITANIUM

VIN: WF0PXXGCHPNY34710

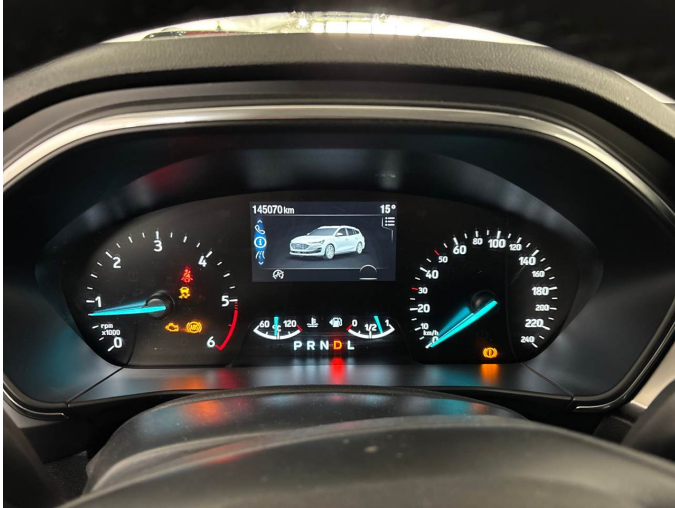
Figure 7: Instrument cluster

**Damage 4:** Instrument panel: Indicator light (Bremsanlage) - on - Perform diagnosis

**Damage 5:** Instrument panel: Indicator light (Abs) - on - Perform diagnosis

**Damage 6:** Instrument panel: Indicator light (Motorkontrollleuchte) - on - Perform diagnosis
