Expertise

Protocol number: 46323022  
Order No. / Reference: 26547211  
Inspection date: 3 Jul 2026

Model: Zafira Life 2.0 D M Edition

VIN: VXEEVHTMNZ072625

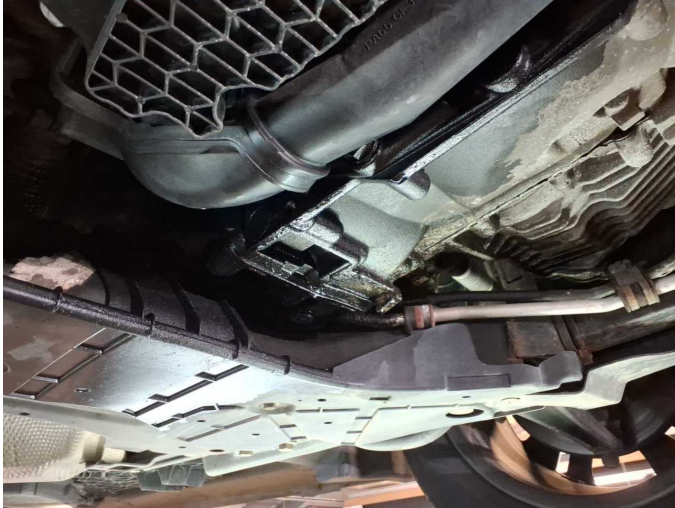
| No. | Component group | Description |
|---|---|---|
| 1 | Gearbox | Gearbox (Tröpfchenbildung, Umweltbelastung) - Leaking - Perform diagnosis |

**Damage 1:** Gearbox: Gearbox (Tröpfchenbildung, Umweltbelastung) - Leaking - Perform diagnosis

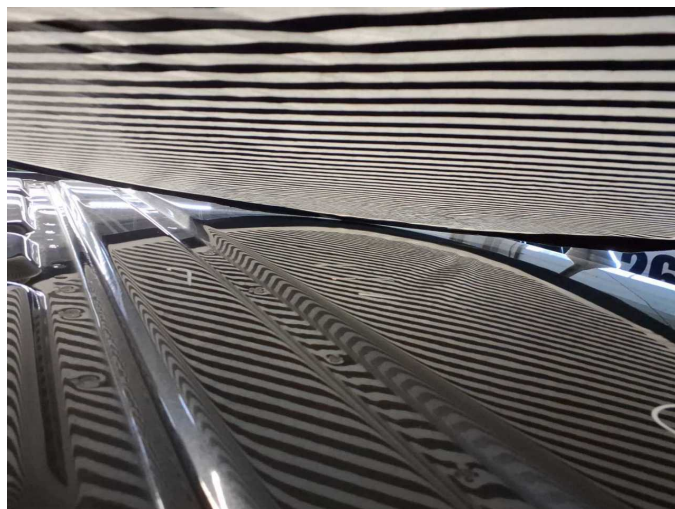
| No. | Component group | Description |
|---|---|---|
| 6 | Roof | Roof (vorne) - dent(s) - Smooth repair work |

**Damage 6:** Roof: Roof (vorne) - dent(s) - Smooth repair work

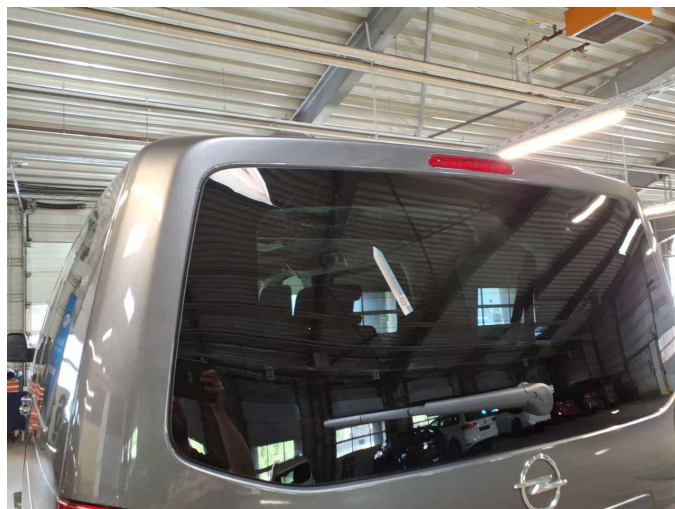
| No. | Component group | Description |
|---|---|---|
| 13 | Vehicle glazing | Rear window - Scratched - Replace |

**Damage 13:** Vehicle glazing: Rear window - Scratched - Replace

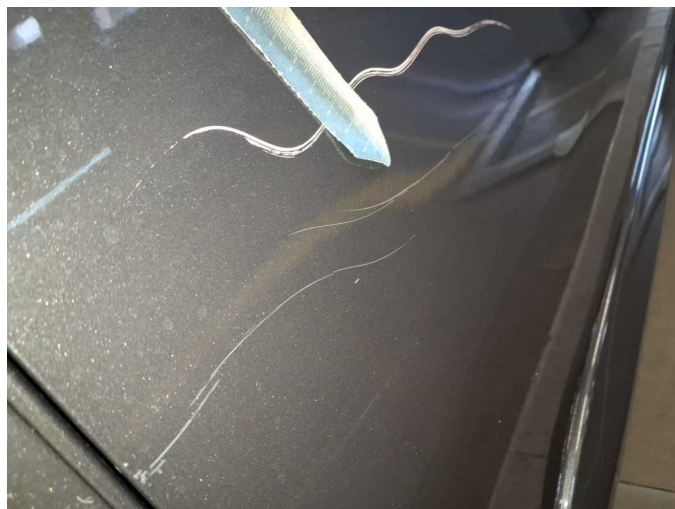
| No. | Component group | Description |
|---|---|---|
| 16 | Sliding door, right | Sliding door (Delle) - Scratched - Repair and paint |

**Damage 16:** Sliding door, right: Sliding door (Delle) - Scratched - Repair and paint

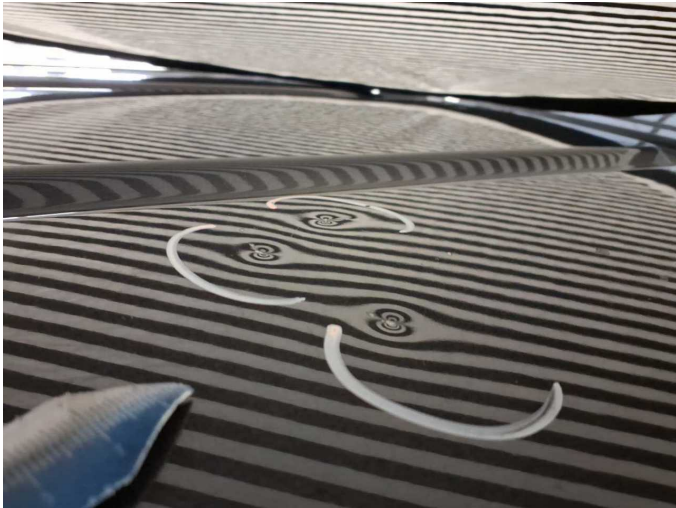
**Damage 18:** Roof: Roof (Mitte) - Dent / paintcoat damage - Repair and paint
