Expertise

Protocol number: 46627076  
Order No. / Reference: 26761051  
Inspection date: 15 Jul 2026

Manufacturer: Ford

Model: Focus Turnier 1.0 EcoBoost Start-Stopp-System  
COOL&CONNECT

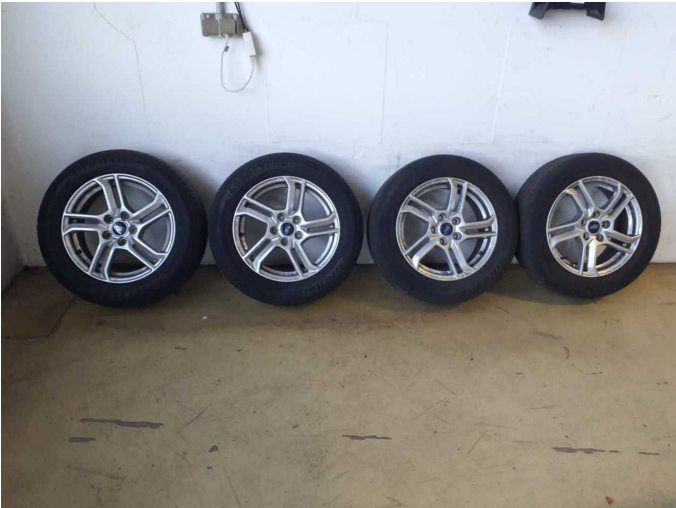
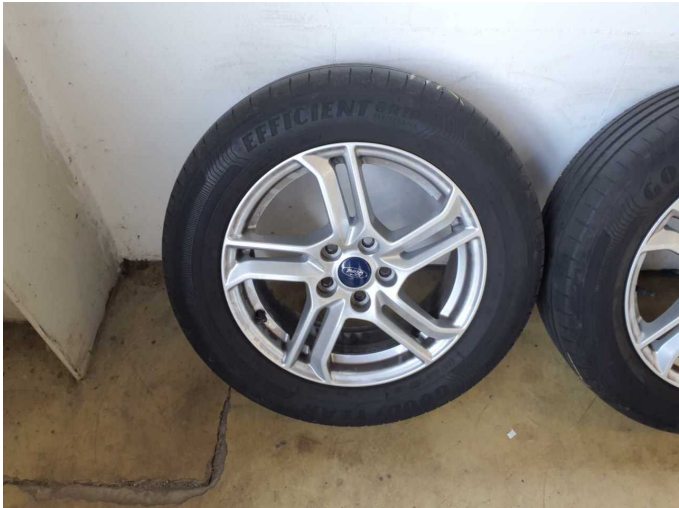
Figure 15: Additional tyres

| No. | Component group | Description |
|---|---|---|
| 6 | 2nd wheel set | 3 tyres - Worn - Replace |
