Expertise

Protocol number: 46765144  
Order No. / Reference: 26812652  
Inspection date: 28 Jul 2026

Manufacturer: Volkswagen

Model: Caddy Cargo 2.0 TDI BMT

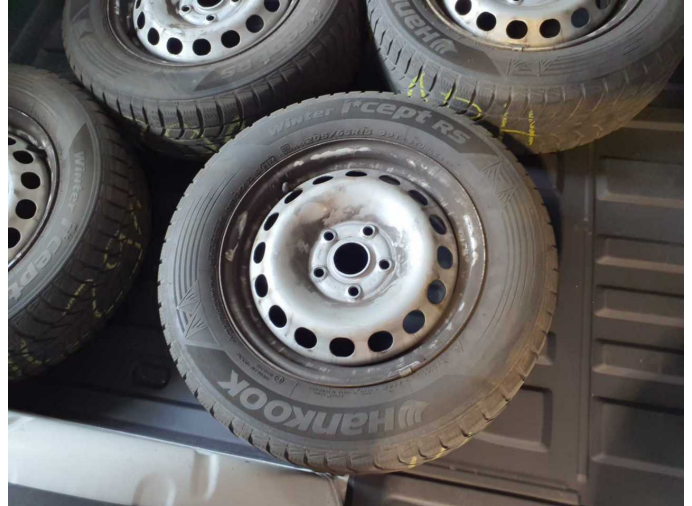
| No. | Component group | Description |
|---|---|---|
| 1 | 2nd wheel set | 2 tyres (nicht Teil der Ausstattung) - Worn - No deduction |

Figure 14: Additional tyres

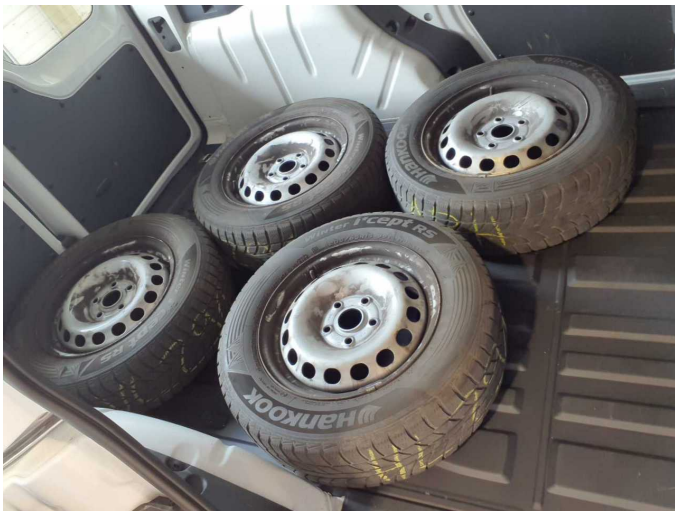
Figure 15: Additional tyres
