Expertise

Protocol number: 45890795
Order No. / Reference: 26389772
Inspection date: 9 Jun 2026

Model: 317 CDI Sprinter Standard HA 9G-Tronic

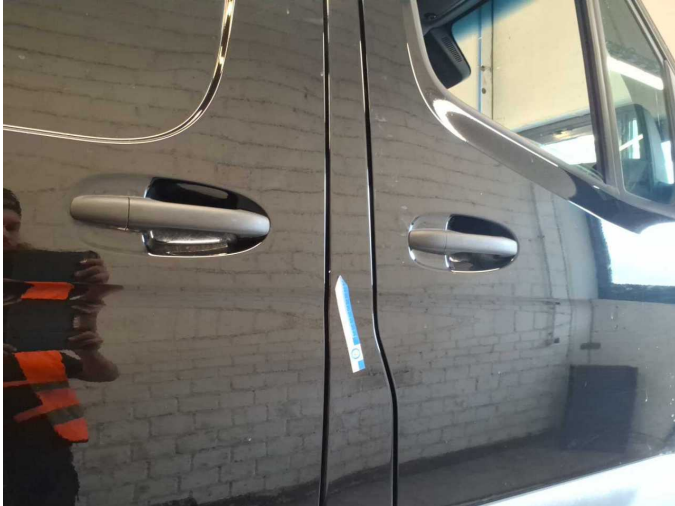
| No. | Component group | Description |
|---|---|---|
| 1 | Body | B-pillar - right side - Scratch(es) - Smart repair |

Damage 1: Body: B-pillar - right side - Scratch(es) - Smart repair
