Expertise

Protocol number: 46275888
Order No. / Reference: 26652927
Inspection date: 2 Jul 2026

Model: 308 SW BlueHDi 130 EAT8 Stop & Start GT

VIN: VF3LCYHZKLS293138

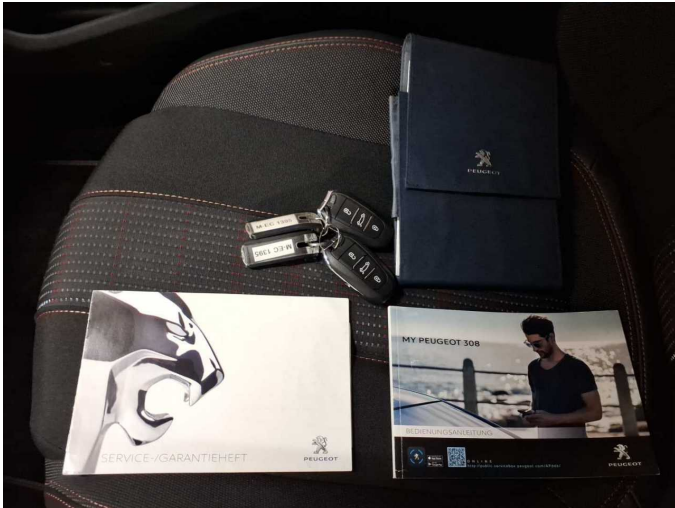
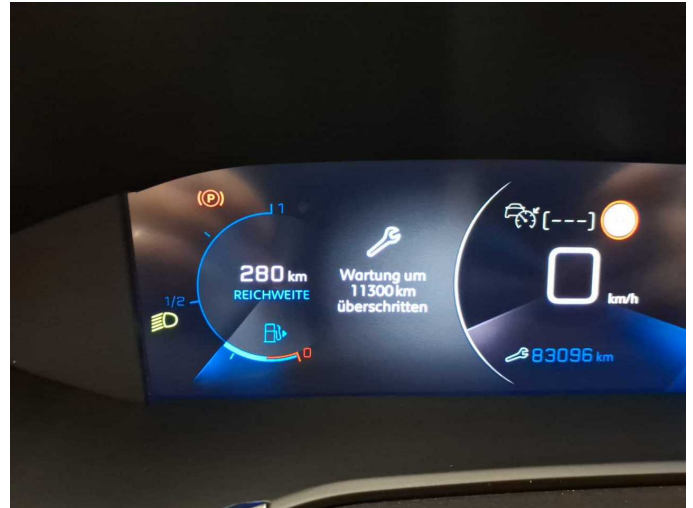
Documents submitted	At the time of the inspection, the vehicle registration certificate Part 2 (title) was available, but the vehicle registration certificate Part 1 (document) was not. (Copy)
VIN comparison	The vehicle identification number (VIN) was read from the vehicle and its conformity with the submitted documents was confirmed by the undersigned during the inspection.
Inspection	The inspection conditions were sufficient for the assessment of the vehicle. Lifting equipment and/or a pit were available for examining the vehicle.
Test drive	A short maneuvering and shunting exercise was carried out on the company premises.
Engine function test	An engine test run was performed.
readiness to drive	The vehicle was not capable of driving under its own power at the time of inspection, but can be moved on its own axle with the aid of assistance.

- Die erste Seite der ZBII wurde nicht übermittelt. Es ist nicht ersichtlich, ob das Fahrzeug vorher als Mietwagen genutzt wurde.
- Winterradsatz ist kein Bestandteil des Auslieferungsumfangs.
