Expertise

Protocol number: 46104689
Order No. / Reference: 26467023
Inspection date: 23 Jun 2026

Model: Focus Turnier 2.0 EcoBlue Start-Stopp-System Aut. ACTIVE

VIN: WF0PXXGCHPLB18849

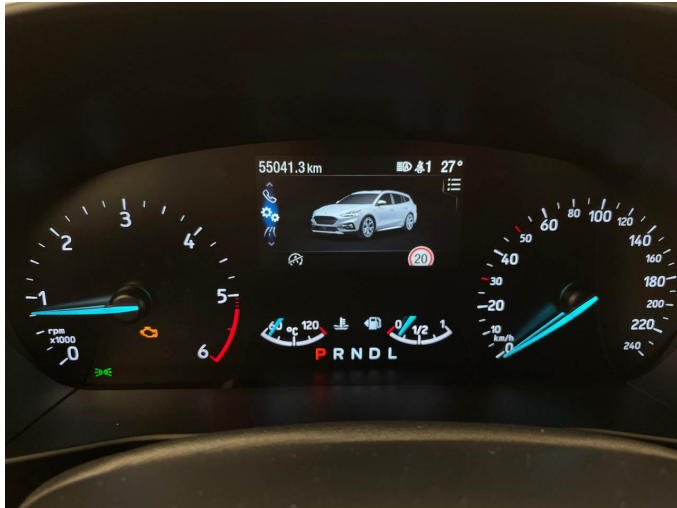
Figure 7: Instrument cluster

Damage 4: Instrument panel: Indicator light (Motorkontrollleuchte, nicht fahrbereit) - on - Perform diagnosis
