Expertise

Protocol number: 46166303
Order No. / Reference: 26501194
Inspection date: 25 Jun 2026

Manufacturer: Ford

Model: Focus Turnier 1.5 EcoBlue Start-Stopp-System Aut. TITANIUM

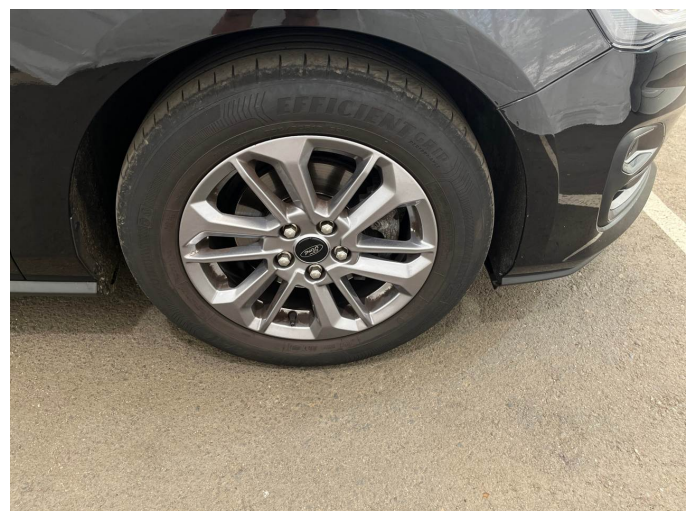
Figure 12: Mounted tyres

#	Tyre size	Type of tyre	Manufacturer	Tread depth
1)	205/60 R16 92V	Summer tyres on Light alloy	Goodyear	4mm / 4mm
2)	205/60 R16 92V	Summer tyres on Light alloy	Goodyear	6mm / 6mm

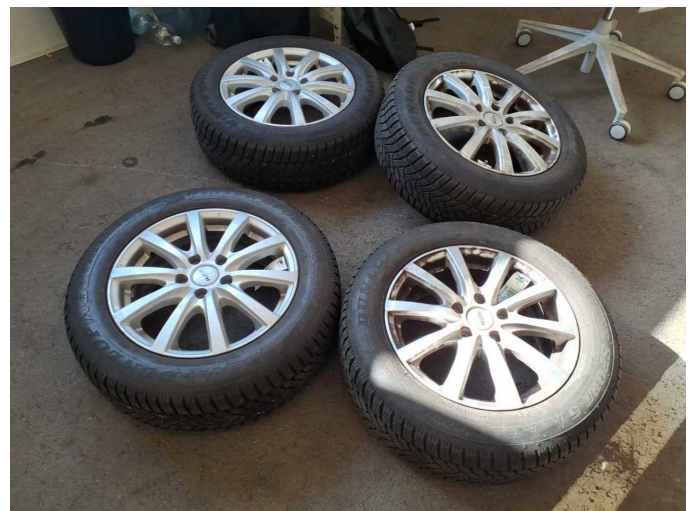
Figure 18: Additional tyres

#	Tyre size	Type of tyre	Manufacturer	Tread depth
1)	205/60 R16 92H	Winter tyres on Light alloy	Dunlop	6mm / 6mm
2)	205/60 R16 92H	Winter tyres on Light alloy	Dunlop	6mm / 6mm

Die zusätzlichen Winterräder sind kein Bestandteil der Ausstattung.
