## Expertise

Protocol number: 46179601  
Order No. / Reference: 26499281  
Inspection date: 26 Jun 2026

Manufacturer: Ford

Model: Mondeo Turnier 2.0 EcoBlue Aut. Titanium

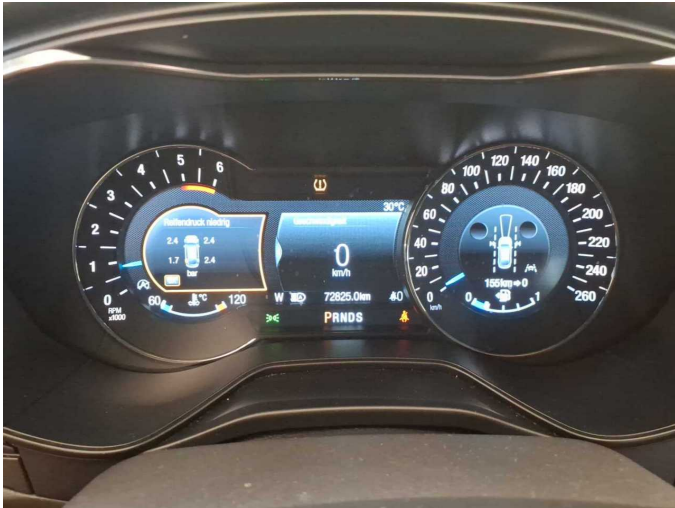
Figure 7: Instrument cluster

**Damage 2:** Instrument panel: Indicator light (Reifendruck Kontrollleuchte) - on - Perform diagnosis
