Expertise

Protocol number: 46259325
Order No. / Reference: 26151980
Inspection date: 29 Jun 2026

Model: Vito 116 CDI Extralang HA Aut. PRO

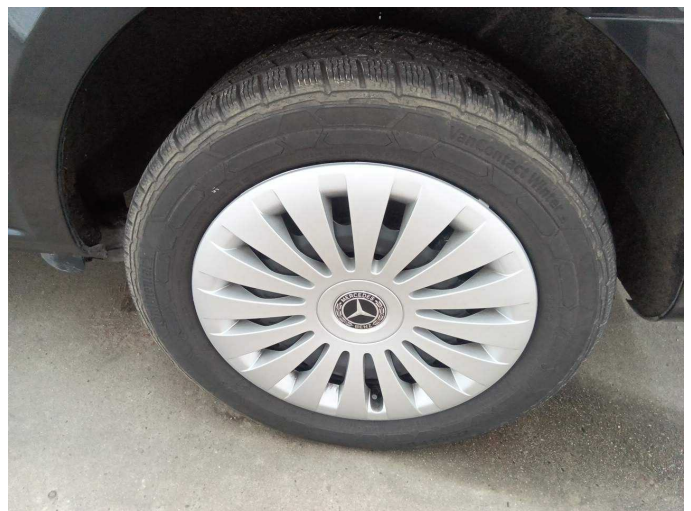
Figure 12: Mounted tyres

#	Tyre size	Type of tyre	Manufacturer	Tread depth
1)	225/55 R17 109T	Winter tyres on Steel rim with wheel cover	Continental	4mm / 4mm
2)	225/55 R17 109T	Winter tyres on Steel rim with wheel cover	Continental	4mm / 4mm
