## Expertise

Protocol number: 46349289  
Order No. / Reference: 26185535  
Inspection date: 30 Jun 2026

Model: 319 CDI Sprinter Standard HA 9G-TRONIC PRO

VIN: W1V3MBTZXP849547

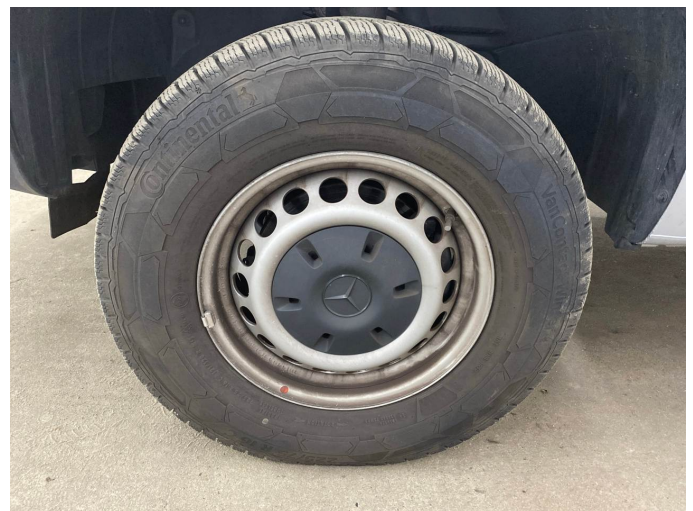
Figure 12: Mounted tyres

#	Tyre size	Type of tyre	Manufacturer	Tread depth
1)	225/75 R16 120R	Winter tyres on Steel rim with wheel cover	Continental	8mm / 8mm
2)	225/75 R16 120R	Winter tyres on Steel rim with wheel cover	Continental	8mm / 8mm

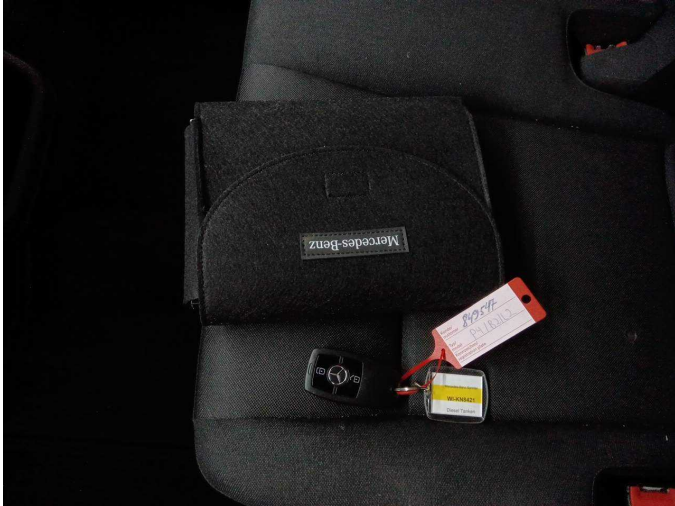
Figure 13: Documents

Documents submitted	At the time of the inspection, the vehicle registration certificate Part 2 (title) was available, but the vehicle registration certificate Part 1 (document) was not. (Copy)
VIN comparison	The vehicle identification number (VIN) was read from the vehicle and its conformity with the submitted documents was confirmed by the undersigned during the inspection.
Inspection	The inspection conditions were sufficient for the assessment of the vehicle. Lifting equipment and/or a pit were available for examining the vehicle.
Test drive	No test drive/shunting maneuver was carried out during the inspection of the vehicle.
Engine function test	An engine test run was performed.
readiness to drive	The vehicle was roadworthy at the time of inspection.
