Expertise

Protocol number: 46161280
Order No. / Reference: 26437526
Inspection date: 24 Jun 2026

Model: Jumpy e-Spacetourer XL (75 kWh) Feel

VIN: VF7VZZKXZPZ088528

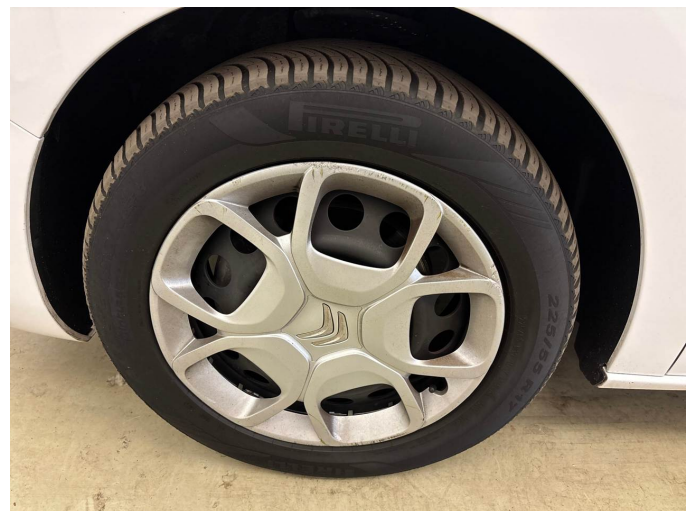
Figure 12: Mounted tyres

#	Tyre size	Type of tyre	Manufacturer	Tread depth
1)	225/55 R17 101Y	All-season tyres on Steel rim with wheel cover	Pirelli	3mm / 3mm
2)	225/55 R17 101Y	All-season tyres on Steel rim with wheel cover	Pirelli	5mm / 5mm
