Expertise

Protocol number: 45304332
Order No. / Reference: 25785008
Inspection date: 27 Apr 2026

Manufacturer: Mercedes-Benz

Model: eSprinter Standard 55/47 kWh

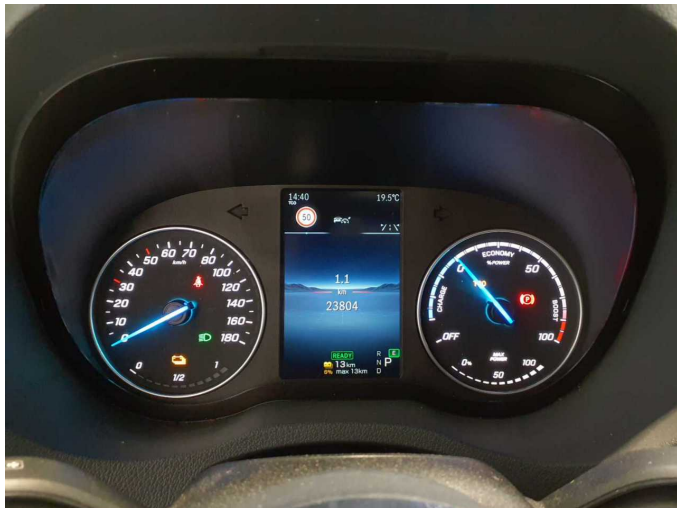
Figure 7: Instrument cluster

Mileage (Read) 23,804 km

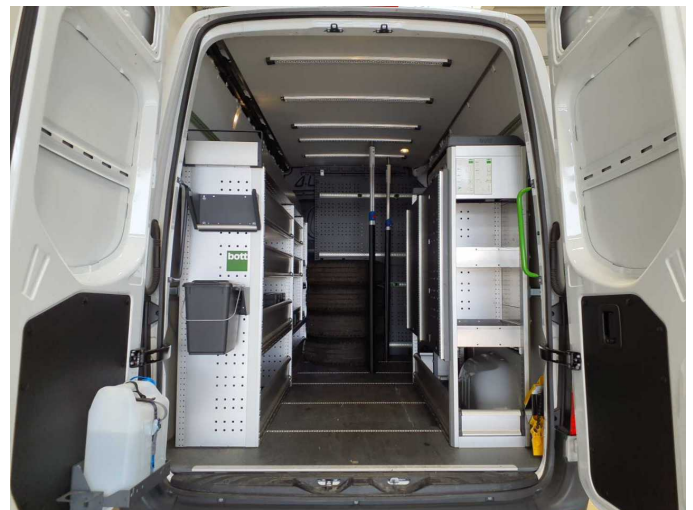
Figure 10: Cargo area

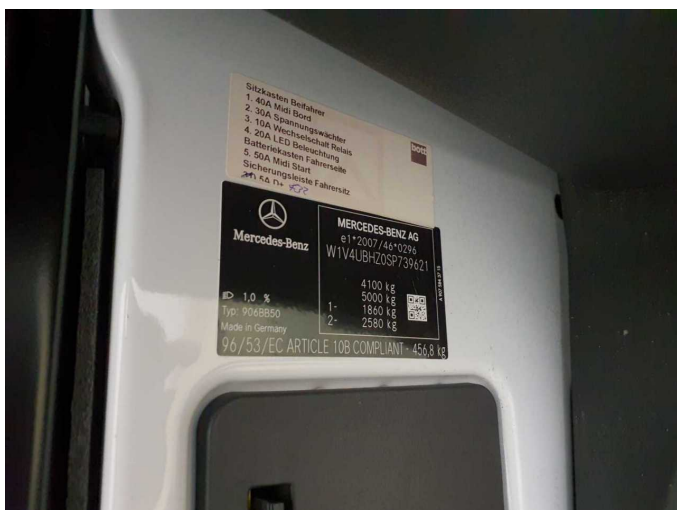
Figure 11: VIN

Documents submitted	At the time of the inspection, the vehicle registration certificate Part 2 (title) was available, but the vehicle registration certificate Part 1 (document) was not. (Copy)
VIN comparison	The vehicle identification number (VIN) was read from the vehicle and its conformity with the submitted documents was confirmed by the undersigned during the inspection.
Inspection	The inspection conditions were sufficient for the assessment of the vehicle. Lifting equipment and/or a pit were available for examining the vehicle.
Test drive	No test drive/shunting maneuver was carried out during the inspection of the vehicle.
Engine function test	An engine test run was performed.

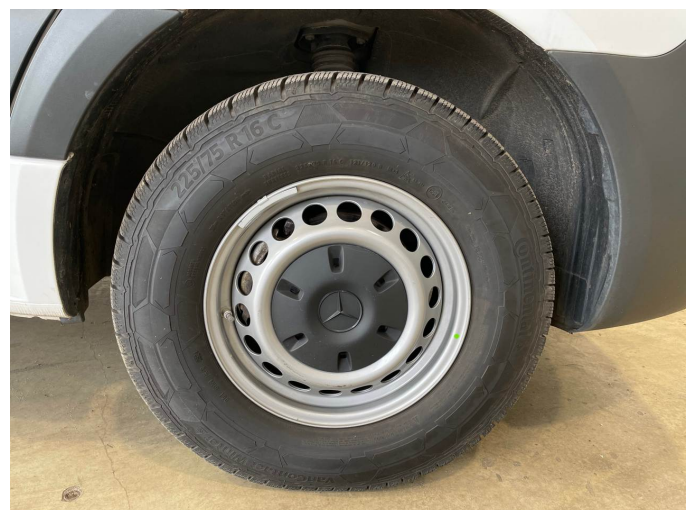
Figure 12: Mounted tyres

#	Tyre size	Type of tyre	Manufacturer	Tread depth
1)	225/75 R16 121R	Winter tyres on Steel	Continental	9mm / 9mm
2)	225/75 R16 121R	Winter tyres on Steel	Continental	7mm / 7mm

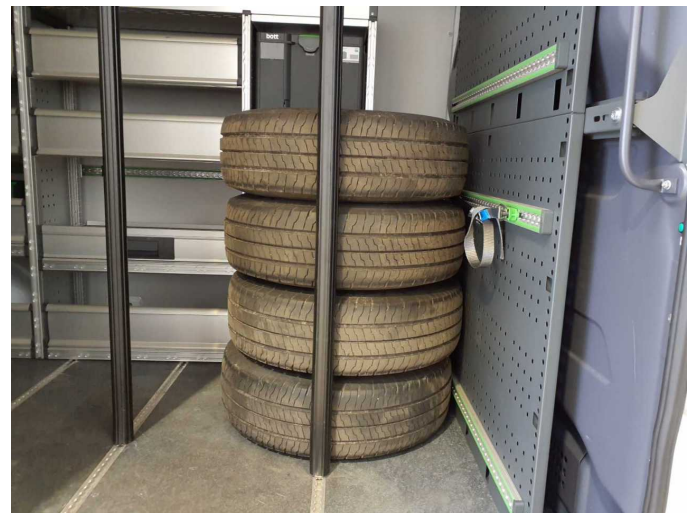
Figure 16: Additional tyres

#	Tyre size	Type of tyre	Manufacturer	Tread depth
1)	225/75 R16 121R	Summer tyres on Steel	Continental	6mm / 6mm
2)	225/75 R16 121R	Summer tyres on Steel	Continental	8mm / 8mm
