Expertise

Protocol number: 46916854  
Order No. / Reference: 26751035  
Inspection date: 5 Aug 2026

Manufacturer: Mercedes-Benz

Model: C 400 e 4Matic 9G-TRONIC Avantgarde

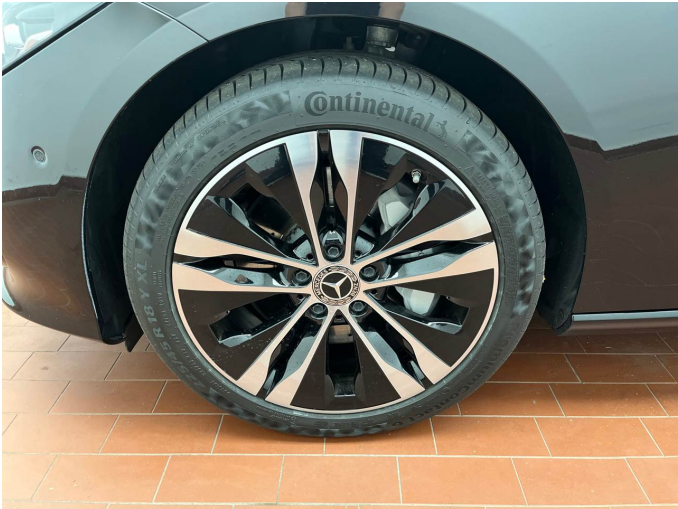
Figure 12: Mounted tyres

| # | Tyre size | Type of tyre | Manufacturer | Tread depth |
|---|---|---|---|---|
| 1) | 225/45 R18 95Y | Summer tyres on Light alloy | Continental | 6mm / 6mm |
| 2) | 255/40 R18 99Y | Summer tyres on Light alloy | Continental | 7mm / 7mm |

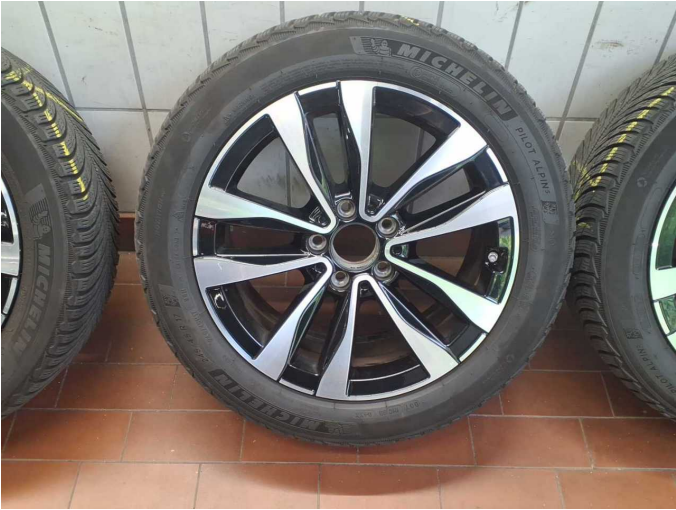
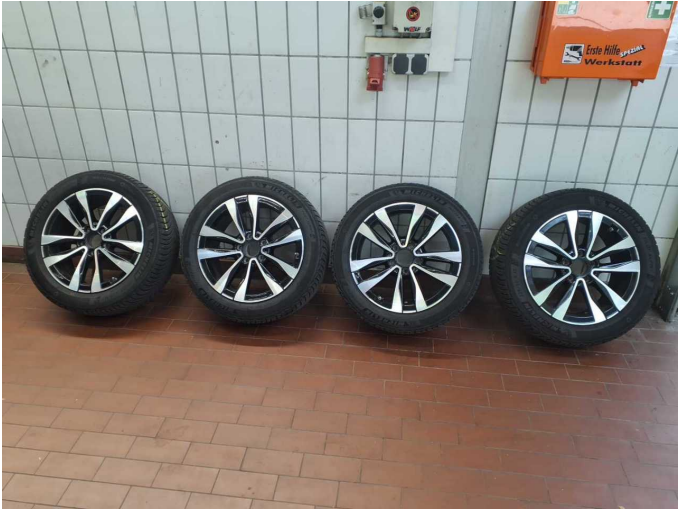
| # | Tyre size | Type of tyre | Manufacturer | Tread depth |
|---|---|---|---|---|
| 1) | 225/50 R17 98H | Winter tyres on Light alloy | Michelin | 6mm / 6mm |
| 2) | 245/45 R17 99H | Winter tyres on Light alloy | Michelin | 6mm / 6mm |

Figure 15: Additional tyres

Figure 16: Additional tyres

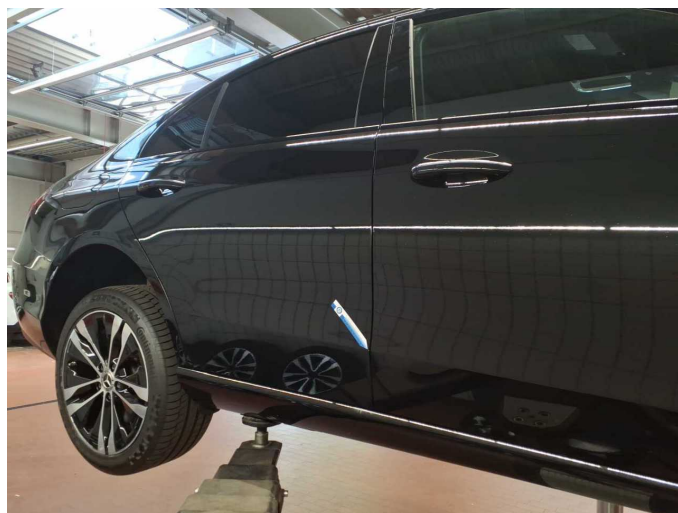
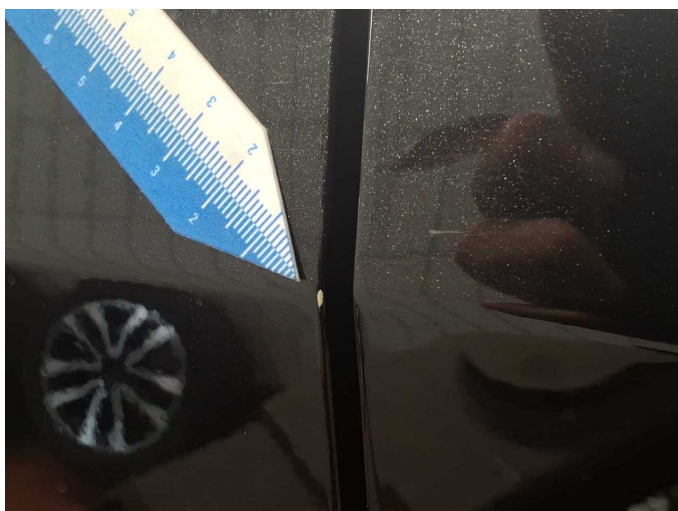
**Damage 1:** Door - rear right side: Door - Scratch(es) - Smart repair

| No. | Component group | Description |
|---|---|---|
| 1 | Door - rear right side | Door - Scratch(es) - Smart repair |

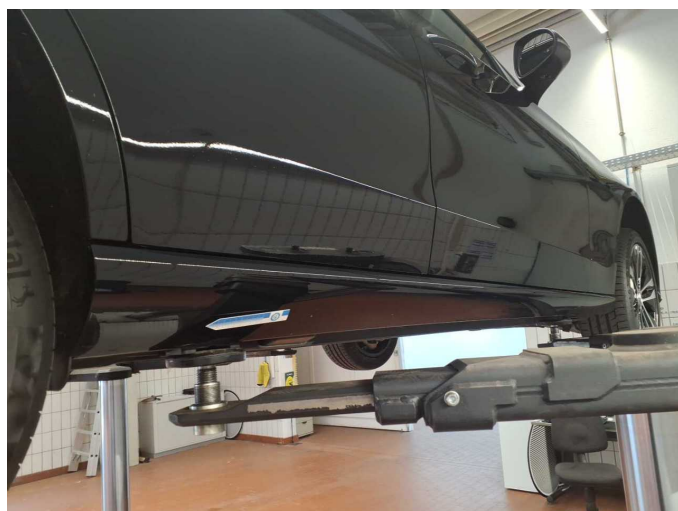
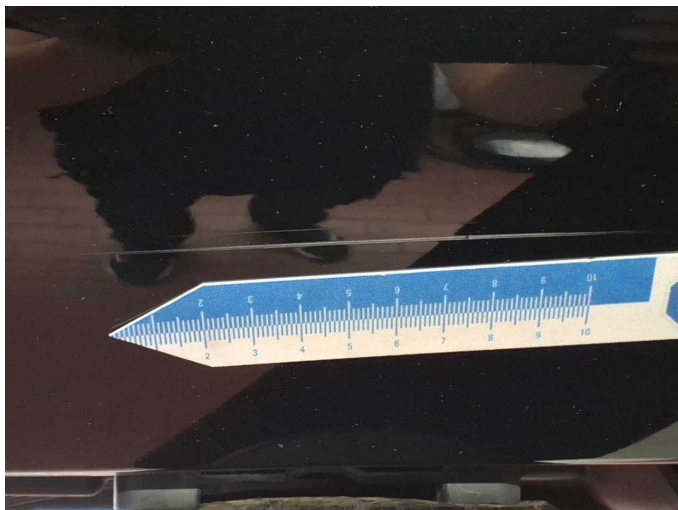
**Damage 2:** Sill - right side: Trim - Scratch(es) - Smart repair

| No. | Component group | Description |
|---|---|---|
| 2 | Sill - right side | Trim - Scratch(es) - Smart repair |

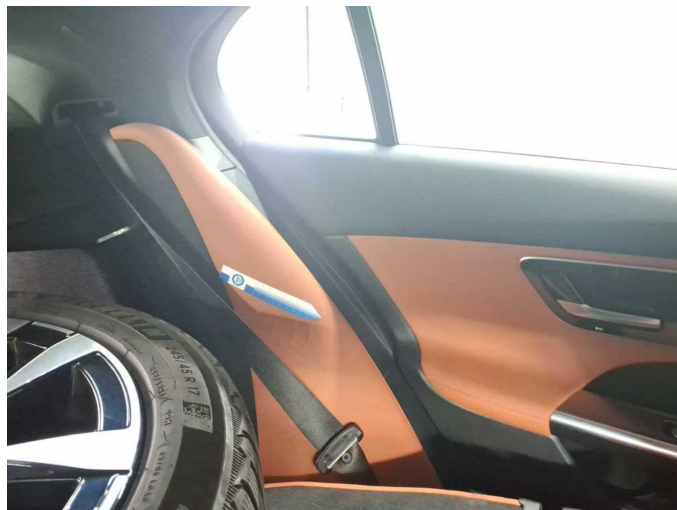
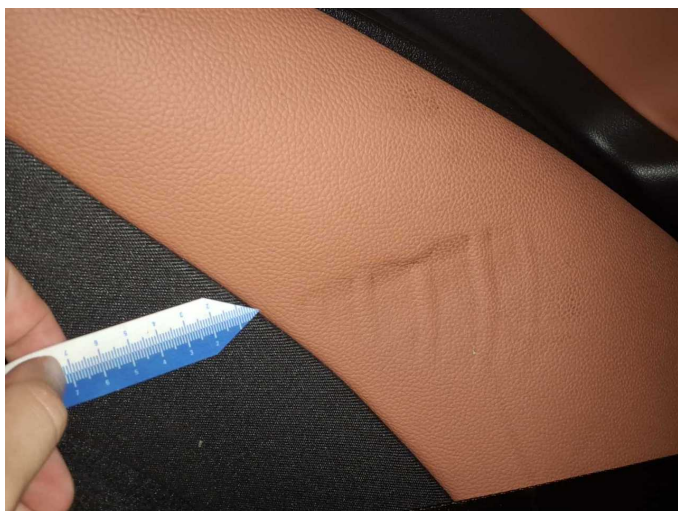
**Damage 3:** Side panel - rear left side: Interior trim (Polster Einstieg Links; Reifenabdruck) - Smart repair

| No. | Component group | Description |
|---|---|---|
| 3 | Side panel - rear left side | Interior trim (Polster Einstieg Links; Reifenabdruck) - Smart repair |

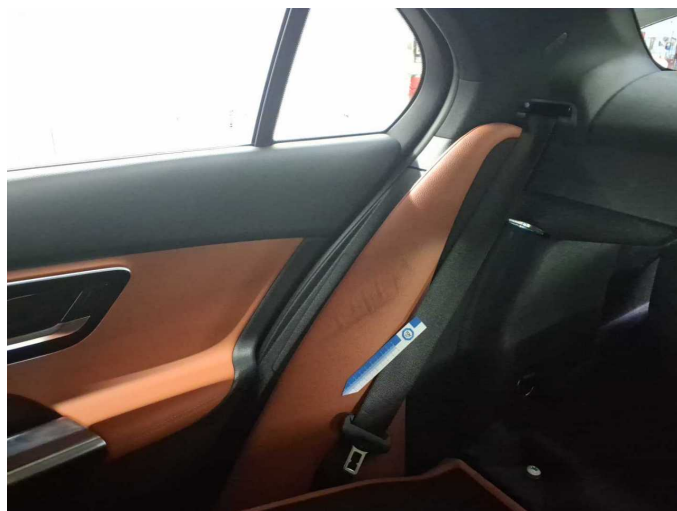
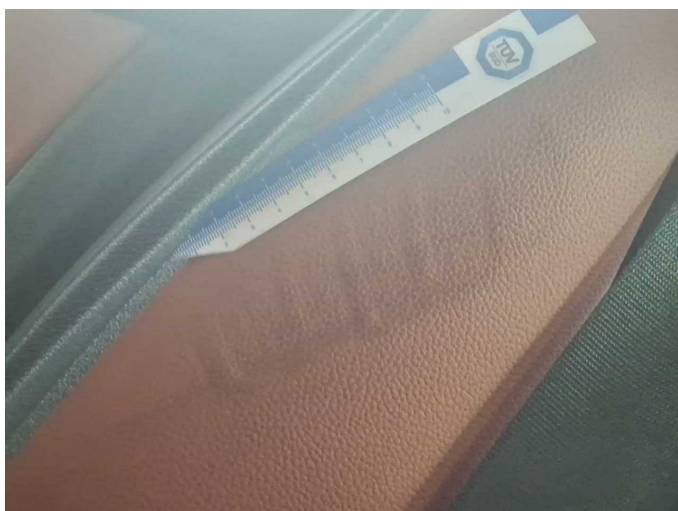
**Damage 4:** Side panel - rear right side: Interior trim (Polster Einstieg Rechts; Reifenabdruck) - Smart repair

| No. | Component group | Description |
|---|---|---|
| 4 | Side panel - rear right side | Interior trim (Polster Einstieg Rechts; Reifenabdruck) - Smart repair |

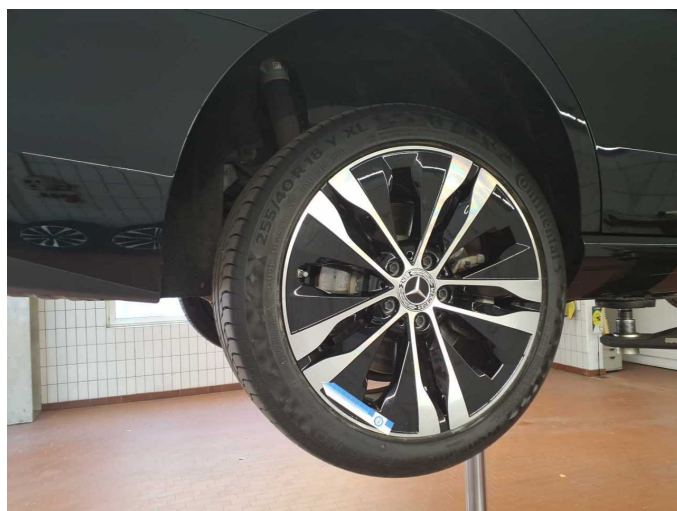
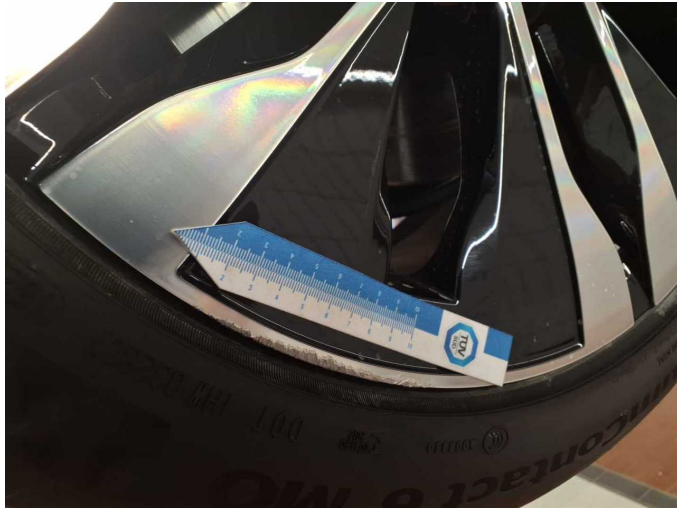
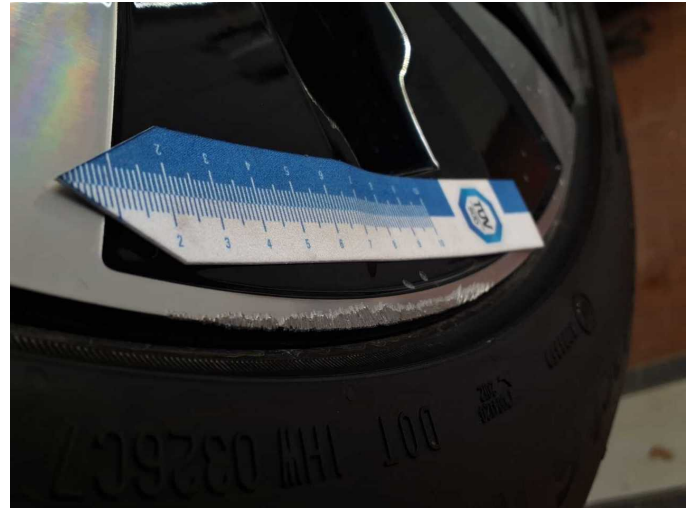
**Damage 5:** Wheel / tyres: Alloy rim - rear right side - Scratched - Replace

| No. | Component group | Description |
|---|---|---|
| 5 | Wheel / tyres | Alloy rim - rear right side - Scratched - Replace |

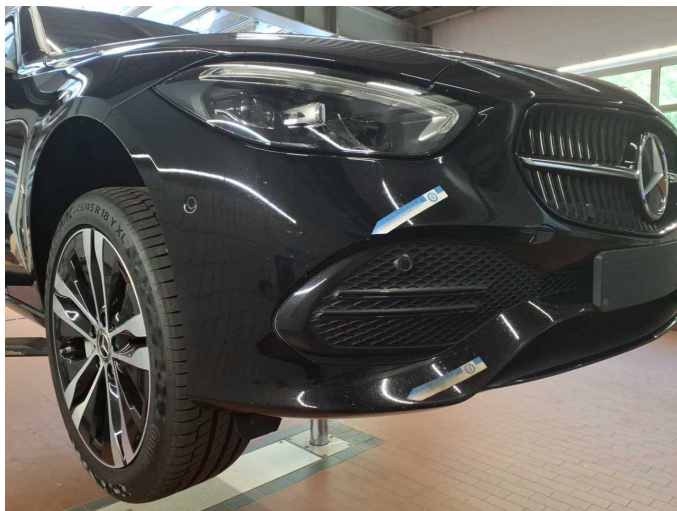
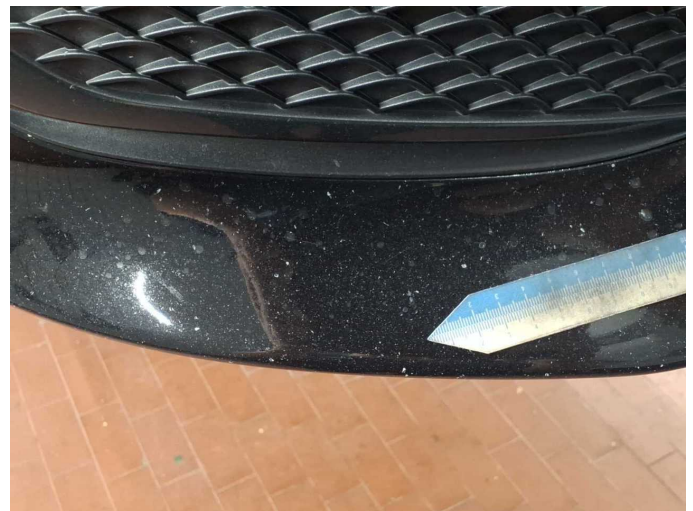
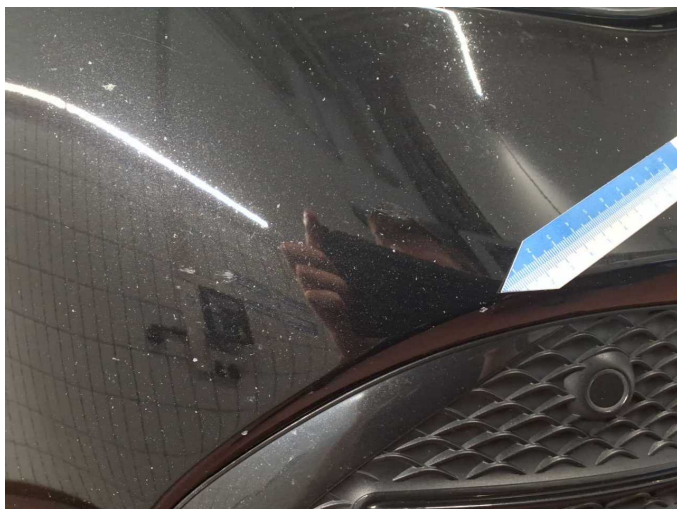
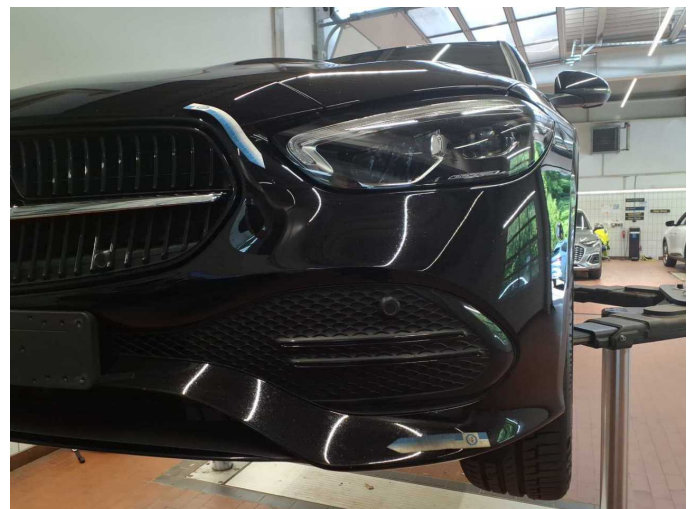
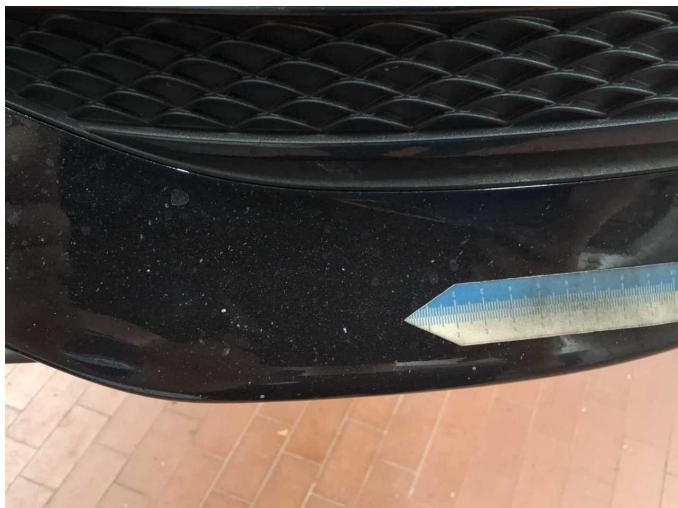
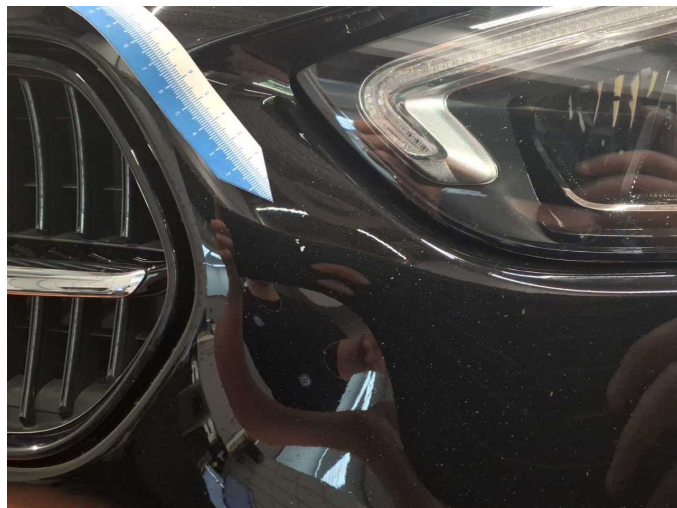
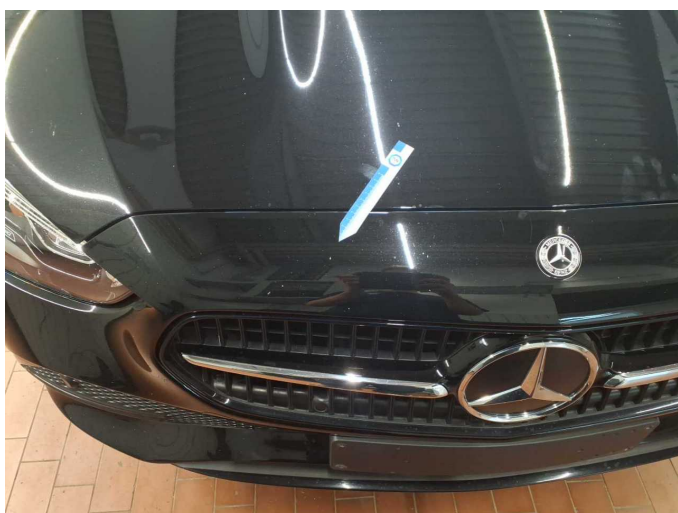
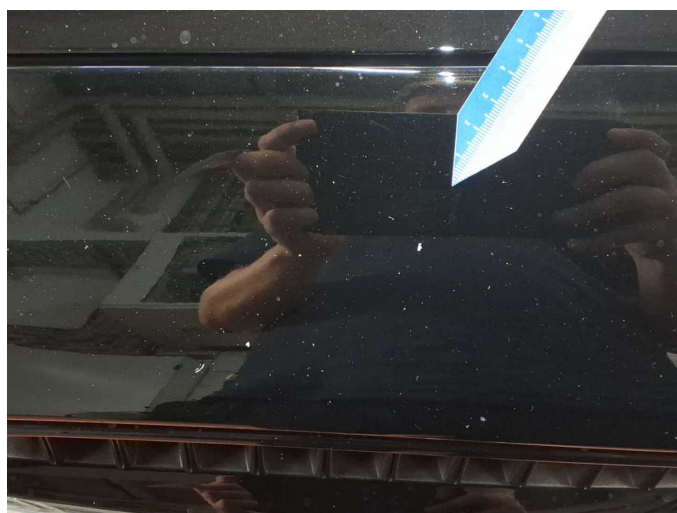
**Damage 6:** Front bumper: Front bumper - Stone chips - Paint

| No. | Component group | Description |
|---|---|---|
| 6 | Front bumper | Front bumper - Stone chips - Paint |

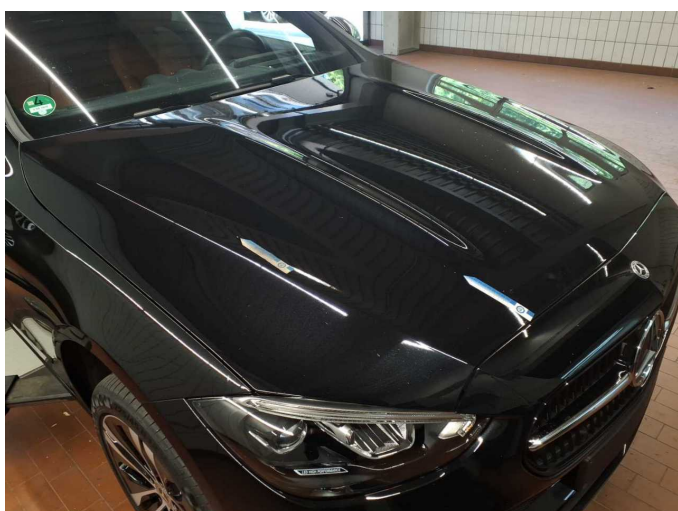
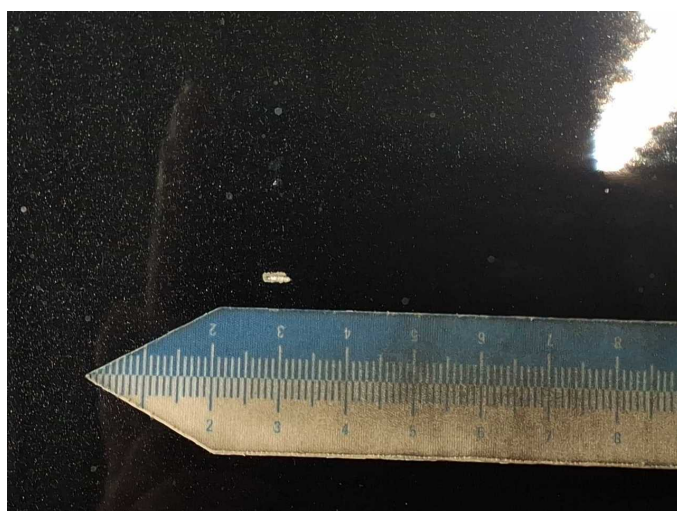
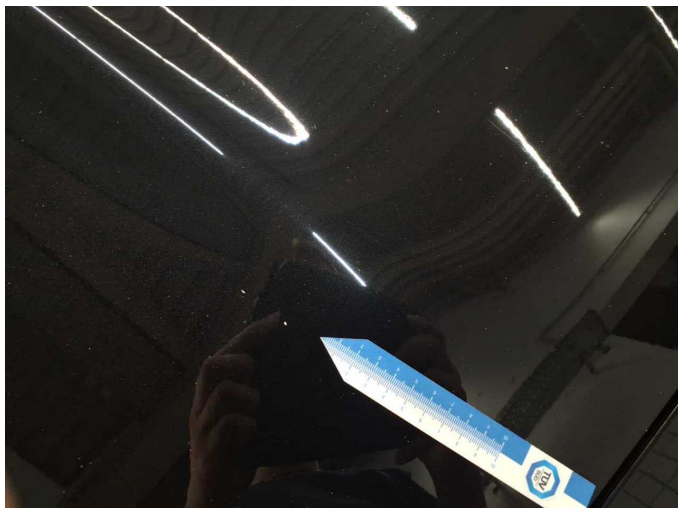
**Damage 7:** Bonnet: Bonnet (+ Steinschläge) - Scratch(es) - Paint

| No. | Component group | Description |
|---|---|---|
| 7 | Bonnet | Bonnet (+ Steinschläge) - Scratch(es) - Paint |
