Expertise

Protocol number: 45234339
Order No. / Reference: 26242439
Inspection date: 23 Apr 2026

Model: S 400 d 4Matic L 9G-TRONIC

VIN: W1K6G3DBXPA203989

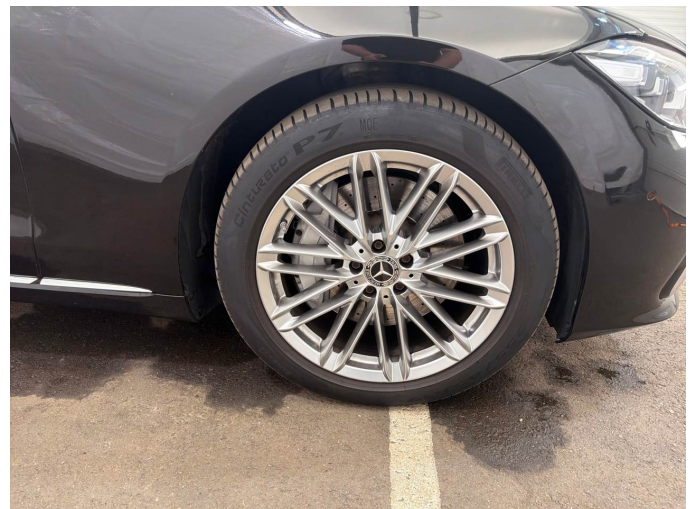
#	Tyre size	Type of tyre	Manufacturer	Tread depth
1)	255/45 R19 104Y	Summer tires (with run-flat tires) on Light alloy	Pirelli	5mm / 5mm
2)	255/45 R19 104Y	Summer tires (with run-flat tires) on Light alloy	Pirelli	5mm / 5mm

Figure 12: Mounted tyres

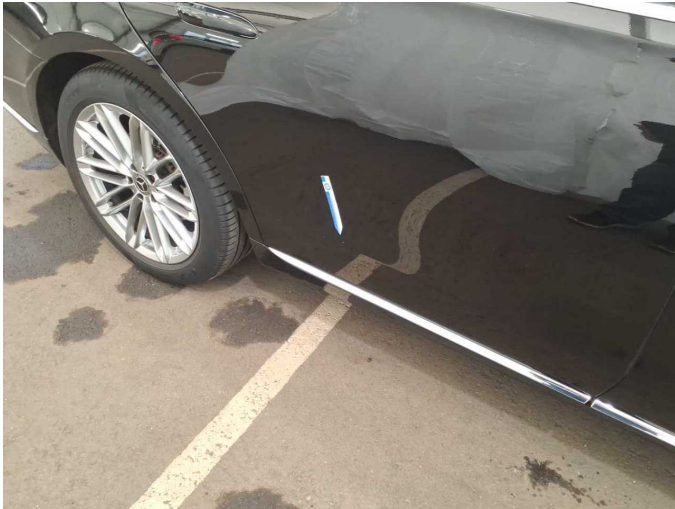
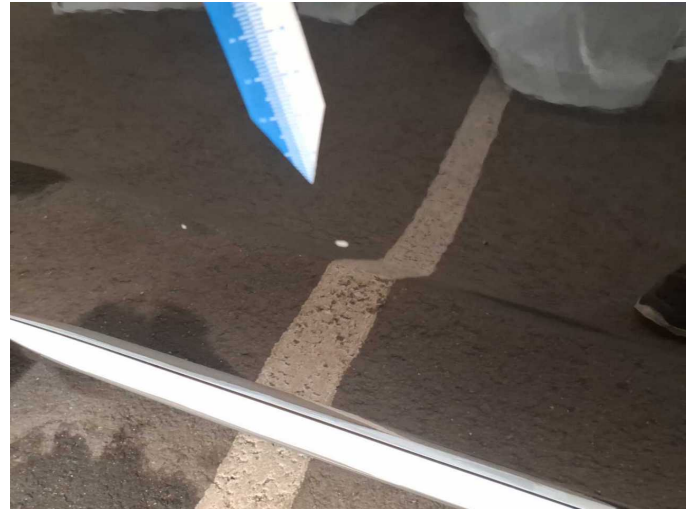
Damage 1: Door - rear right side: Door - Scratched - Smart repair

No.	Component group	Description
1	Door - rear right side	Door - Scratched - Smart repair
2	Body	A-pillar - right side - Stone chips - Smart repair
3	Wheel / tyres	Alloy rim - front right side - Scratched - Loss in value

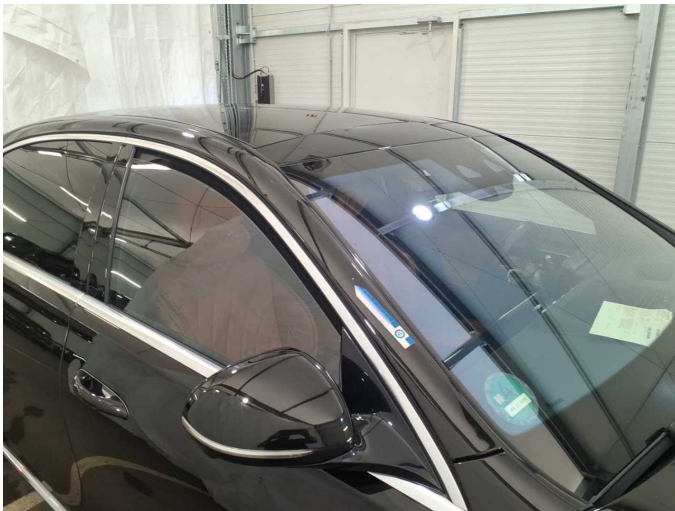
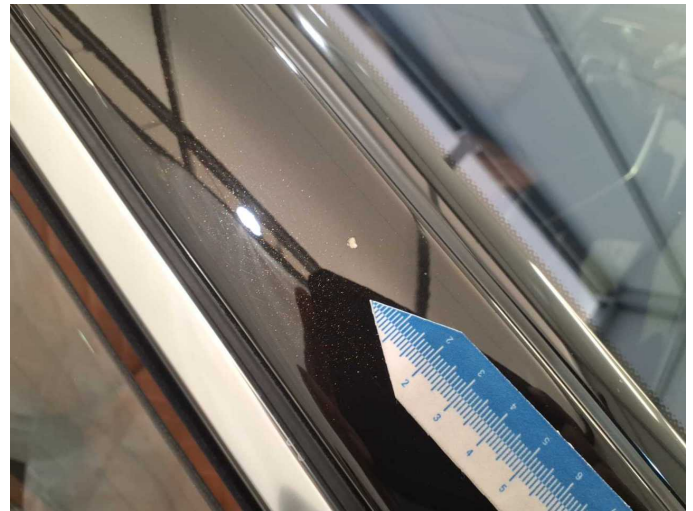
Damage 2: Body: A-pillar - right side - Stone chips - Smart repair

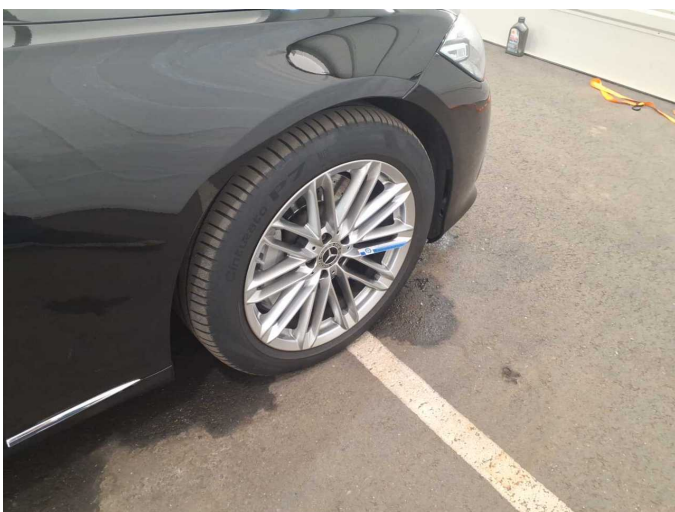
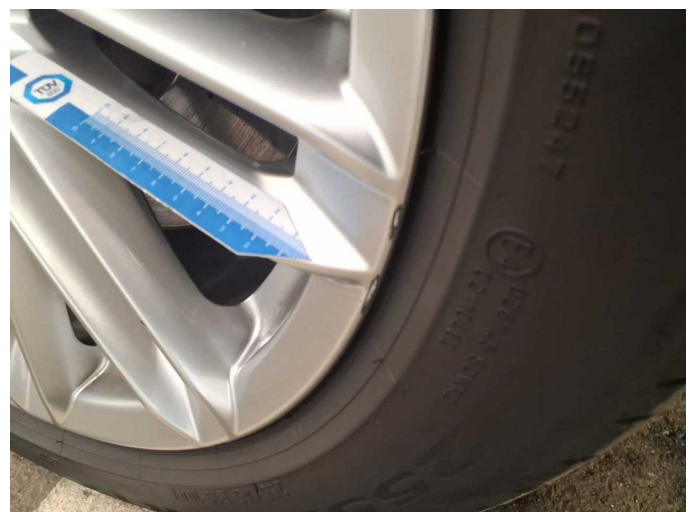
Damage 3: Wheel / tyres: Alloy rim - front right side - Scratched - Loss in value

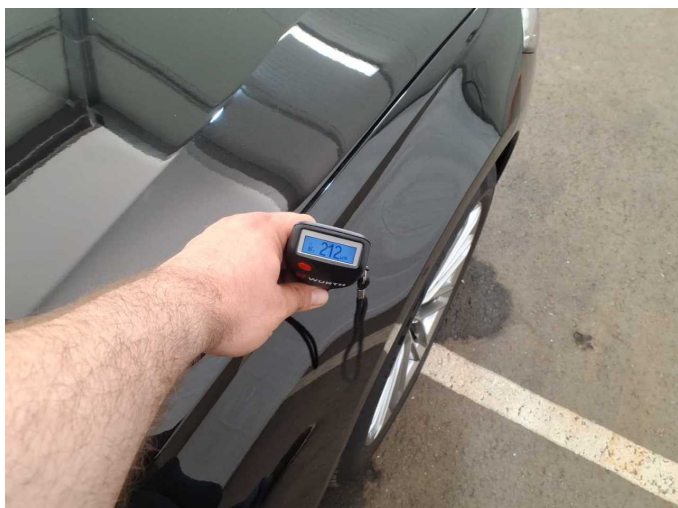
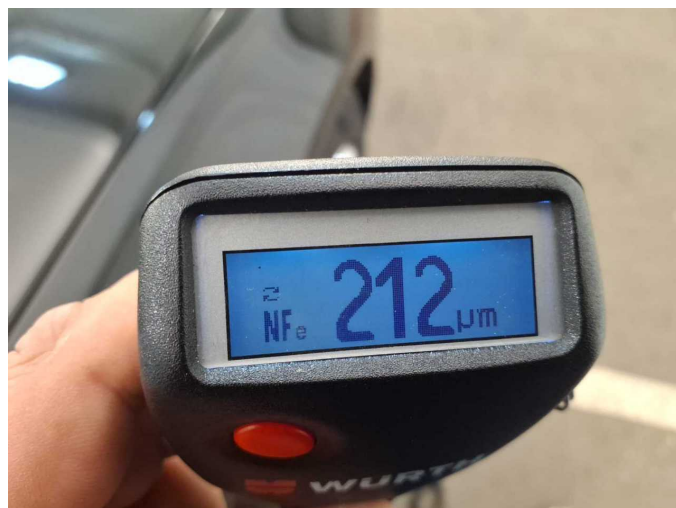
No.	Repainting
1	Mudguard - right side, Professionally carried out, Invoice of repair done Non-existent
2	Bonnet, Professionally carried out, Invoice of repair done Non-existent

Mudguard - right side	212 µm	Bonnet	307 µm
-----------------------	--------	--------	--------

Repainting 1: Mudguard - right side

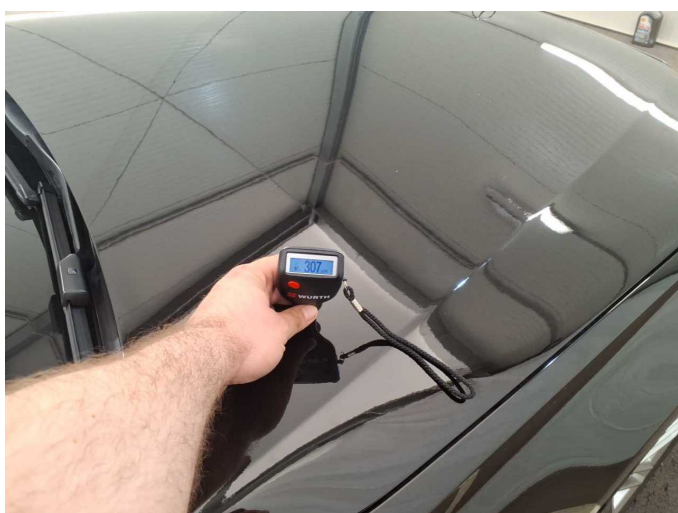
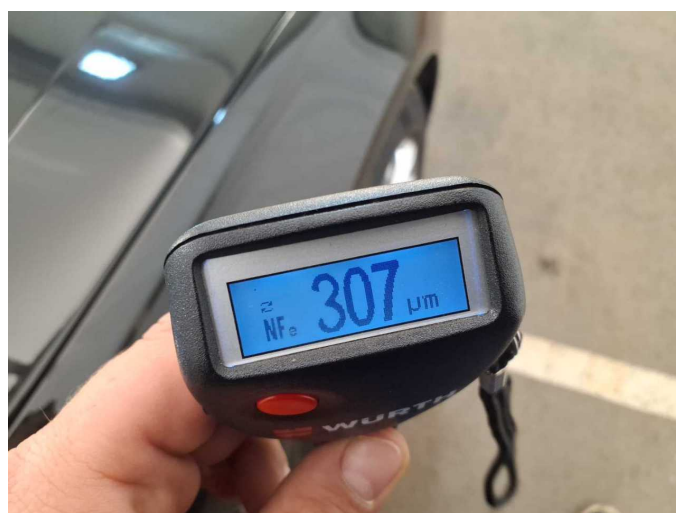
Repainting 2: Bonnet
