Expertise

Protocol number: 46401174  
Order No. / Reference: 26690758  
Inspection date: 8 Jul 2026

Manufacturer: Mercedes-Benz

Model: GLC 220 d 4Matic 9G-TRONIC Avantgarde Advanced

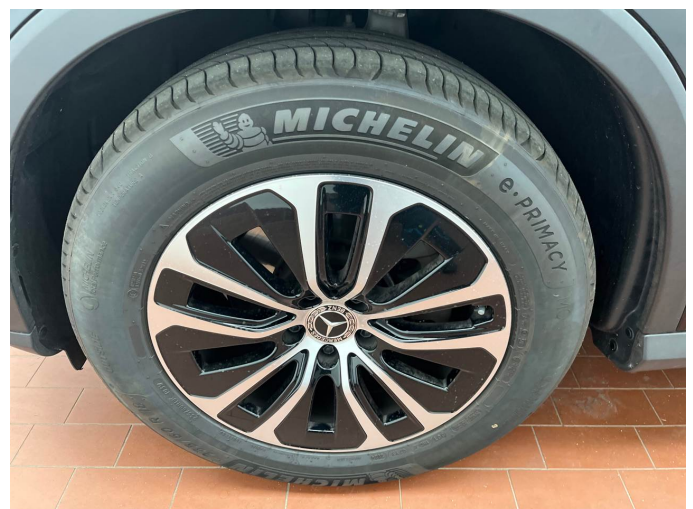
**Figure 12: Mounted tyres**

| # | Tyre size | Type of tyre | Manufacturer | Tread depth |
|---|---|---|---|---|
| 1) | 235/60 R18 103W | Summer tyres on Light alloy | Michelin | 6mm / 6mm |
| 2) | 235/60 R18 103W | Summer tyres on Light alloy | Michelin | 6mm / 6mm |

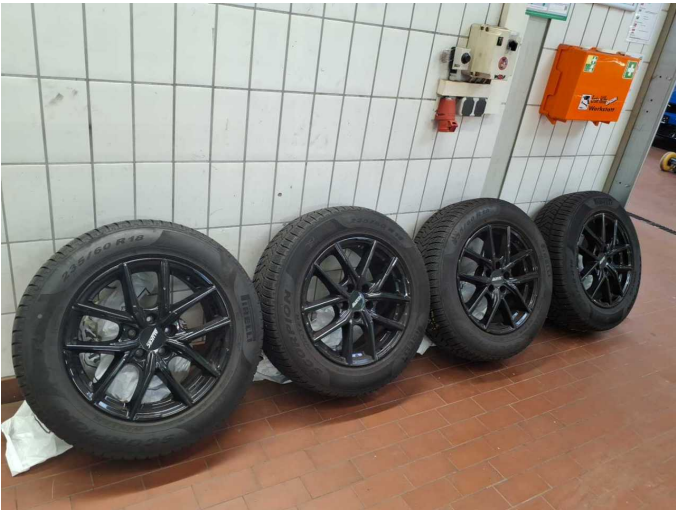
Figure 15: Additional tyres

| # | Tyre size | Type of tyre | Manufacturer | Tread depth |
|---|---|---|---|---|
| 1) | 235/60 R18 103H | Winter tyres on Light alloy | Pirelli | 6mm / 6mm |
| 2) | 235/60 R18 103H | Winter tyres on Light alloy | Pirelli | 7mm / 7mm |

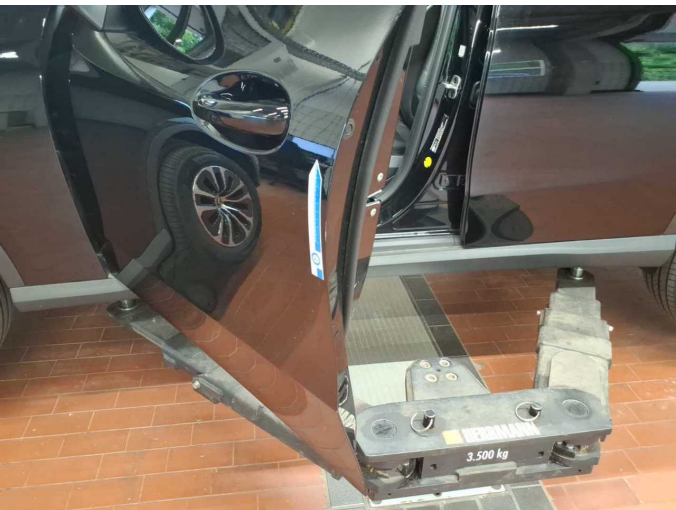
| No. | Component group | Description |
|---|---|---|
| 1 | Door - front left side | Door edge - Scratch(es) - Smart repair |

Damage 1: Door - front left side: Door edge - Scratch(es) - Smart repair

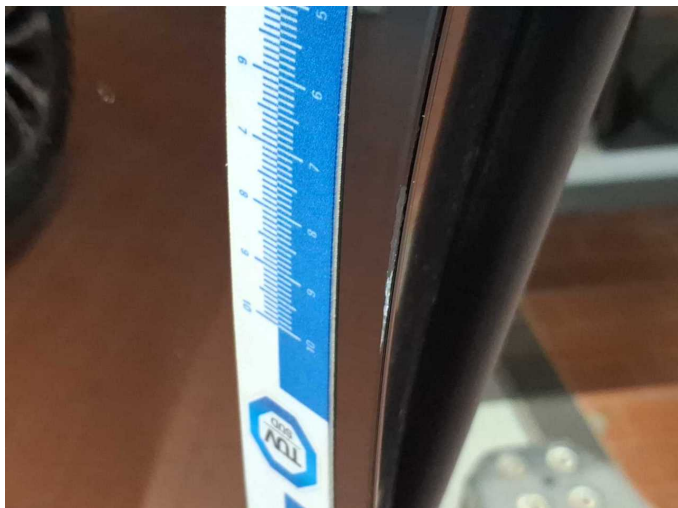
**Damage 1:** Door - front left side: Door edge - Scratch(es) - Smart repair

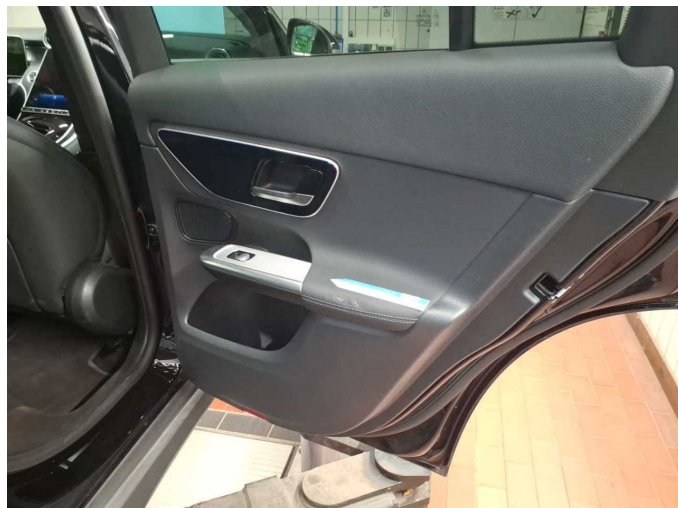
| No. | Component group | Description |
|---|---|---|
| 2 | Trim / covers | Door trim - rear right side - dent(s) - Loss in value |

**Damage 2:** Trim / covers: Door trim - rear right side - dent(s) - Loss in value

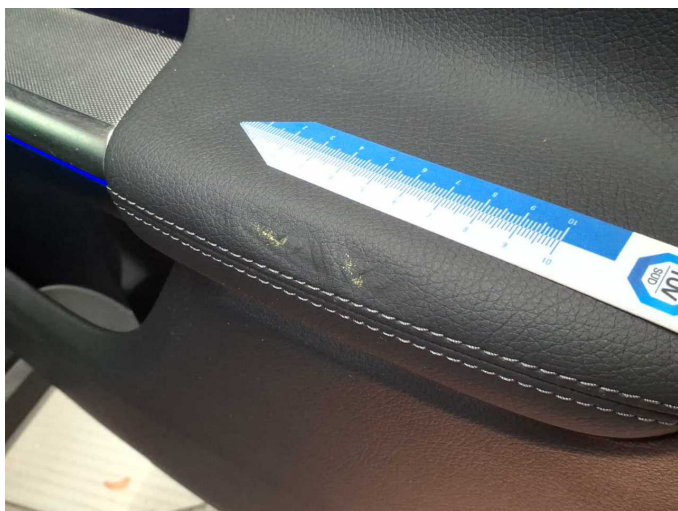
**Damage 2:** Trim / covers: Door trim - rear right side - dent(s) - Loss in value

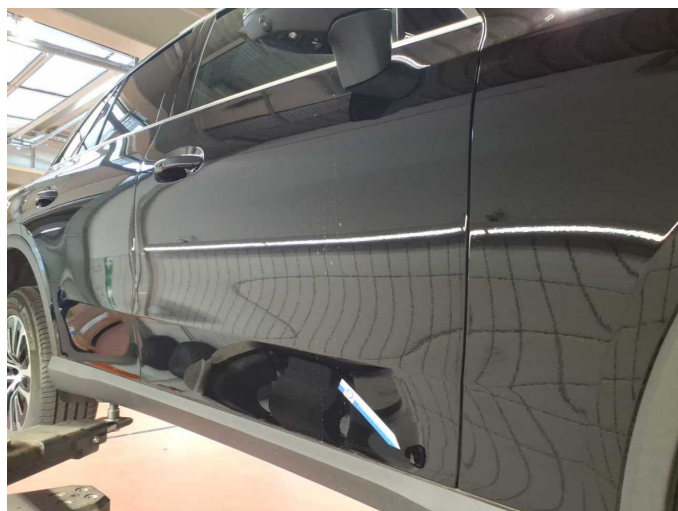
| No. | Component group | Description |
|---|---|---|
| 3 | Door - front right side | Door - Dent / paintcoat damage - Smart repair |

**Damage 3:** Door - front right side: Door - Dent / paintcoat damage - Smart repair

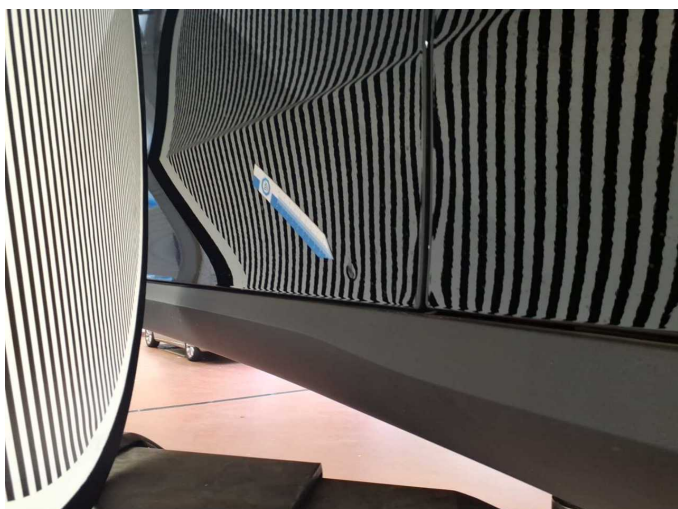
**Damage 3:** Door - front right side: Door - Dent / paintcoat damage - Smart repair

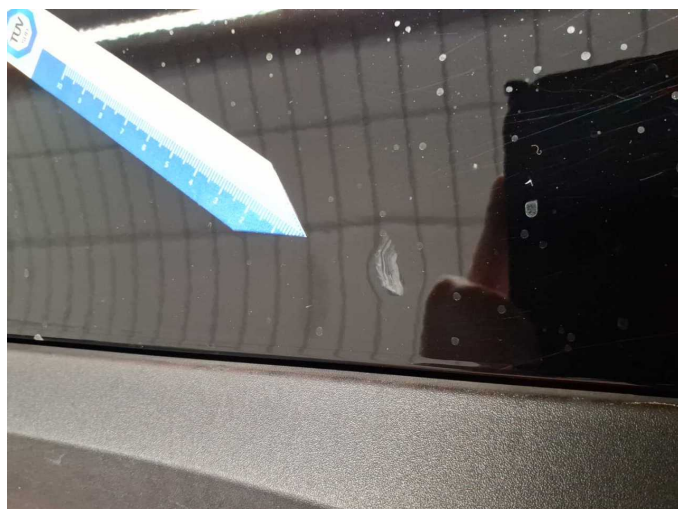
**Damage 3:** Door - front right side: Door - Dent / paintcoat damage - Smart repair

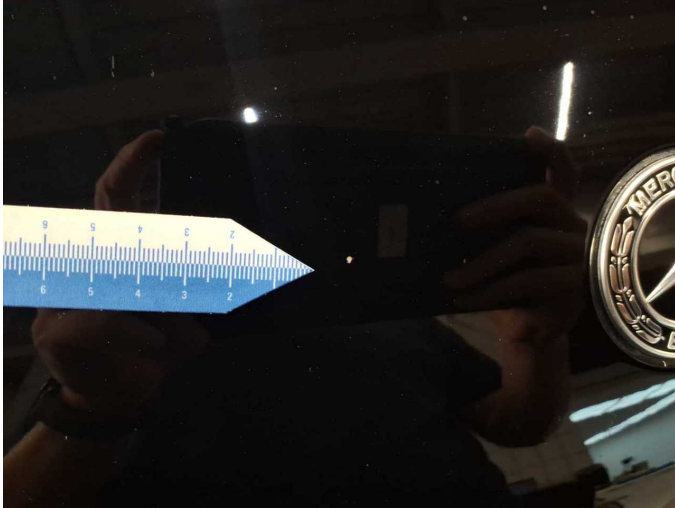
| No. | Component group | Description |
|---|---|---|
| 1 | Bonnet | Bonnet - Stone chips - No deduction |

**Wear and tear 1:** Bonnet: Bonnet - Stone chips - No deduction
