2-FAJ-896 · Move! 1.0 TSI 110cv DSG unicolor · 28 July 2026 · Zaventem (BE)

Specifications

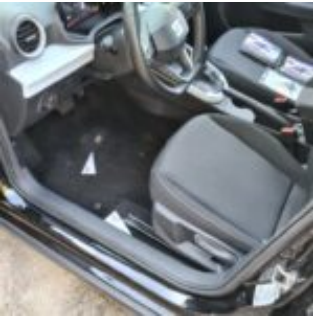
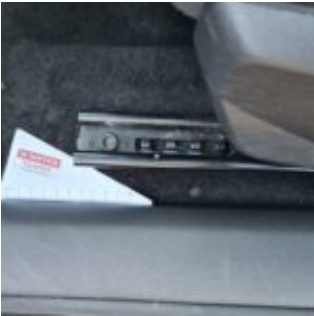
| Damage Part | Damage Type | Notes | Repair Type | Acceptable |
|---|---|---|---|---|
| Interior | Burned | Vloerbedekking | Cloth Repair | No |

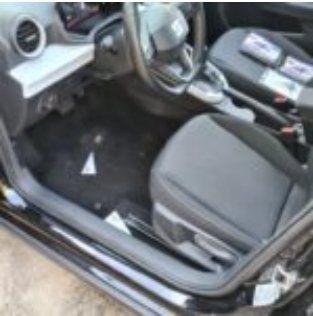
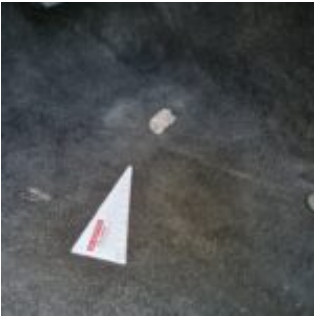
| Damage Part | Damage Type | Notes | Repair Type | Acceptable |
|---|---|---|---|---|
| Interior | Damaged | Vloerbedekking | Cloth Repair | No |

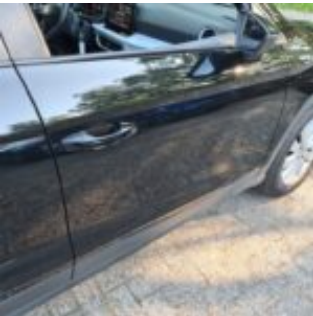
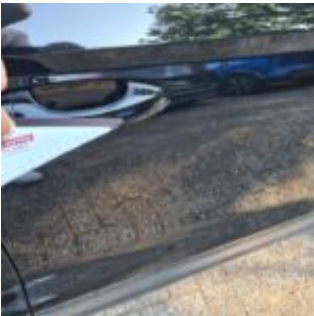
| Damage Part | Damage Type | Notes | Repair Type | Acceptable |
|---|---|---|---|---|
| Frontdoor – Right | Small scratch(es) | Handgreep | Acceptable | Yes |

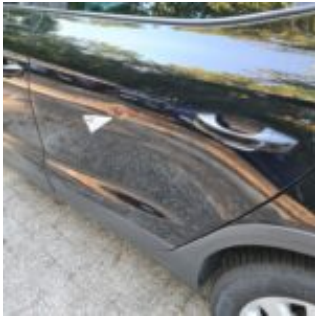
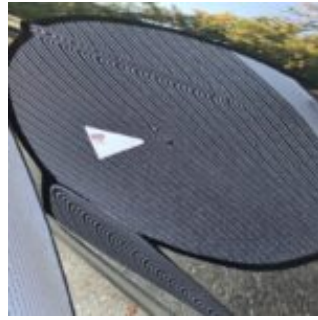
Damage Part  
Reardoor - Left

Damage Type  
Small dent(s)

Acceptable  
No

Repair Type  
Restyle

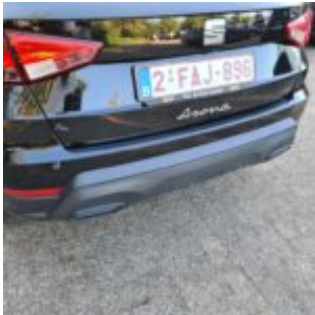
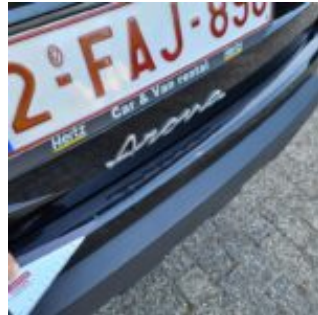
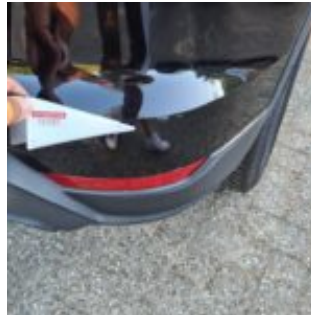
Damage Part  
Bumper - Rear

Damage Type  
Scratch(es)

Acceptable  
No

Repair Type  
Spray

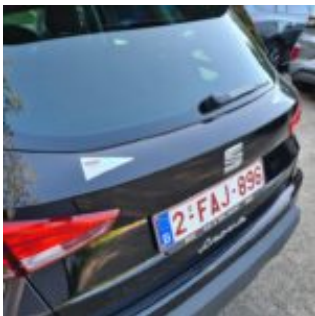
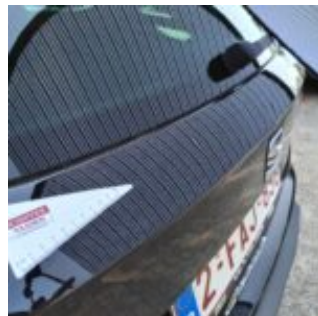
Damage Part  
Tailgate

Damage Type  
Small dent(s)

Acceptable  
No

Repair Type  
Restyle
