Zustandsbericht / Minderwertgutachten

Mobility Concept GmbH, Grünwalder Weg 34, 82041 Oberhaching
12.06.2026

Erstzulassung	10.06.2022	Letzte Zulassung	10.06.2022
Fahrzeugart	PKW	Hersteller	SEAT
Typ / Verkaufsbez.	Ibiza 1.0 TSI S&S Fast Lane FR Pro	Aufbauart	Limousine
Türen	5	Sitzplätze	5
Fahrzeug-Ident.-Nr.	VSSZZKJZNR106625	HSN / TSN	7593 / ANG
Schlüssel-Nr.	10192874	Km-Stand abgelesen	25380
Nächste HU §29 StVZO	02 / 2028	Energiequelle / Kraftstoff	Benzin
Zylinderanzahl	4 / Reihenmotor	Leistung (kW)	70
Hubraum (ccm)	999	Schadstoffklasse:	EURO6;WLTP;AP;PI/CI; M, N1 I
Antriebsart	Frontantrieb	Getriebe / Gänge	Schaltgetriebe / 5
Felgen	Leichtmetall	Farbe	Blau / Metallic
Polster / Farbe	Stoff / Anthrazit

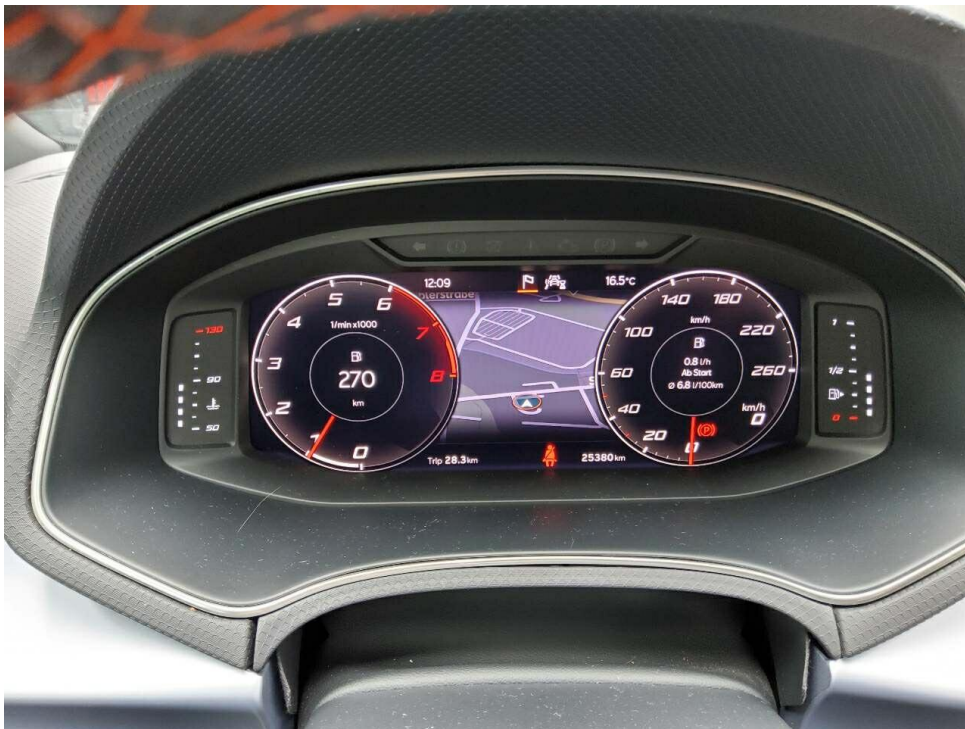
Bild 6 : Kombiinstrument (betriebsbereit) mit Km-Stand

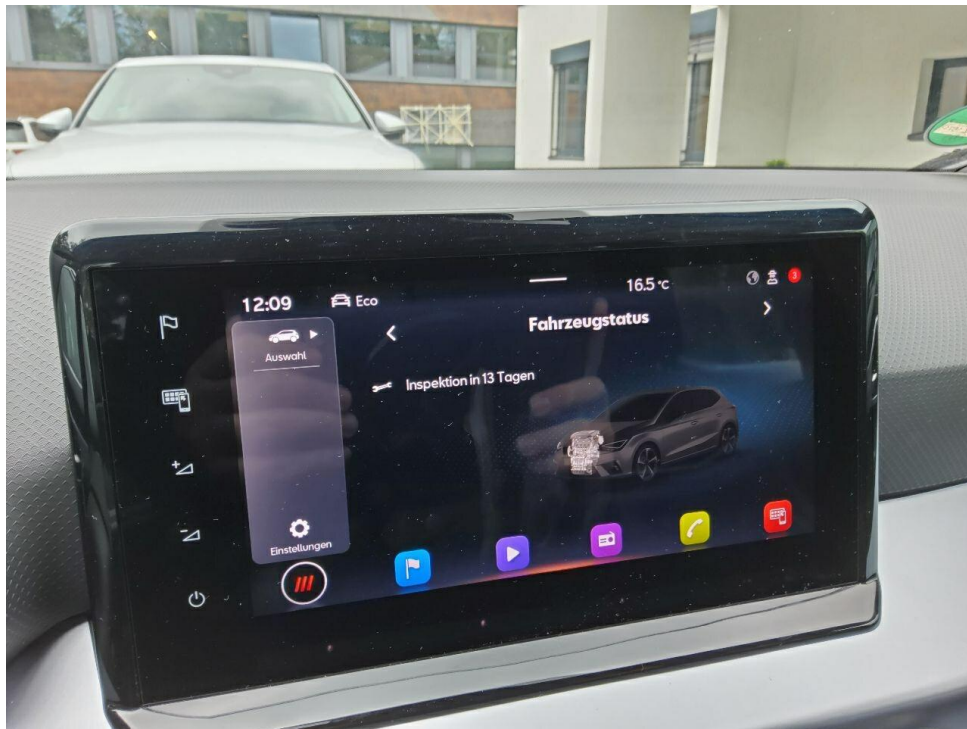
Bild 7 : Serviceintervallanzeige

Wartungsnachweis: digital
letzte Wartung: am 01.09.2025 bei Kilometerstand 20.077
bis Wartung verbleiben: 13 Tage (zum Besichtigungszeitpunkt)

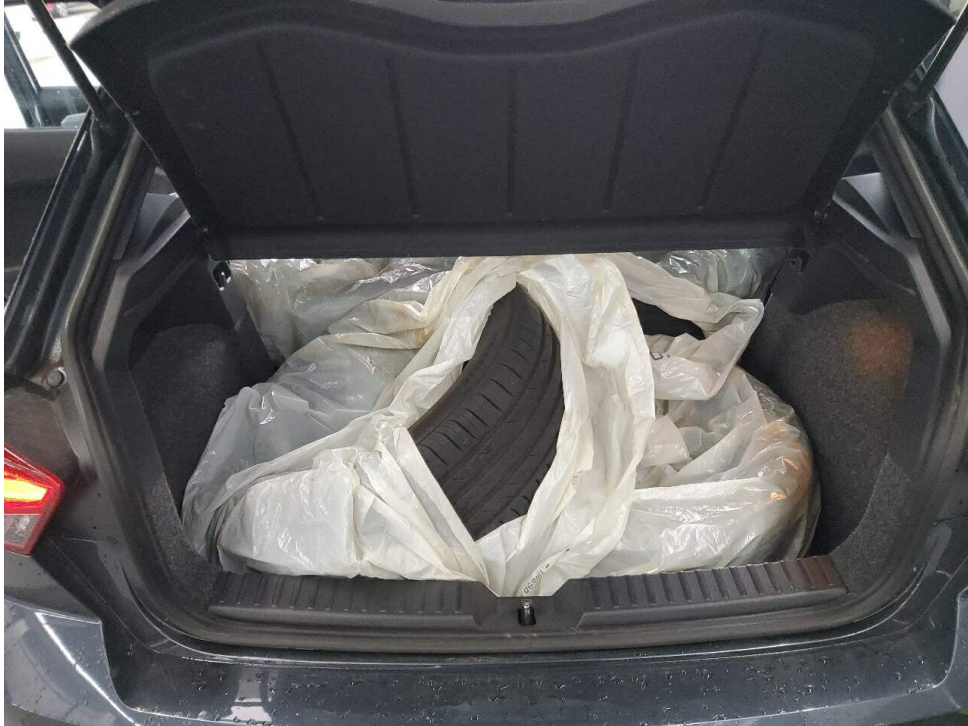
Bild 13 : 2. Radsatz

Reifenbezeichnung	Hersteller/Typ	Art	Profiltiefe
215 / 45 R 17 91 W	Nexen / N blue HD Plus RPB	S /O	6 mm
215 / 45 R 17 91 W	Nexen / N blue HD Plus RPB	S /O	6 mm
215 / 45 R 17 91 W	Nexen / N blue HD Plus RPB	S /O	6 mm
215 / 45 R 17 91 W	Nexen / N blue HD Plus RPB	S /O	6 mm

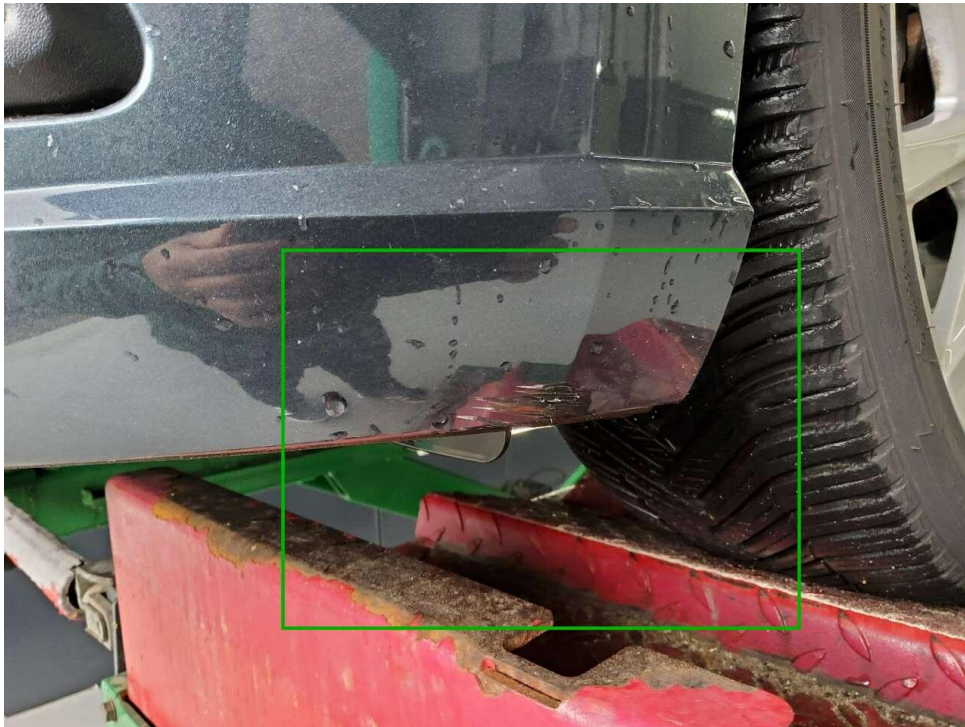
Bild 15 : Stoßfänger vorne links, verschrammt

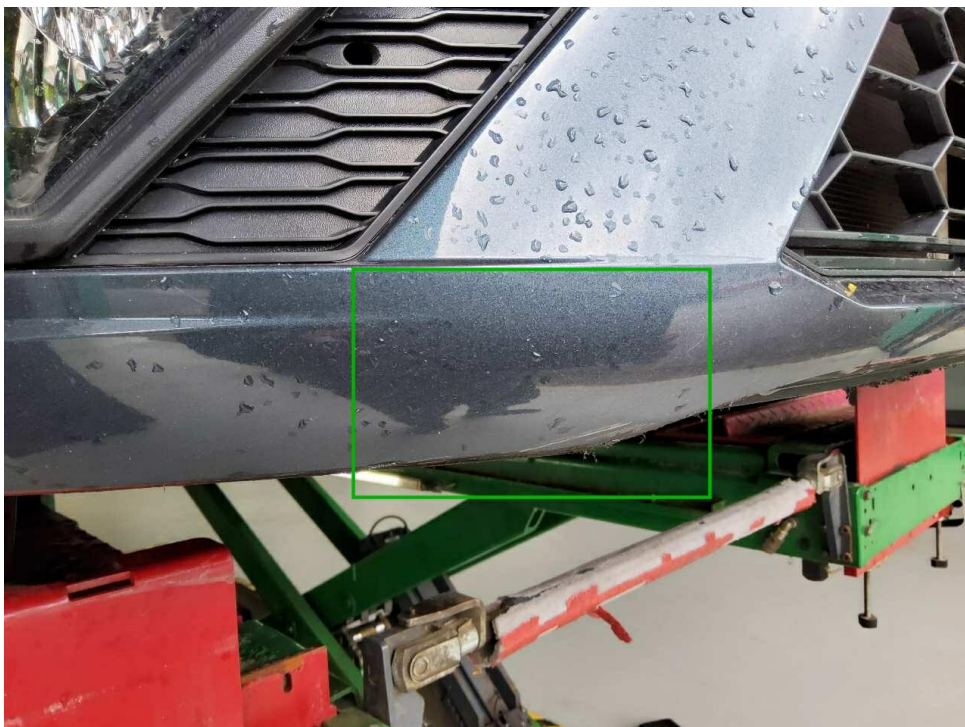
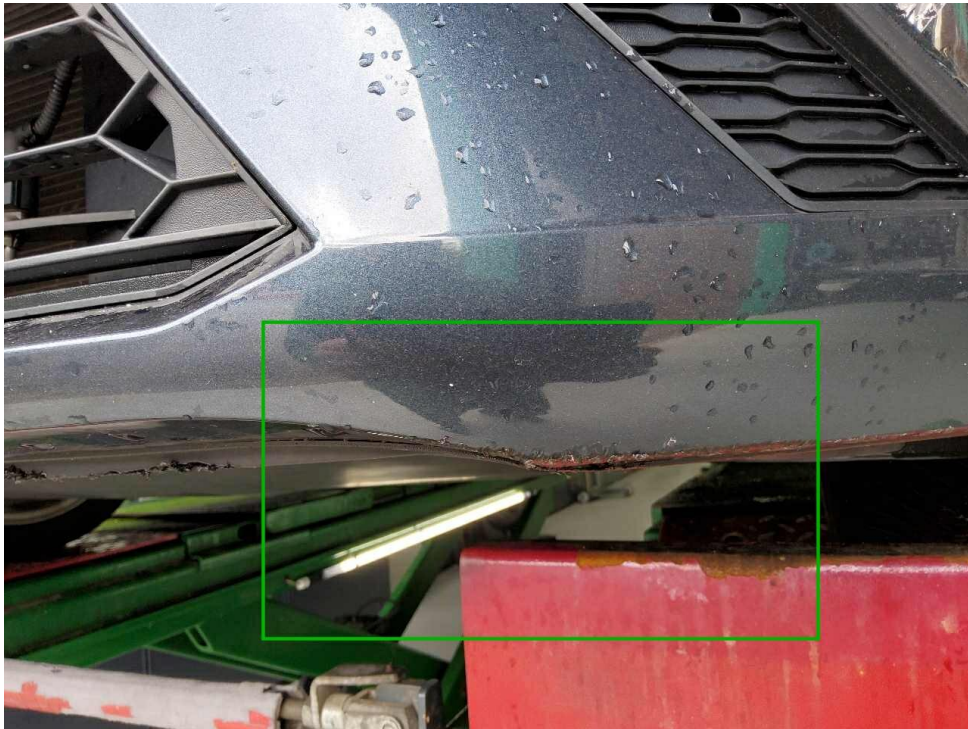
Bild 16 : Stoßfänger vorne, verschrammt

Bild 17 : Stoßfänger vorne, verschrammt

1. Stoßfänger vorne, verschrammt, smart
repair (Bild 16, 17)
