Protocol number: 44892141
Order No. / Reference: 26121020
Inspection date: 9 Apr 2026

Manufacturer: Audi

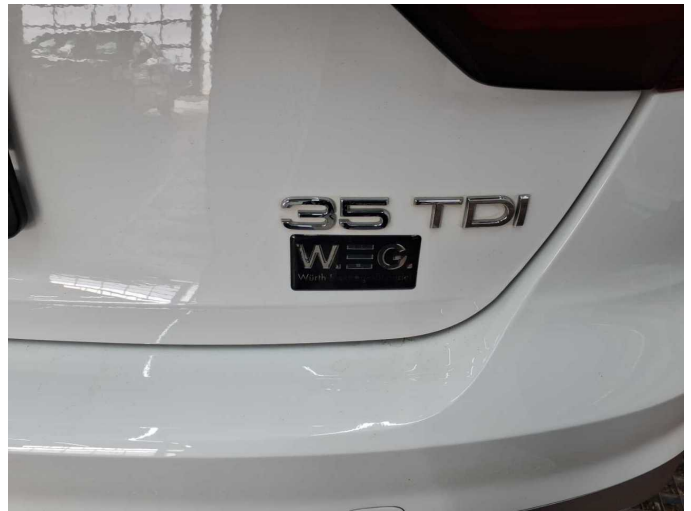
Damage 1: Boot lid / rear door: Boot lid - Glued / labelled - De-glue / neutralise

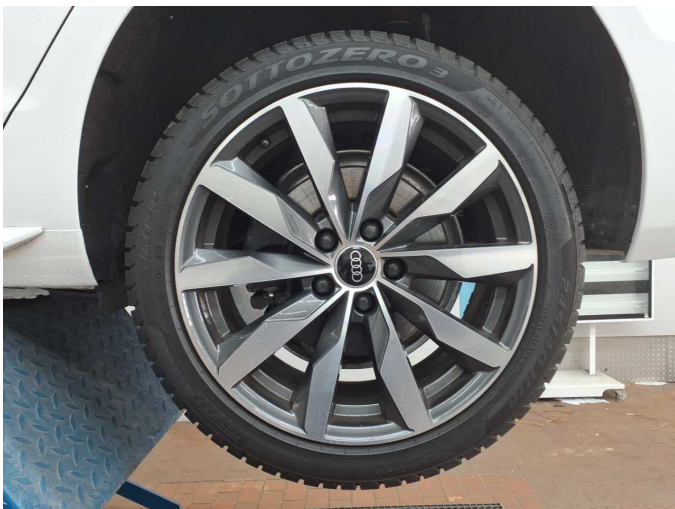
Damage 2: Wheel / tyres: Alloy rim - rear left side - Scratch(es) - Loss in value

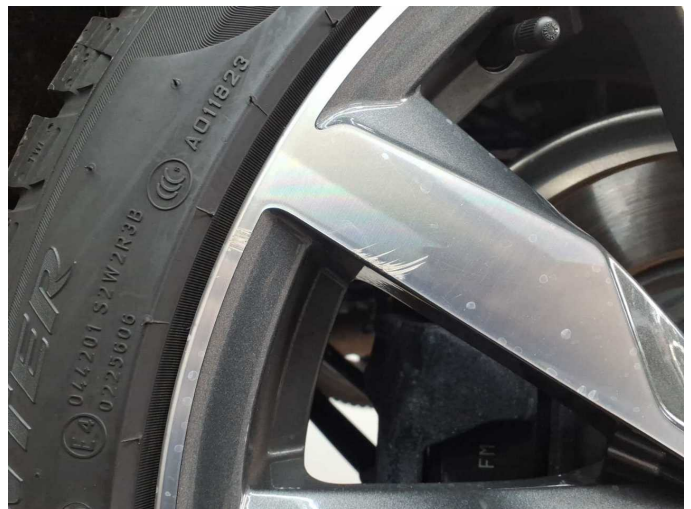
Damage 2: Wheel / tyres: Alloy rim - rear left side - Scratch(es) - Loss in value

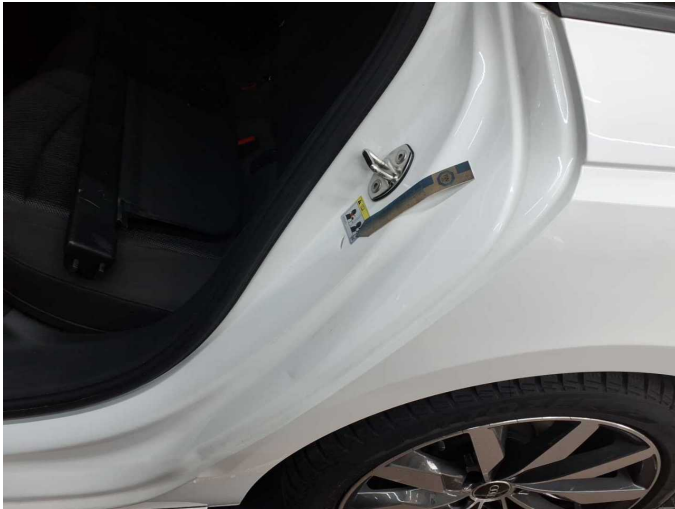
Damage 3: Side panel - rear left side: Sill - Dent / paintcoat damage - Paint

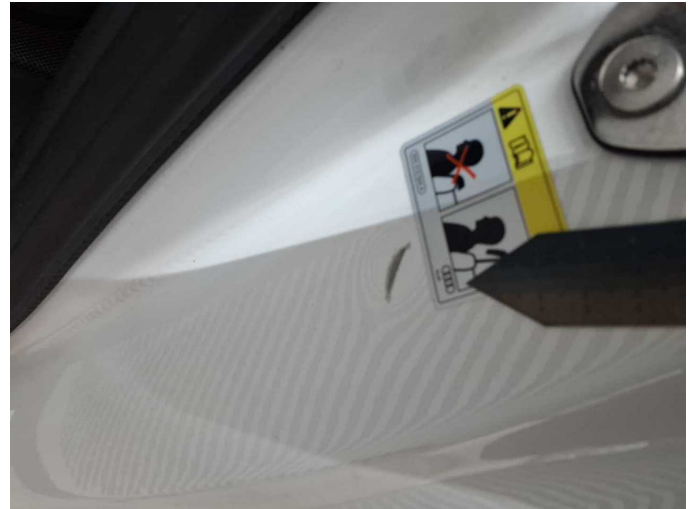
Damage 3: Side panel - rear left side: Sill - Dent / paintcoat damage - Paint

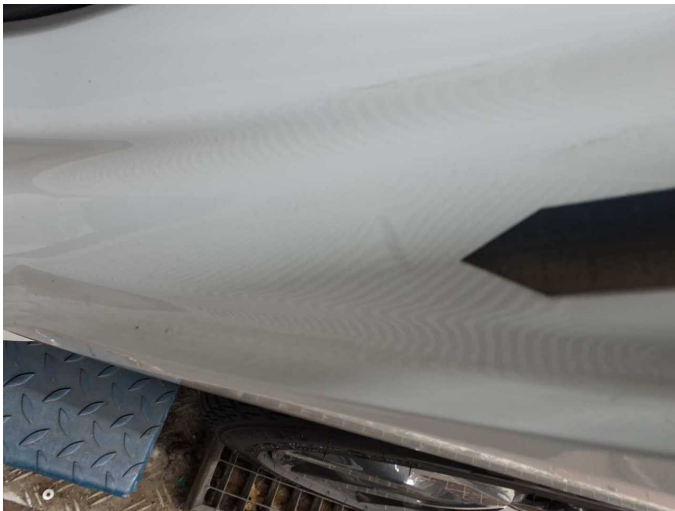
Damage 3: Side panel - rear left side: Sill - Dent / paintcoat damage - Paint

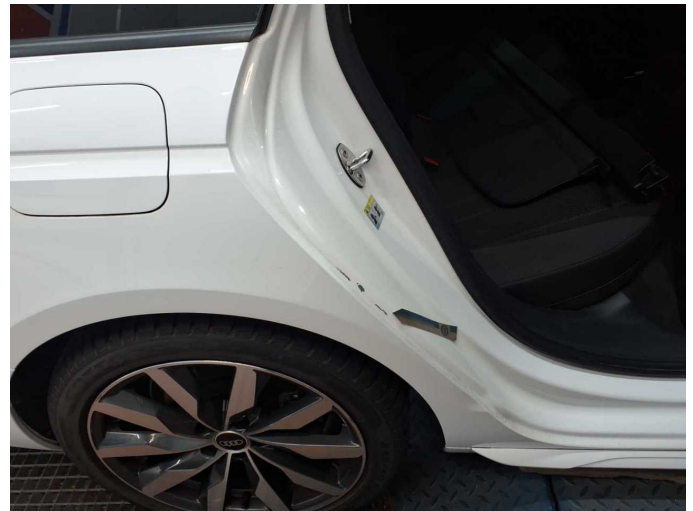
Damage 4: Side panel - rear right side: Sill - Scratch(es) - Paint

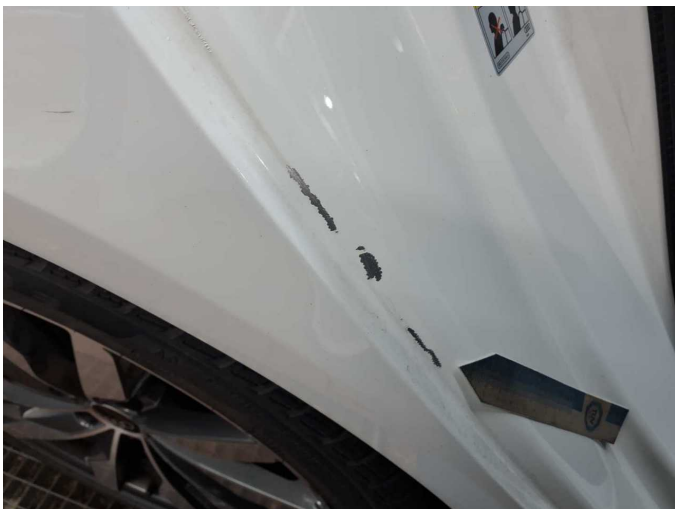
Damage 4: Side panel - rear right side: Sill - Scratch(es) - Paint

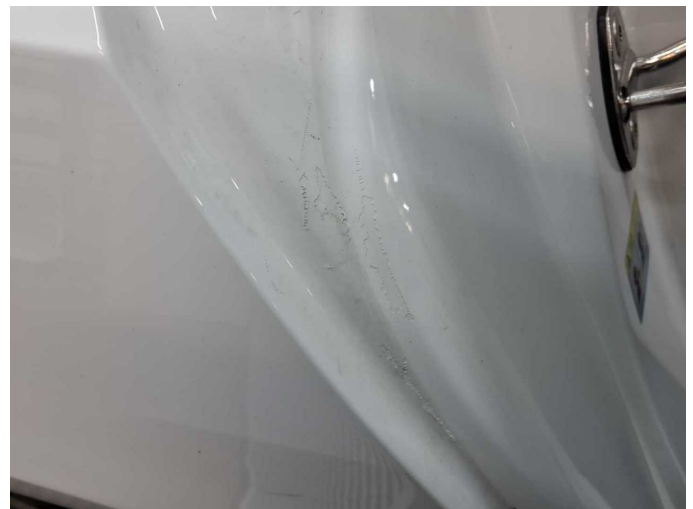
Damage 4: Side panel - rear right side: Sill - Scratch(es) - Paint

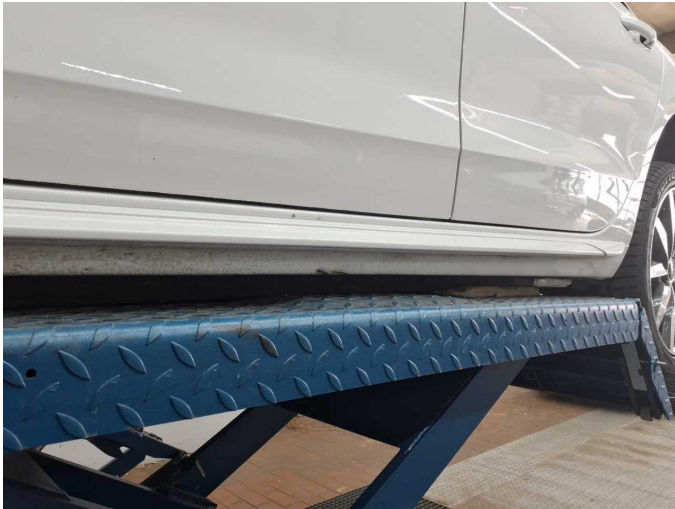
Damage 5: Sill - left side: Sill - Scratch(es) - Paint

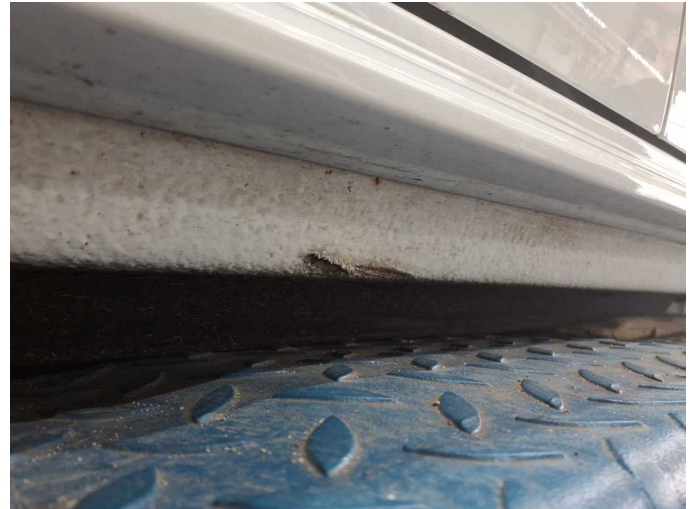
Damage 5: Sill - left side: Sill - Scratch(es) - Paint

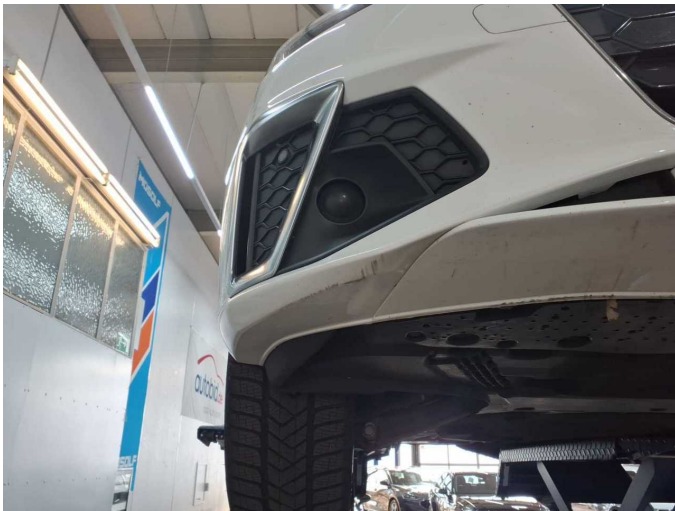
Damage 6: Front bumper: Front bumper (+ Spoiler) - Scratch(es) - Paint

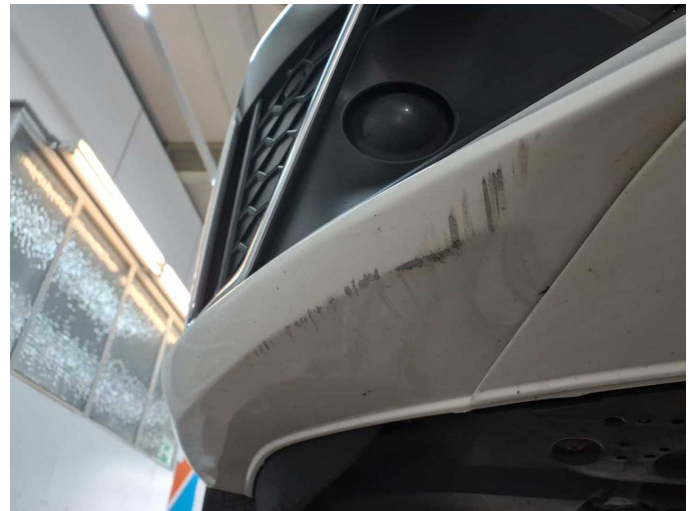
Damage 6: Front bumper: Front bumper (+ Spoiler) - Scratch(es) - Paint

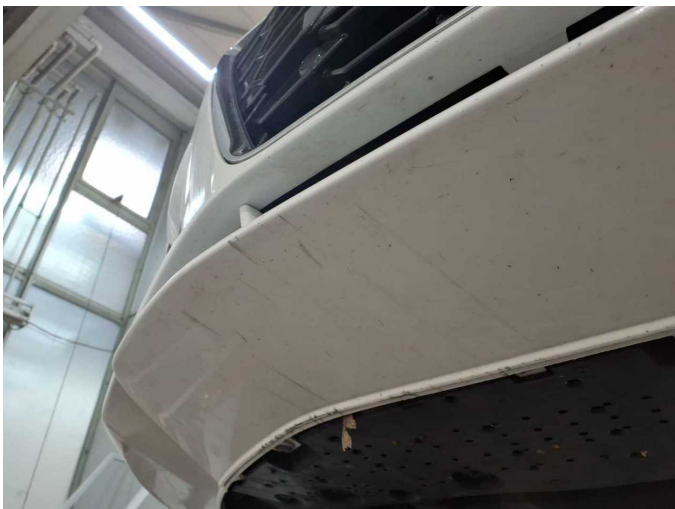
Damage 6: Front bumper: Front bumper (+ Spoiler) - Scratch(es) - Paint

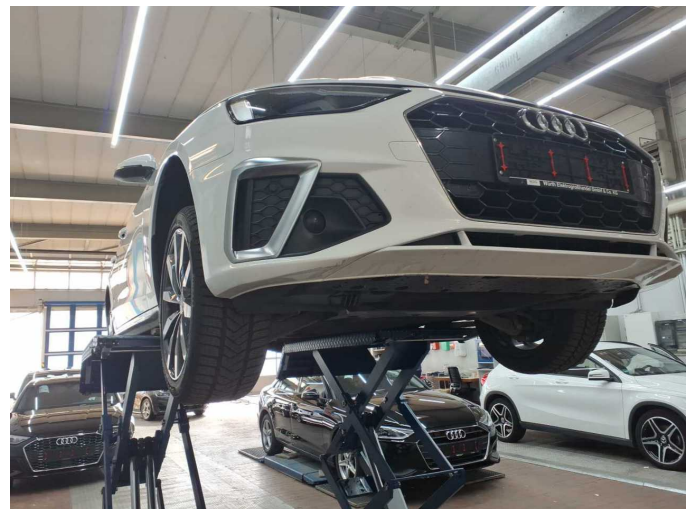
Damage 6: Front bumper: Front bumper (+ Spoiler) - Scratch(es) - Paint

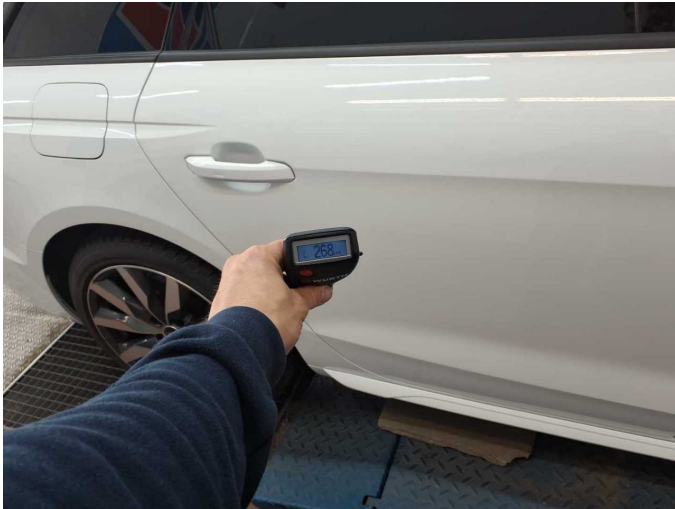
Repainting 1: Roof rail - right side, Side panel - rear right side, Door - rear right side
