Expertise

Protocol number: 46630607  
Order No. / Reference: 26779707  
Inspection date: 20 Jul 2026

Manufacturer: Mercedes-Benz

Model: E 300 e T 9G-TRONIC AMG Line

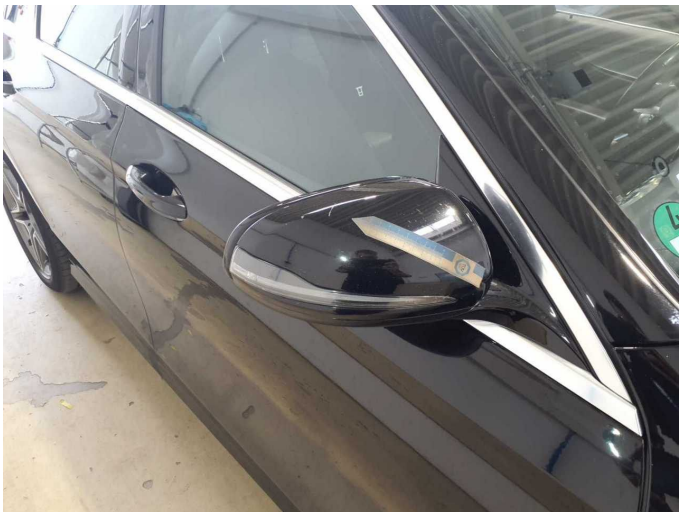
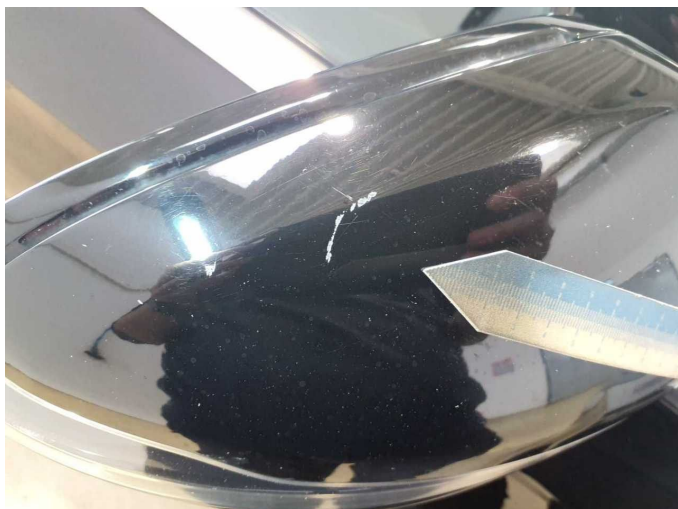
| No. | Component group | Description |
|---|---|---|
| 2 | Wing mirror - right side | Cap - Scratch(es) - Smart repair |

Damage 2: Wing mirror - right side: Cap - Scratch(es) - Smart repair

**Damage 2:** Wing mirror - right side: Cap - Scratch(es) - Smart repair

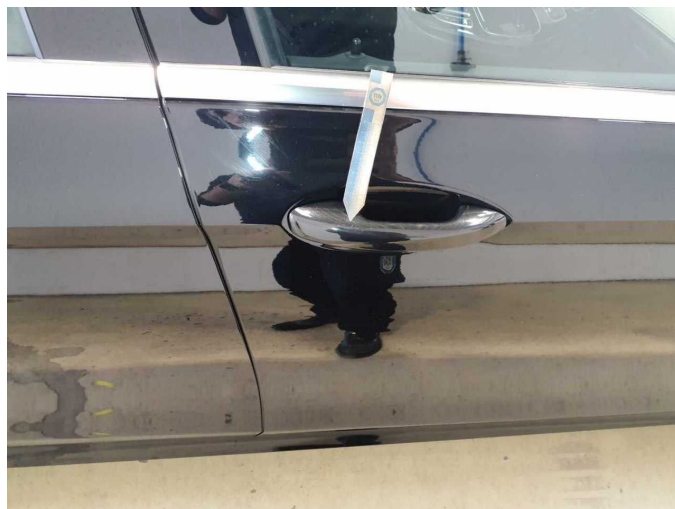
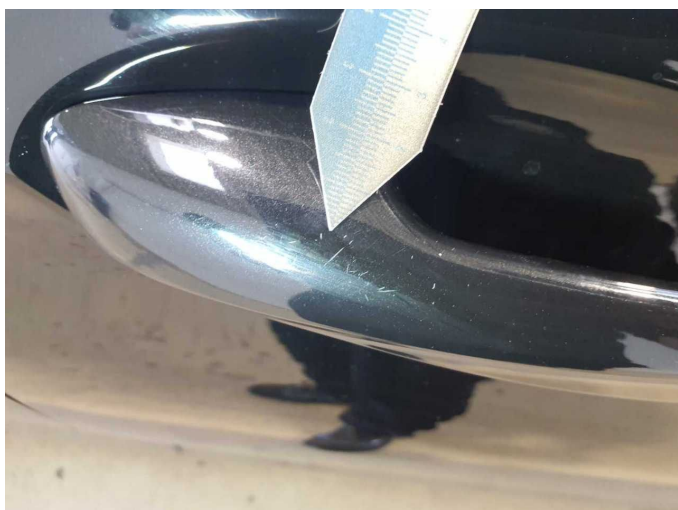
| No. | Component group | Description |
|---|---|---|
| 3 | Door - front right side | Door handle - outside - Scratch(es) - Smart repair |

**Damage 3:** Door - front right side: Door handle - outside - Scratch(es) - Smart repair

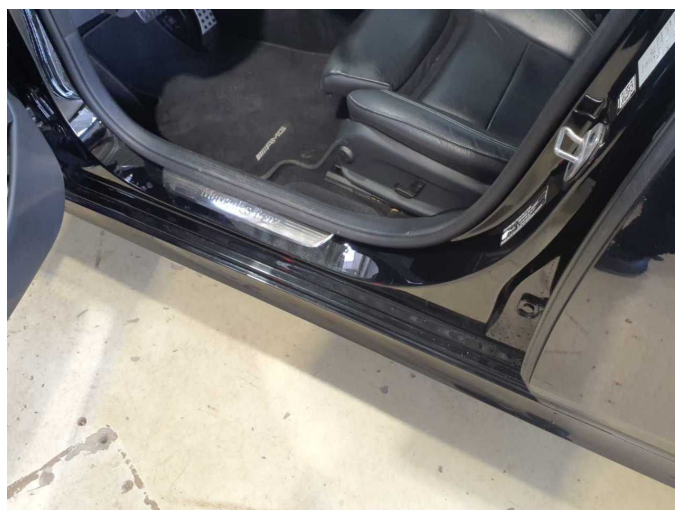
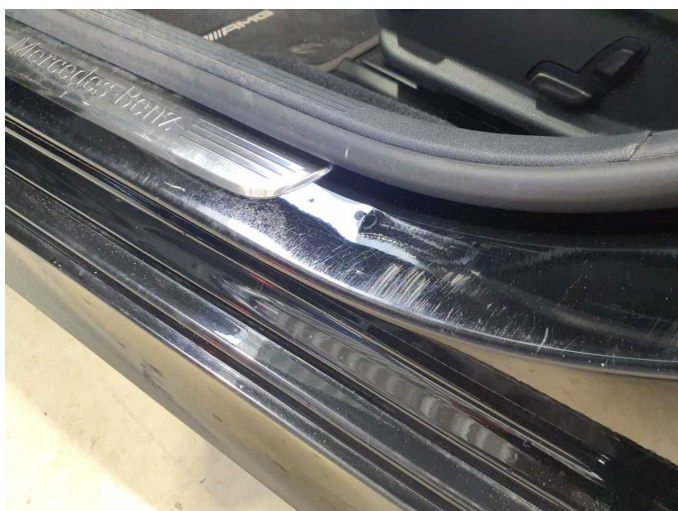
| No. | Component group | Description |
|---|---|---|
| 4 | Sill - left side | Sill - Glued / labelled - Smart repair |

**Damage 4:** Sill - left side: Sill - Glued / labelled - Smart repair

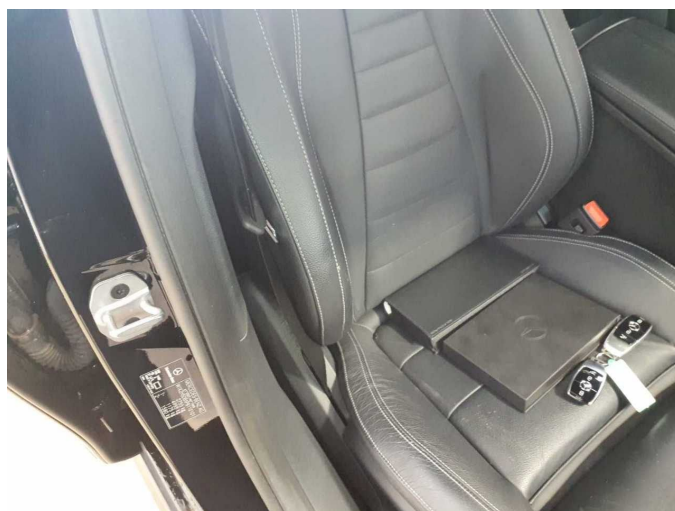
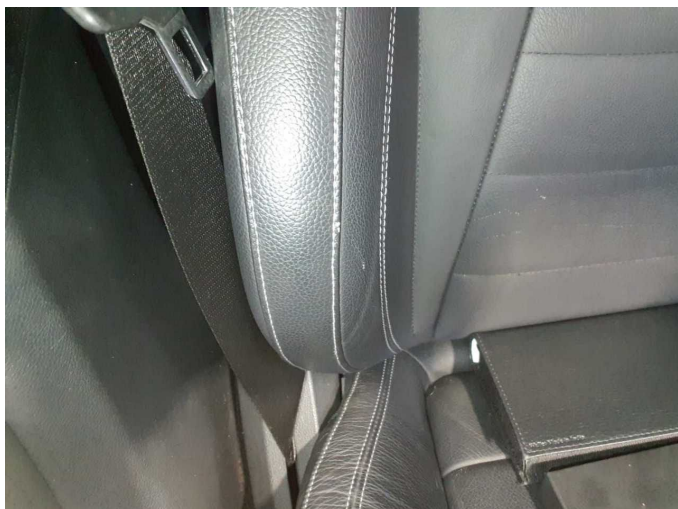
| No. | Component group | Description |
|---|---|---|
| 5 | Seat - front | Seat cover - right side - Scratch(es) - Smart repair |

**Damage 5:** Seat - front: Seat cover - right side - Scratch(es) - Smart repair

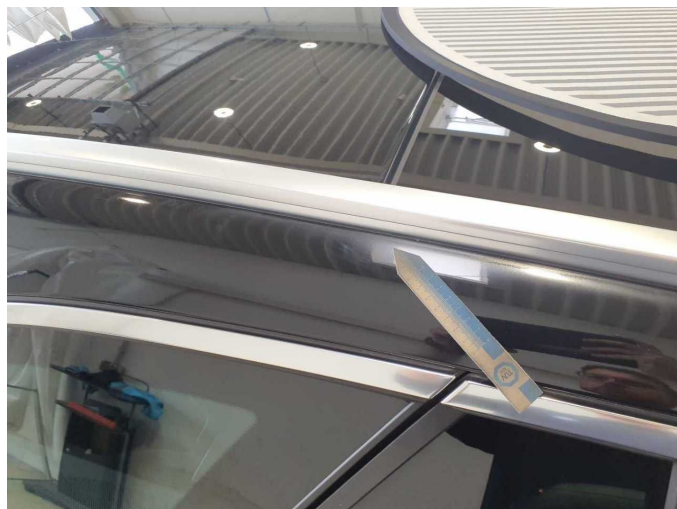
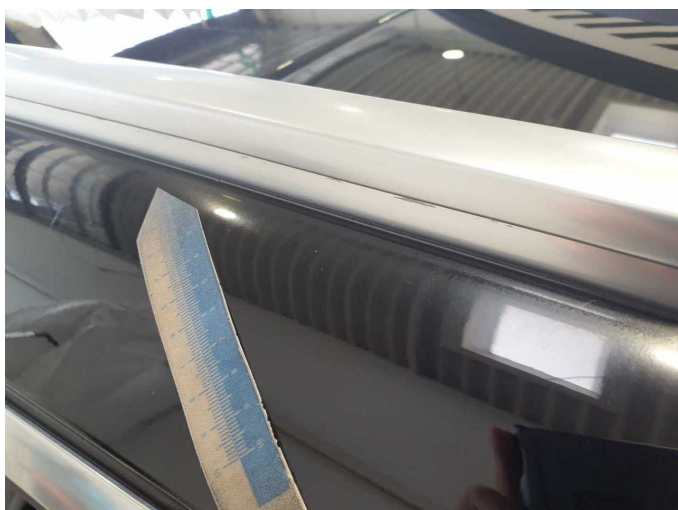
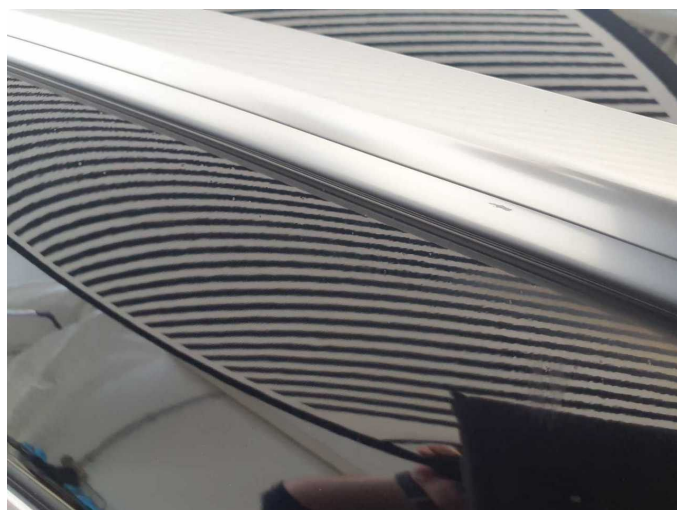
| No. | Component group | Description |
|---|---|---|
| 6 | Roof | Roof rail - right side (Lack Nebel) - Paint defect - Conditioning |

**Damage 6:** Roof: Roof rail - right side (Lack Nebel) - Paint defect - Conditioning

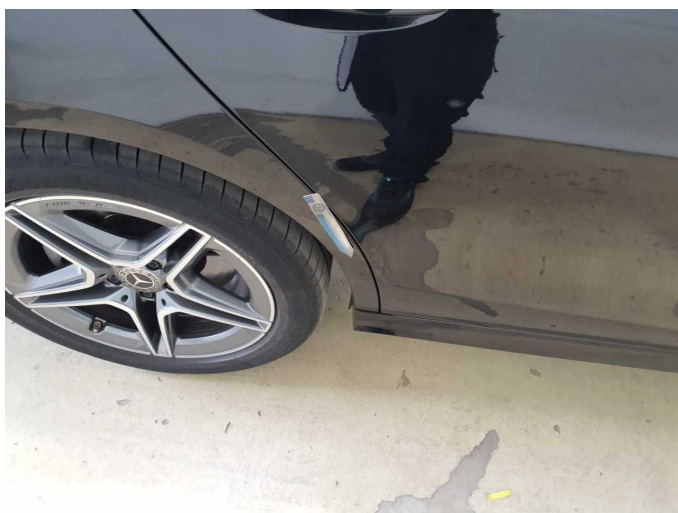
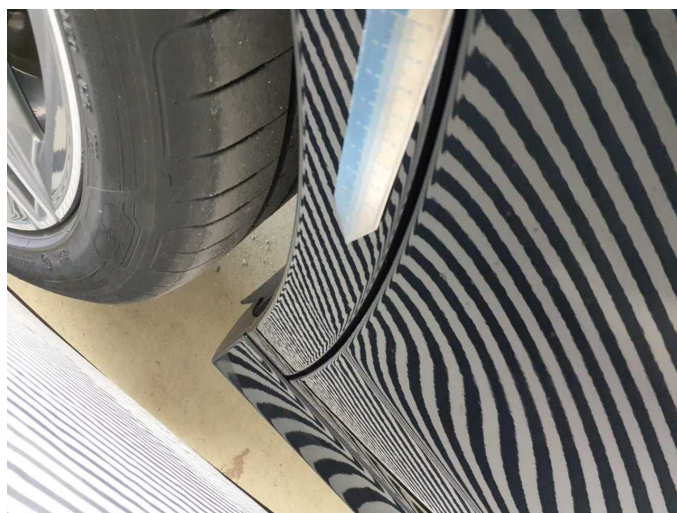
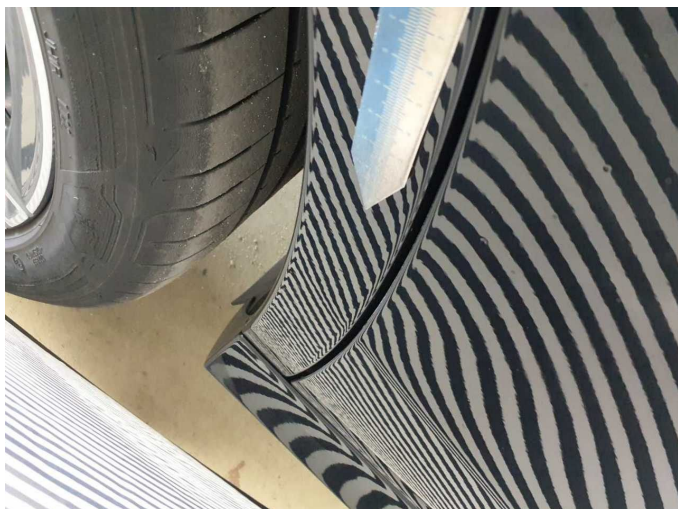
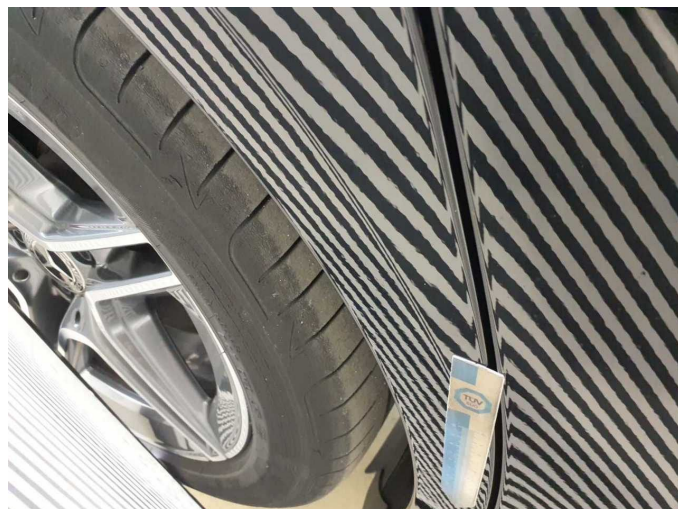
| No. | Component group | Description |
|---|---|---|
| 7 | Side panel - rear right side | Side panel (Einschlüsse-Mehrkosten möglich) - Unprofessionally repaired - Conditioning |

**Damage 7:** Side panel - rear right side: Side panel (Einschlüsse-Mehrkosten möglich) - Unprofessionally repaired - Conditioning

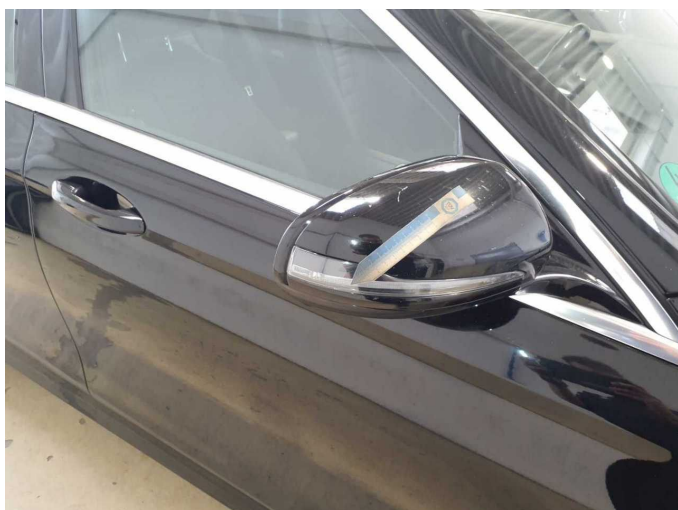
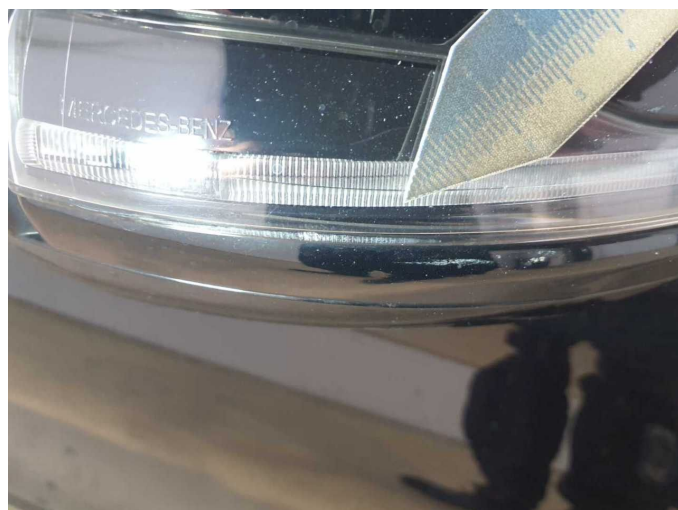
| No. | Component group | Description |
|---|---|---|
| 8 | Indicator - front | Mirror - right side - Scratch(es) - Replace |

**Damage 8:** Indicator - front: Mirror - right side - Scratch(es) - Replace

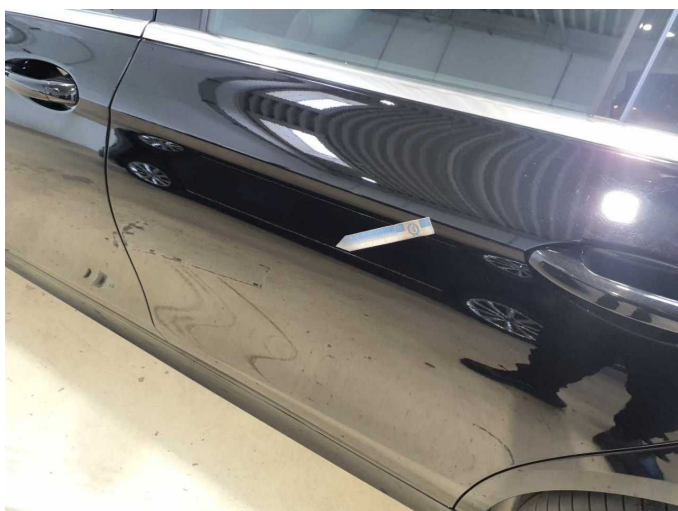
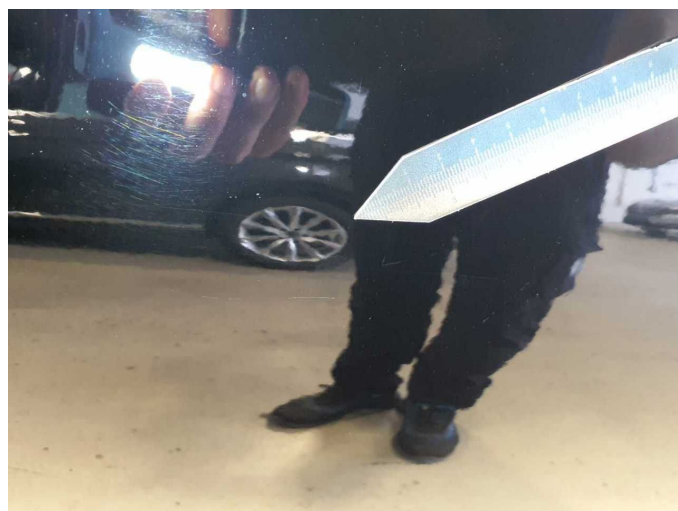
**Damage 9:** Door - rear left side: Door - Scratch(es) - Loss in value

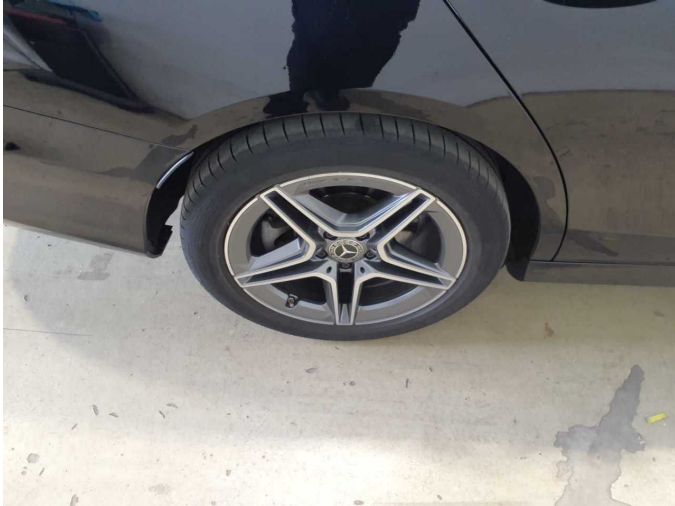
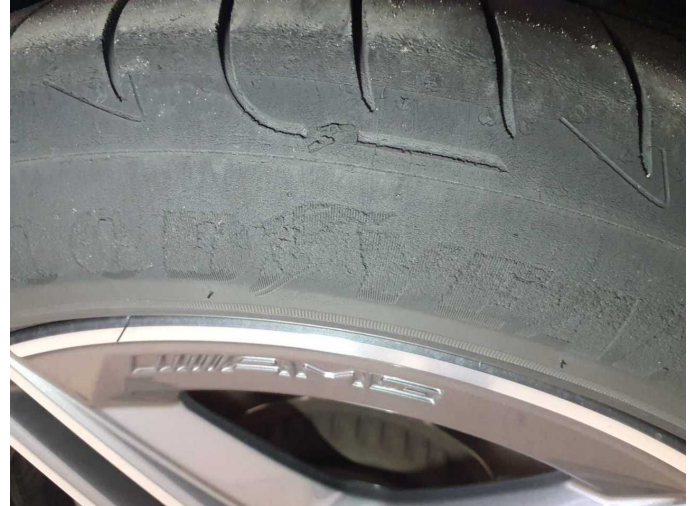
| No. | Component group | Description |
|---|---|---|
| 10 | Wheel / tyres | Tyre - rear right side (nicht fahrbereit) - Damaged - Replace |

**Damage 10:** Wheel / tyres: Tyre - rear right side (nicht fahrbereit) - Damaged - Replace

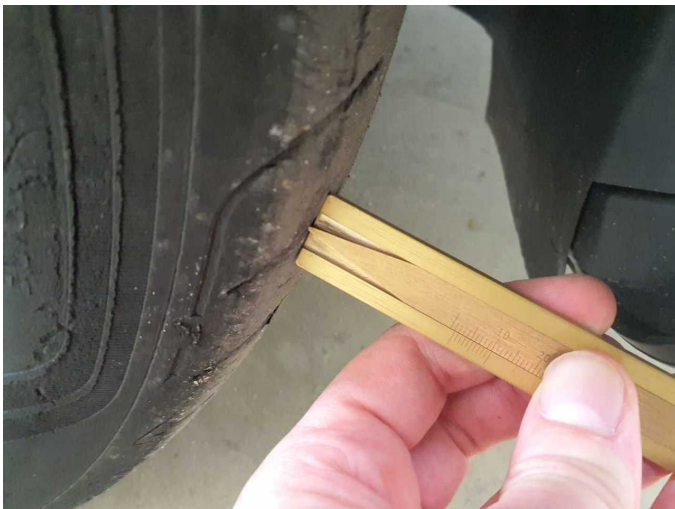
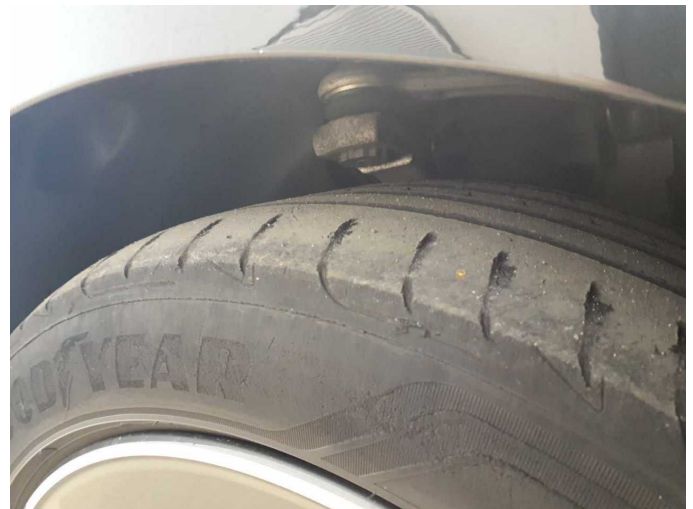
| No. | Component group | Description |
|---|---|---|
| 11 | Wheel / tyres | Tyre - front right side (nicht fahrbereit) - Worn - Replace |

**Damage 11:** Wheel / tyres: Tyre - front right side (nicht fahrbereit) - Worn - Replace

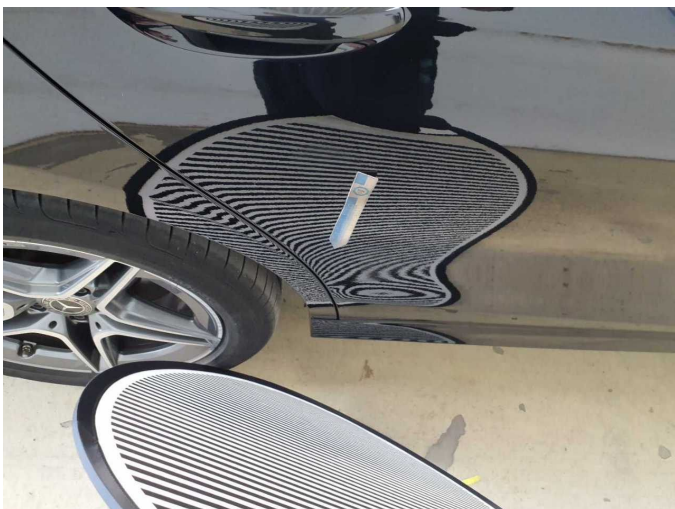
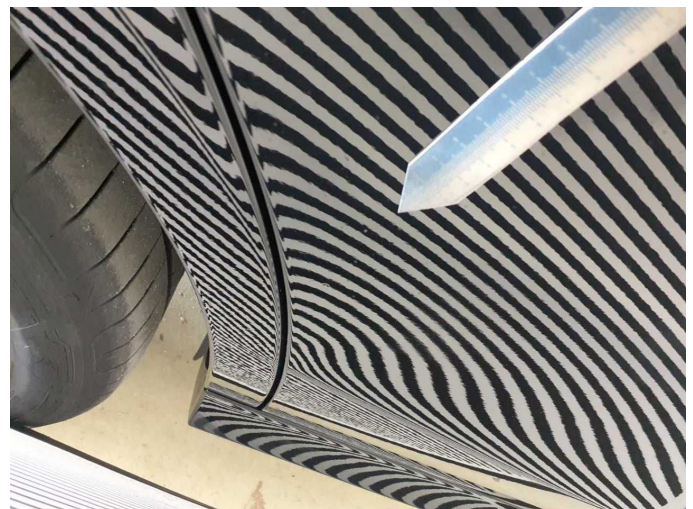
| No. | Component group | Description |
|---|---|---|
| 12 | Door - rear right side | Door (Einschlüsse-Mehrkosten möglich) - Unprofessionally repaired - Conditioning |

**Damage 12:** Door - rear right side: Door (Einschlüsse-Mehrkosten möglich) - Unprofessionally repaired - Conditioning

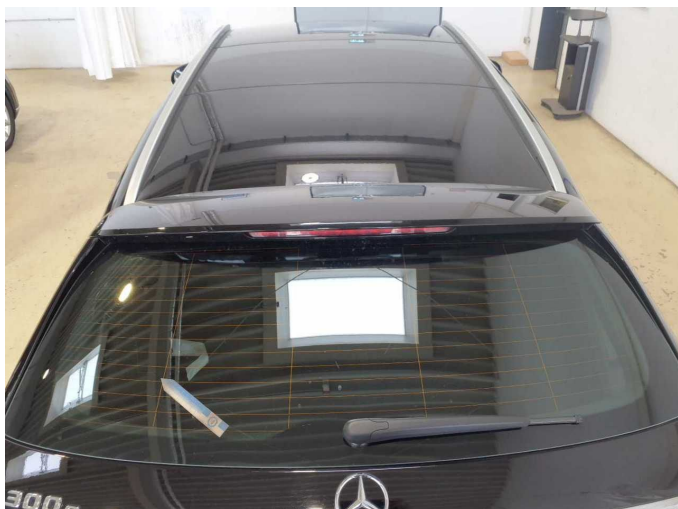
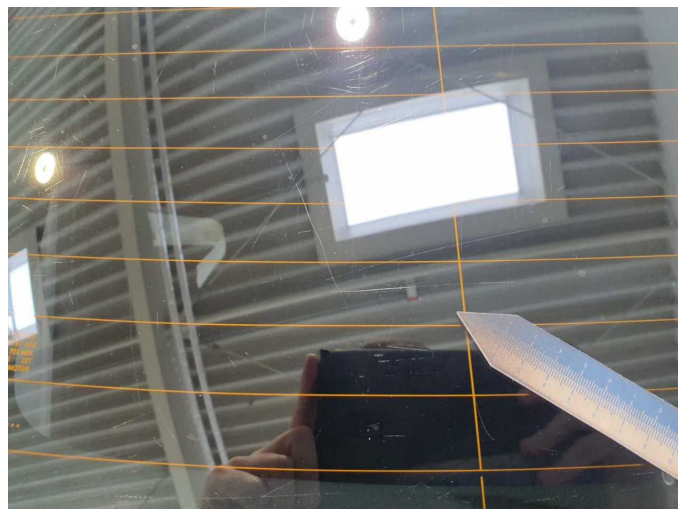
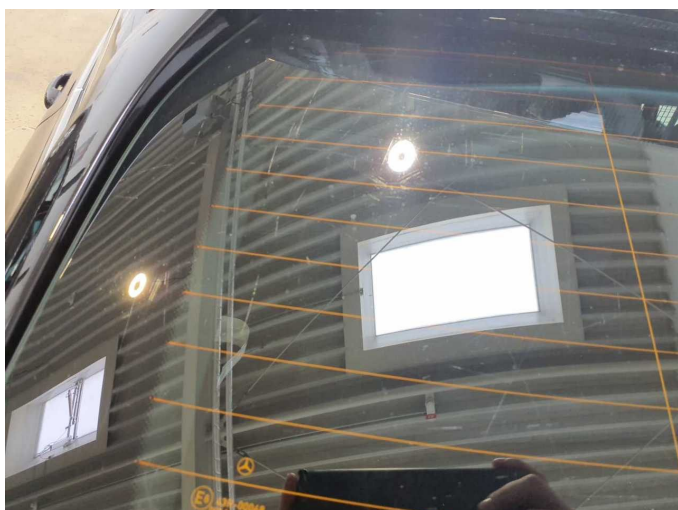
**Damage 13:** Vehicle glazing: Rear window - Scratch(es) - Loss in value

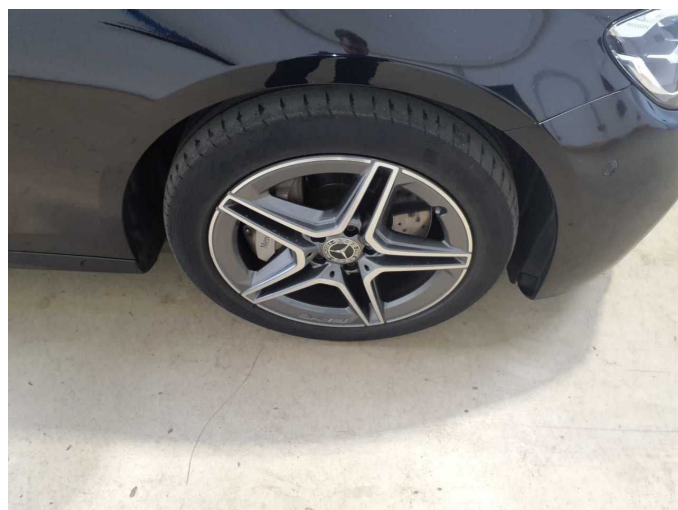
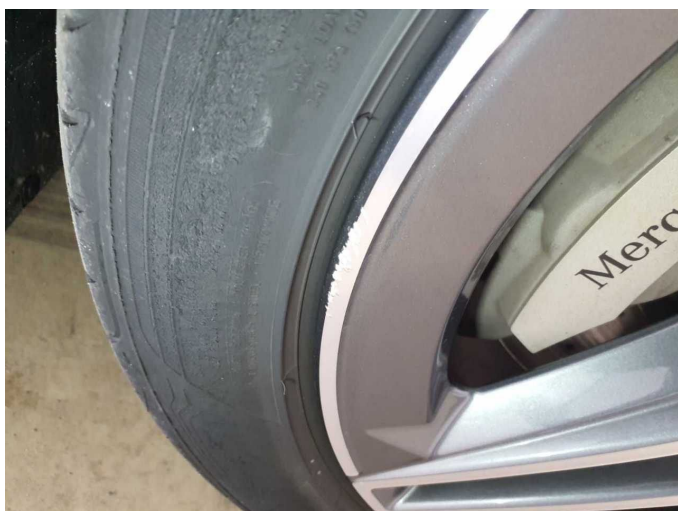
**Damage 14:** Wheel / tyres: Alloy rim - front right side - Scratch(es) - Loss in value

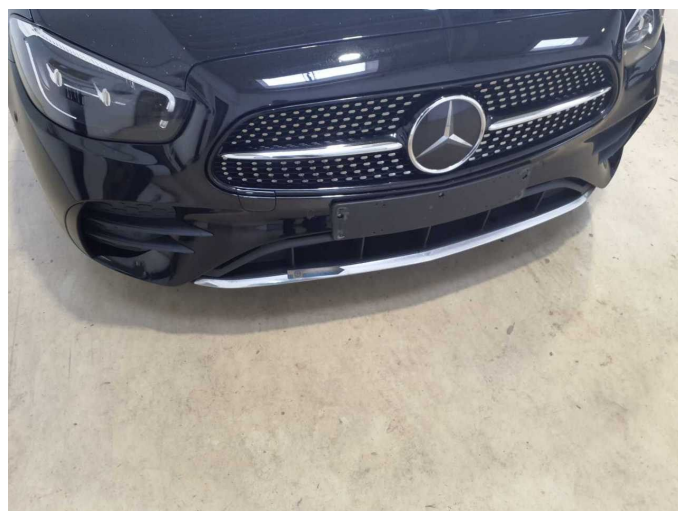
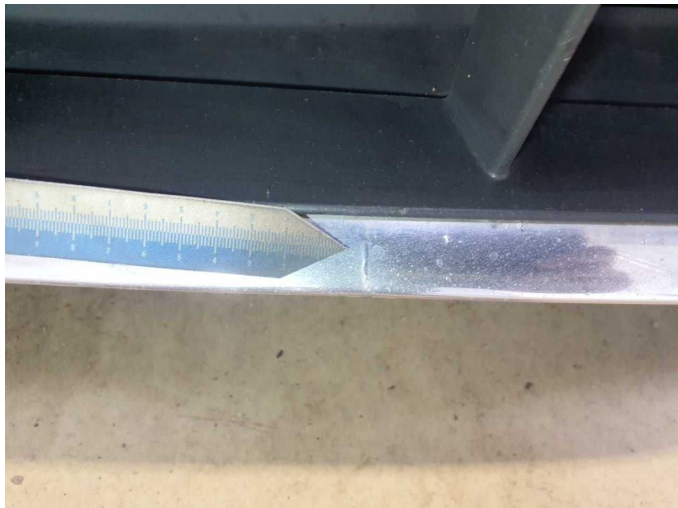
| No. | Component group | Description |
|---|---|---|
| 15 | Trim / covers | Trim / covers - Scratch(es) - Replace |

**Damage 15:** Trim / covers: Trim / covers - Scratch(es) - Replace

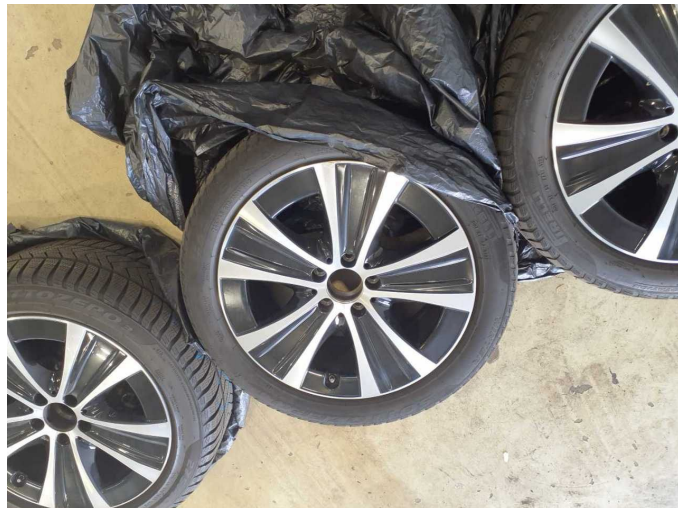
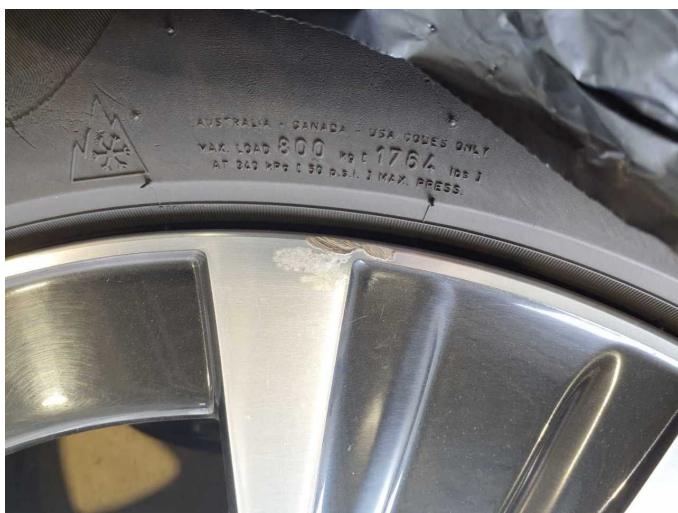
**Damage 16:** 2nd wheel set: 1 alloy rim - Scratch(es) - Loss in value

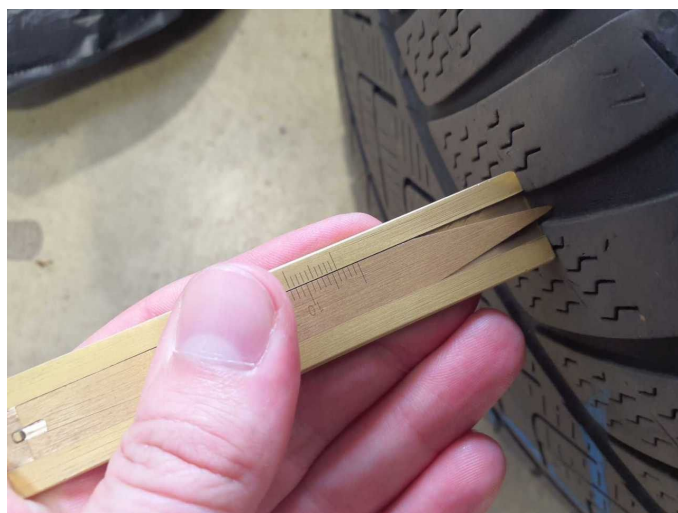
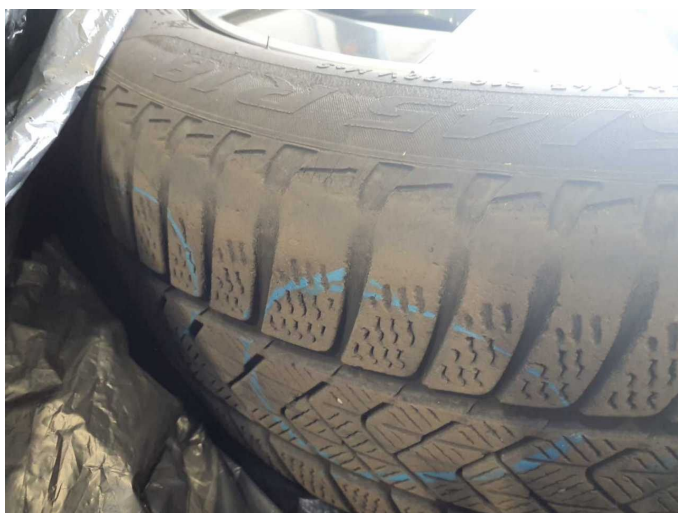
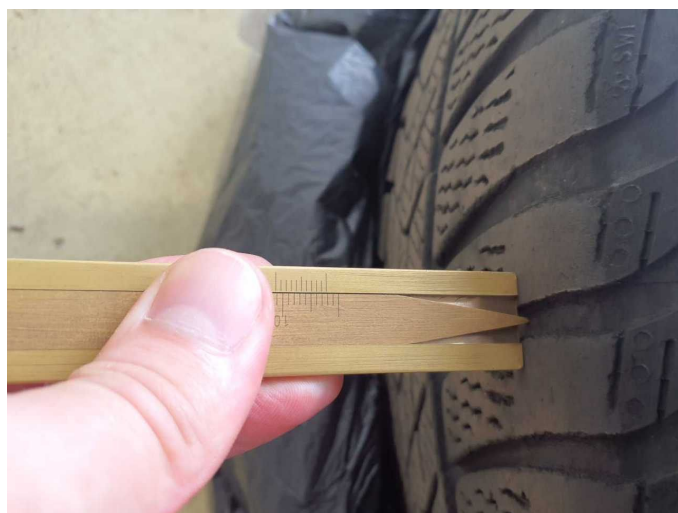
| No. | Component group | Description |
|---|---|---|
| 17 | 2nd wheel set | 3 tyres (einseitig abgefahren) - Does not meet the leasing specifications - Replace |

**Damage 17:** 2nd wheel set: 3 tyres (einseitig abgefahren) - Does not meet the leasing specifications - Replace

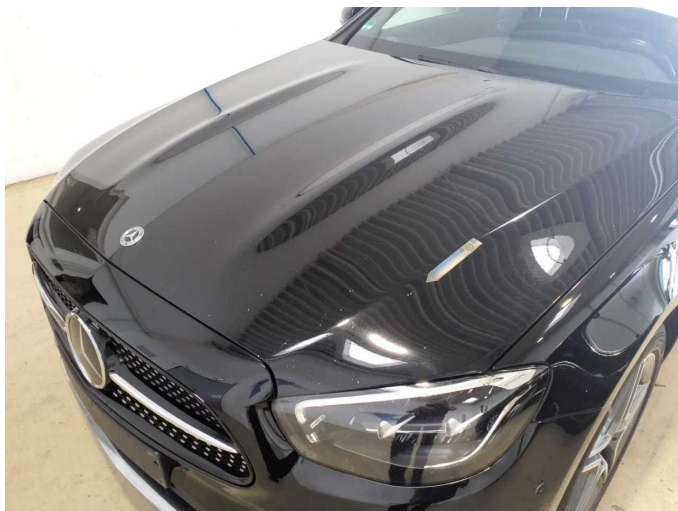
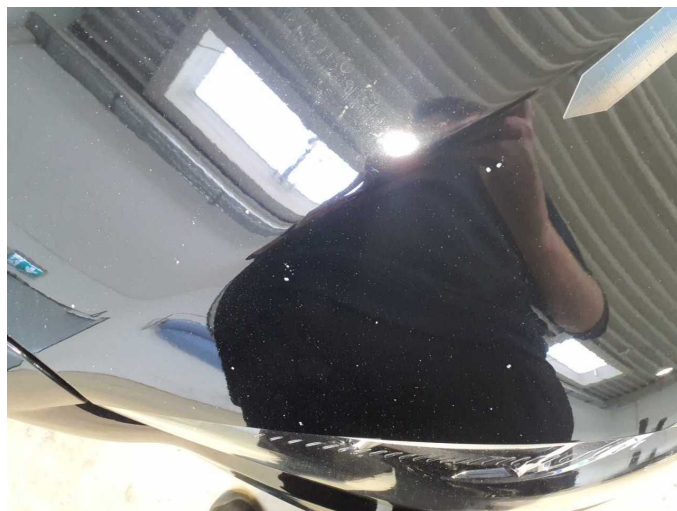
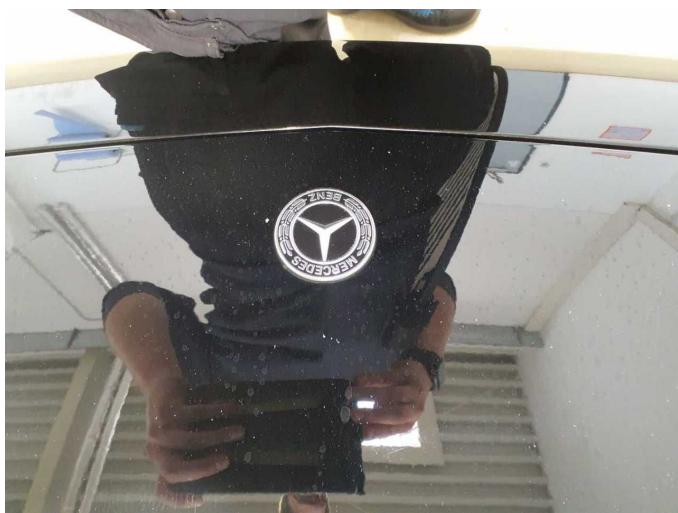
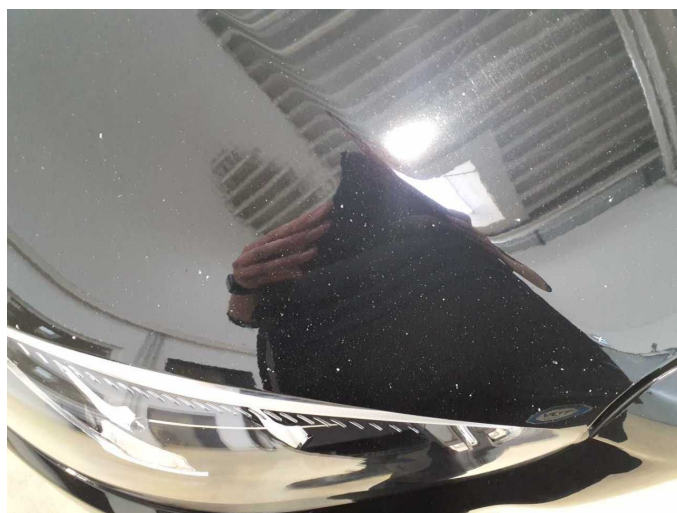
**Damage 18:** Bonnet: Bonnet - Stone chips - Paint

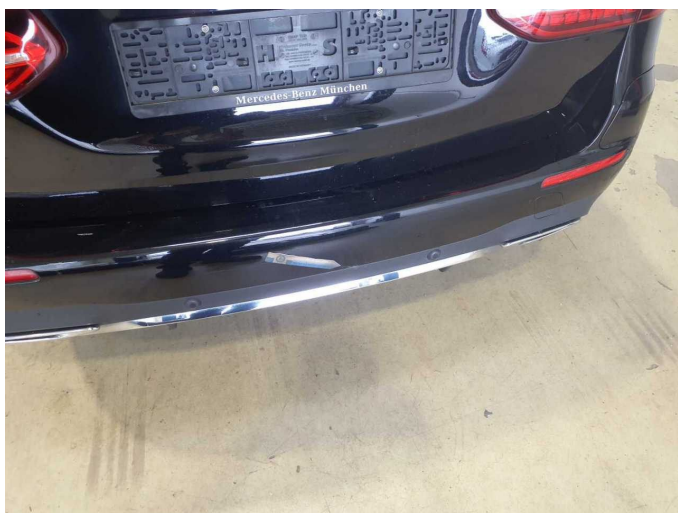
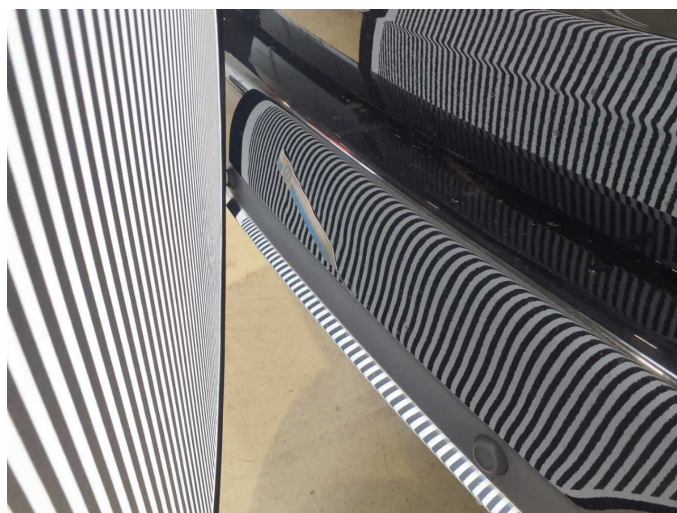
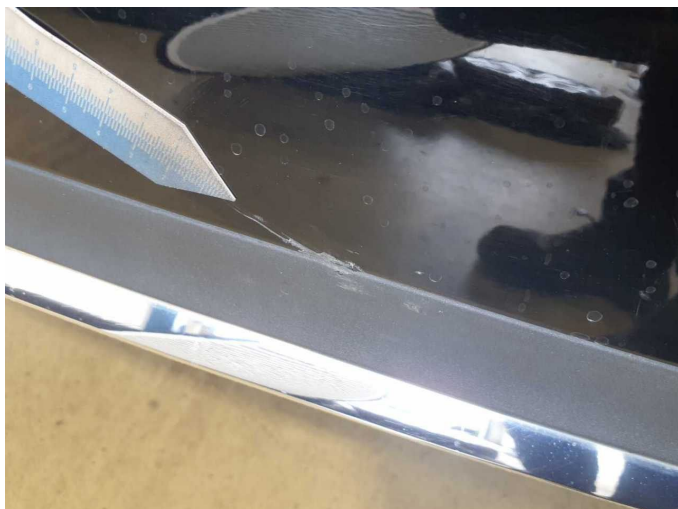
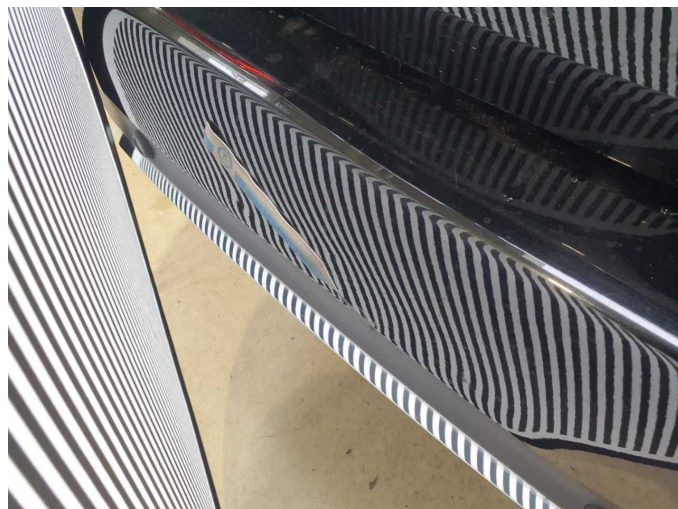
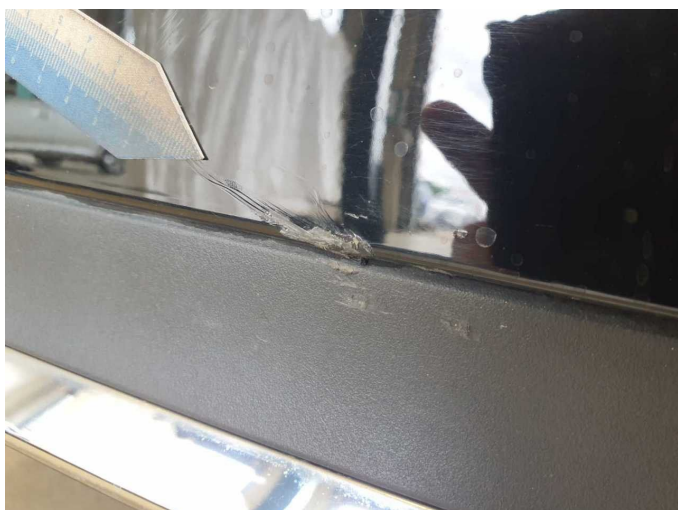
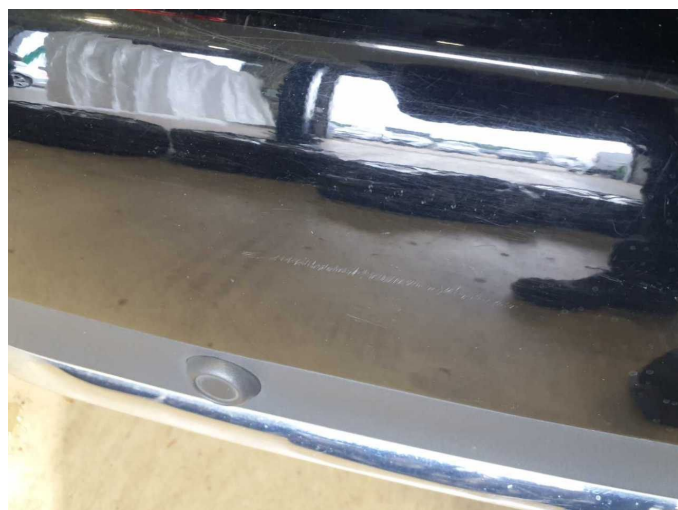
| No. | Component group | Description |
|---|---|---|
| 19 | Rear bumper | Rear bumper (Inklusive Anbauteile) - Dent / paintcoat damage - Repair and paint |

**Damage 19:** Rear bumper: Rear bumper (Inklusive Anbauteile) - Dent / paintcoat damage - Repair and paint

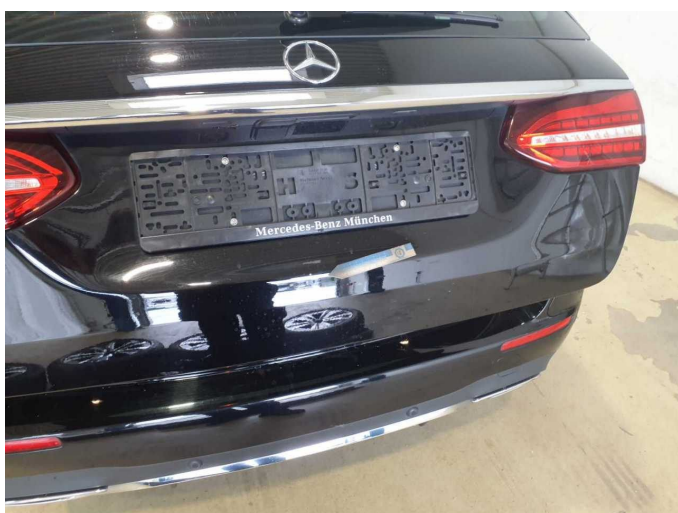
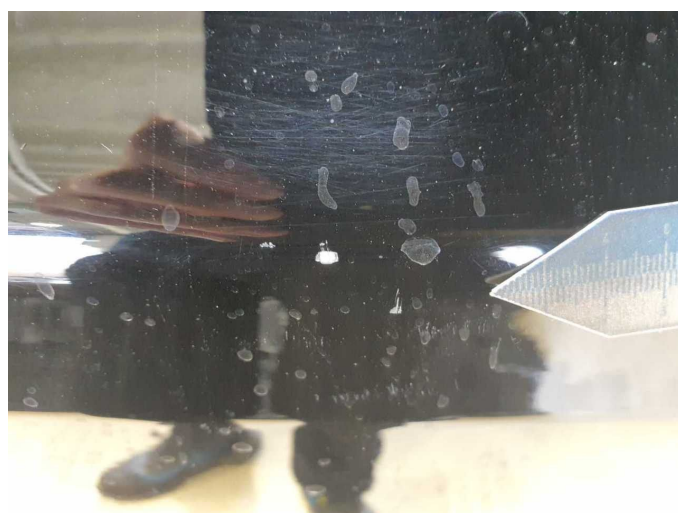
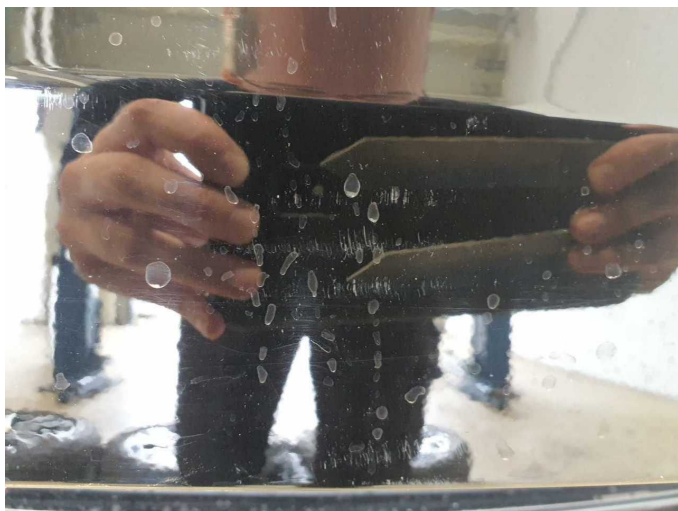
**Damage 20:** Boot lid / rear door: Boot lid - Scratch(es) - Paint

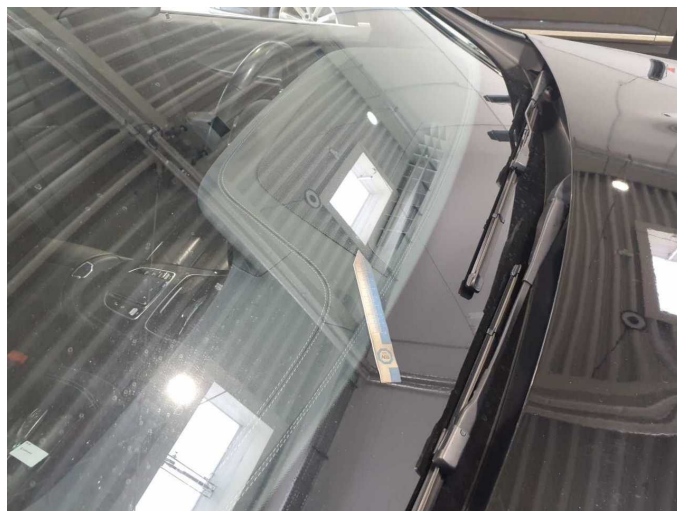
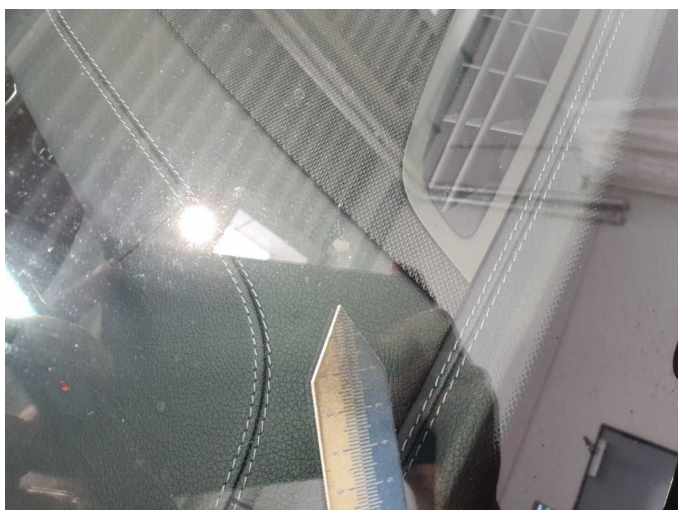
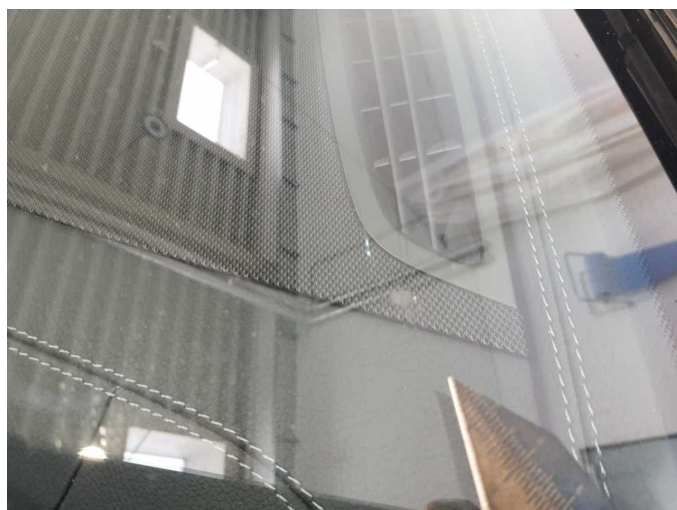
| No. | Component group | Description |
|---|---|---|
| 21 | Vehicle glazing | Windscreen (kein Staubschutz) - Broken / torn - Replace |

**Damage 21:** Vehicle glazing: Windscreen (kein Staubschutz) - Broken / torn - Replace

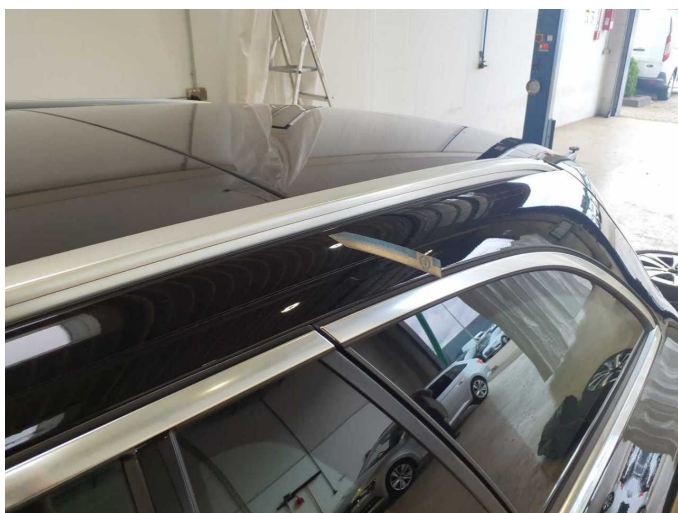
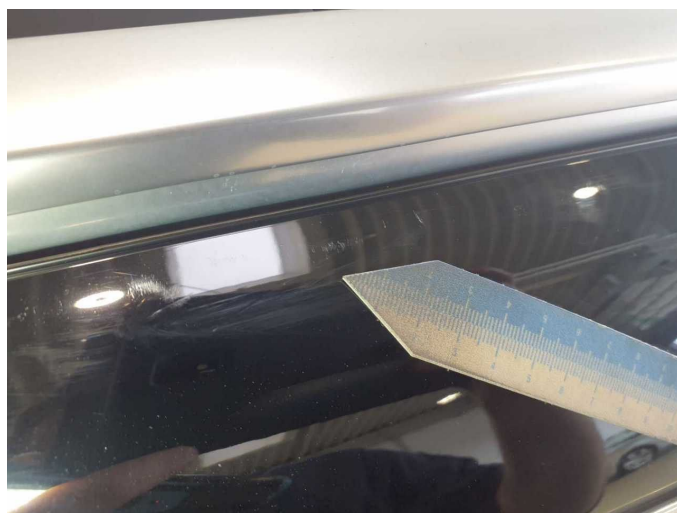
| No. | Component group | Description |
|---|---|---|
| 3 | Roof | Roof rail - left side - Scratch(es) - Smart repair |

**Wear and tear 3:** Roof: Roof rail - left side - Scratch(es) - Smart repair

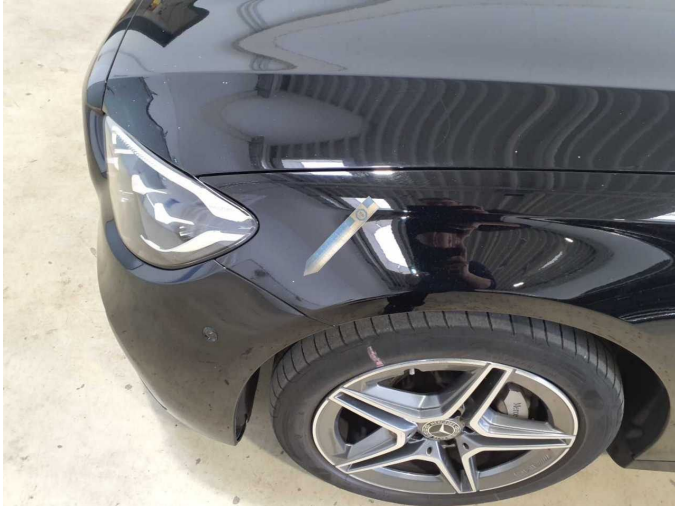
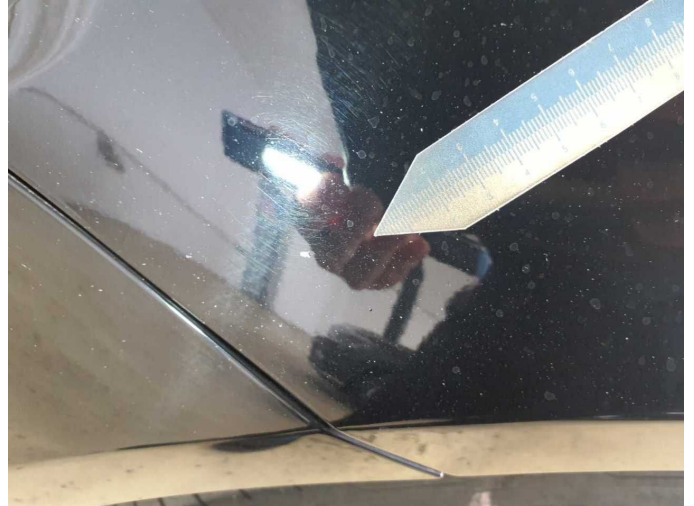
| No. | Component group | Description |
|---|---|---|
| 4 | Mudguard - left side | Mudguard - left side - Stone chips - Smart repair |

**Wear and tear 4:** Mudguard - left side: Mudguard - left side - Stone chips - Smart repair

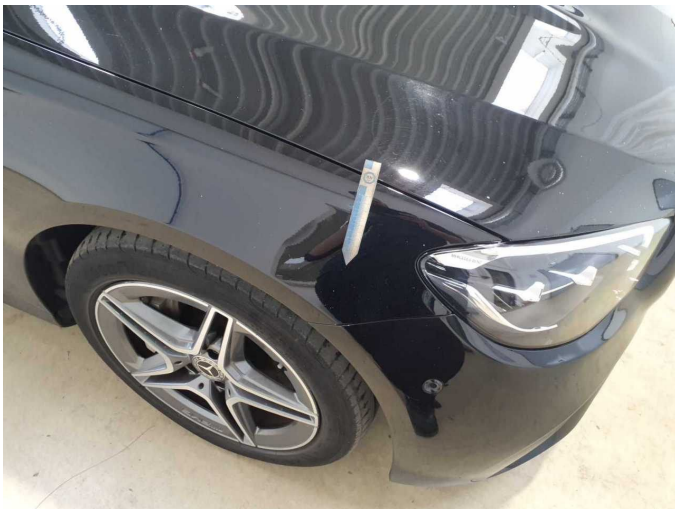
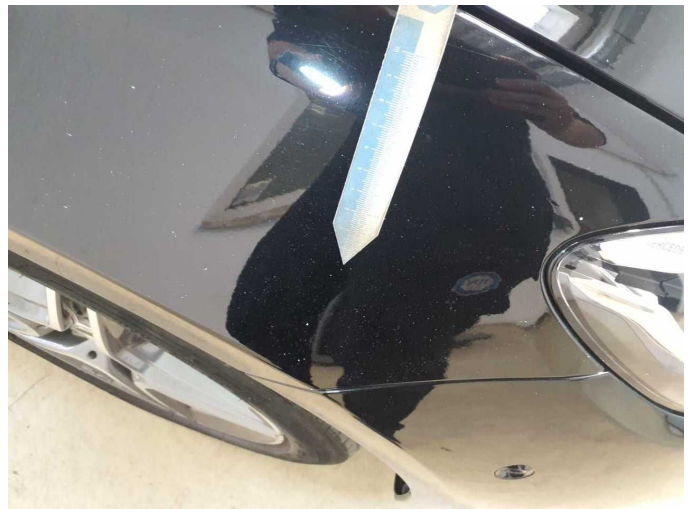
| No. | Component group | Description |
|---|---|---|
| 5 | Mudguard - right side | Mudguard - right side - Stone chips - Smart repair |

**Wear and tear 5:** Mudguard - right side: Mudguard - right side - Stone chips - Smart repair

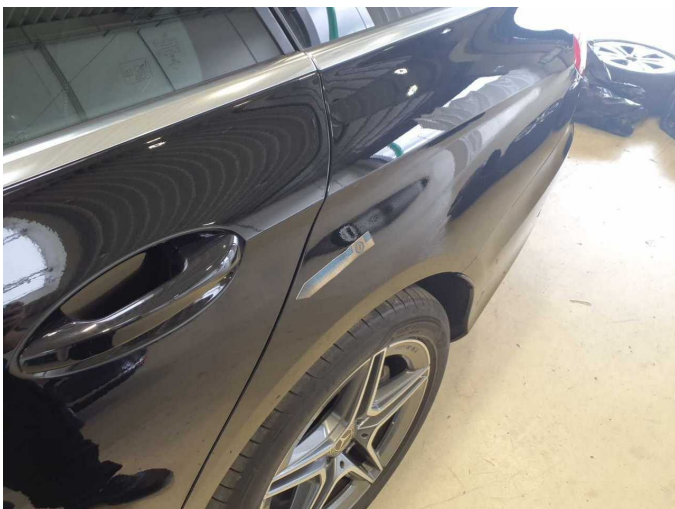
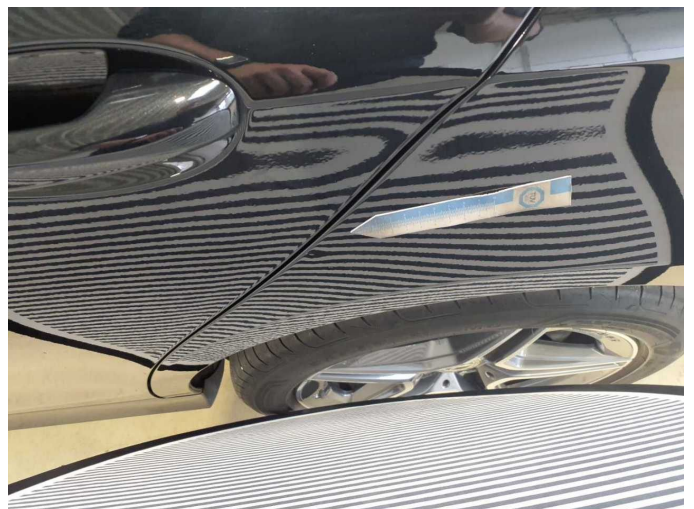
| No. | Component group | Description |
|---|---|---|
| 6 | Side panel - rear left side | Side panel - dent(s) - Smooth repair work |

**Wear and tear 6:** Side panel - rear left side: Side panel - dent(s) - Smooth repair work

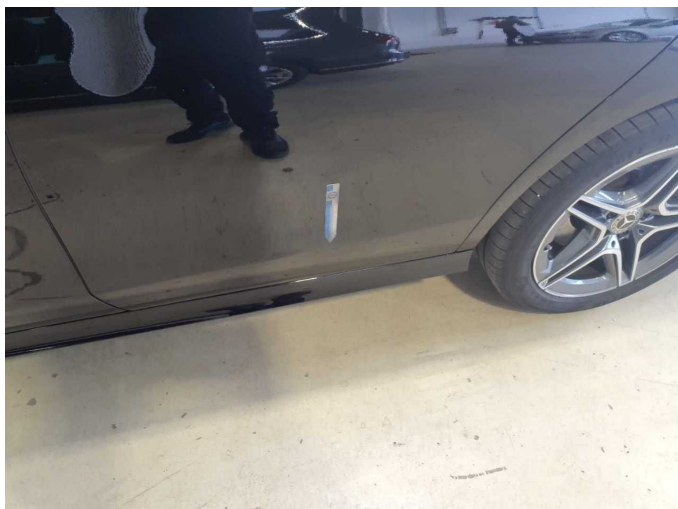
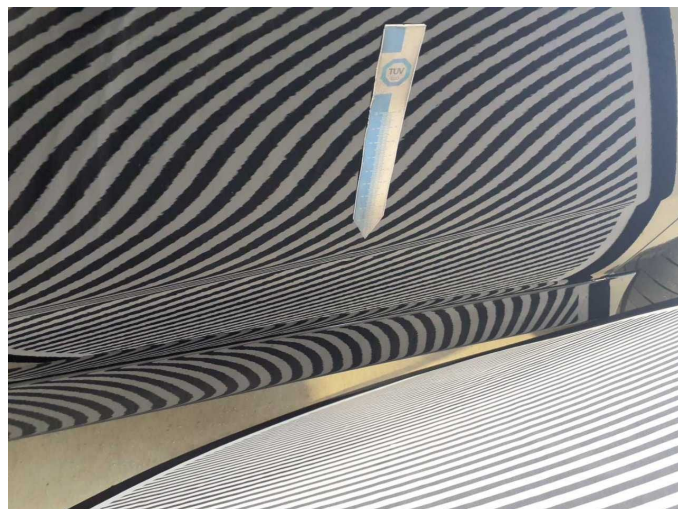
| No. | Component group | Description |
|---|---|---|
| 7 | Door - rear left side | Door - dent(s) - Smart repair |

**Wear and tear 7:** Door - rear left side: Door - dent(s) - Smart repair
