Expertise

Protocol number: 46630607  
Order No. / Reference: 26779707  
Inspection date: 20 Jul 2026

Manufacturer: Mercedes-Benz

Model: E 300 e T 9G-TRONIC AMG Line

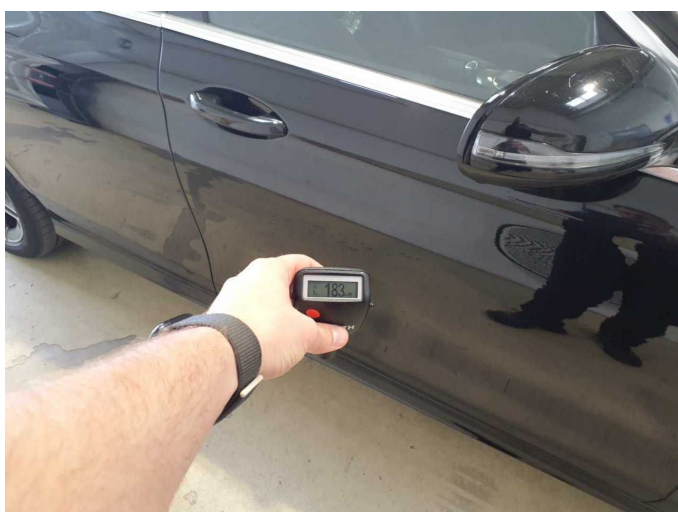
- 1 Door - front right side, Professionally carried out, Invoice of repair done Non-existent
- 2 Side panel - rear right side, Unprofessionally carried out, Invoice of repair done Non-existent
- 3 Door - rear right side, Unprofessionally carried out, Invoice of repair done Non-existent

**Repainting 1:** Door - front right side
