Expertise

Protocol number: 46593722  
Order No. / Reference: 26707272  
Inspection date: 17 Jul 2026

Manufacturer: Mercedes-Benz

Model: E 300 de T 9G-TRONIC Avantgarde

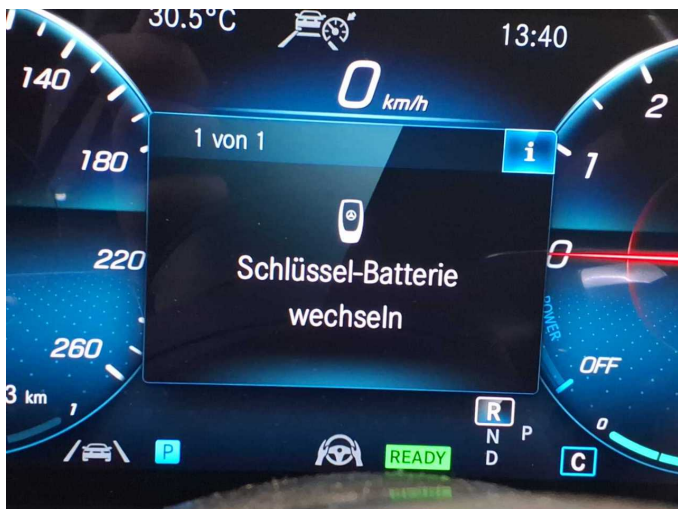
Damage 1: Equipment: Vehicle key with remote control - Due - Replace

| No. | Component group | Description |
|---|---|---|
| 1 | Equipment | Vehicle key with remote control - Due - Replace |

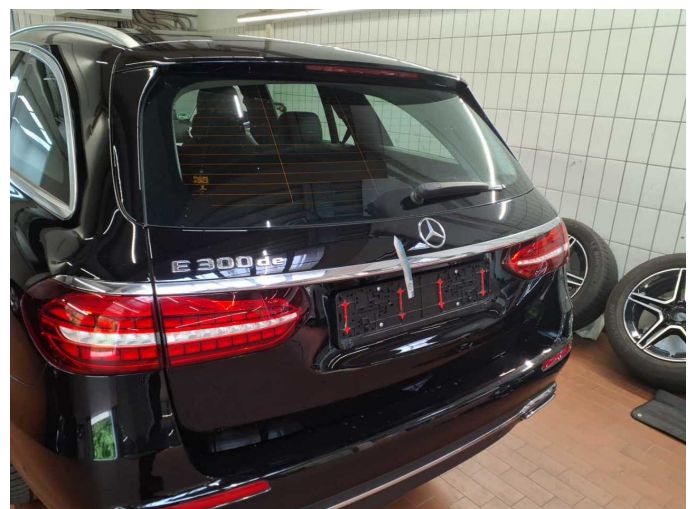
Damage 3: Boot lid / rear door: Boot lid - dent(s) - Smooth repair work

| No. | Component group | Description |
|---|---|---|
| 3 | Boot lid / rear door | Boot lid - dent(s) - Smooth repair work |

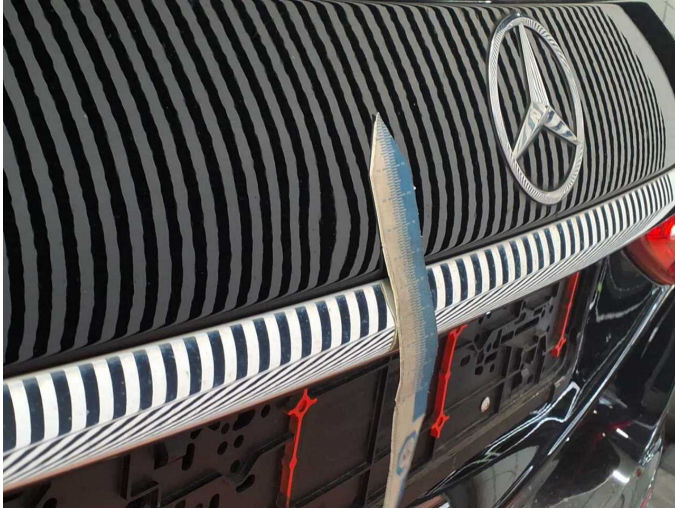
**Damage 3:** Boot lid / rear door: Boot lid - dent(s) - Smooth repair work

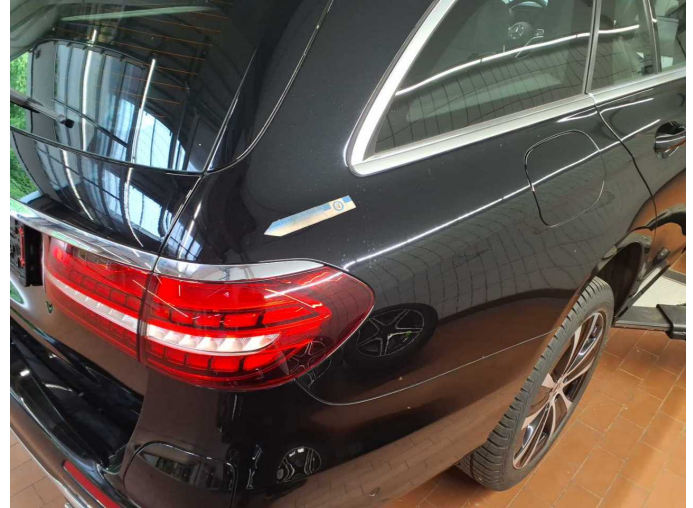
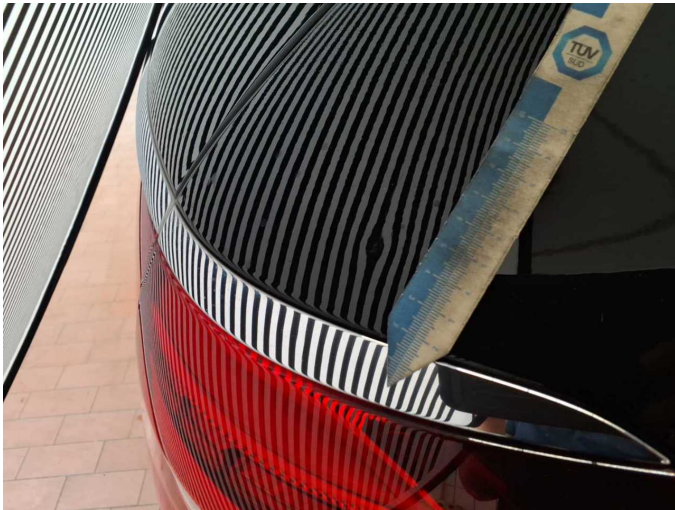
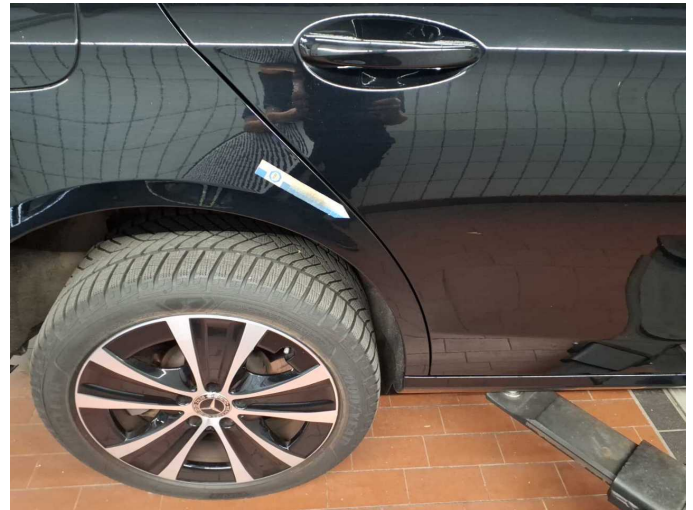
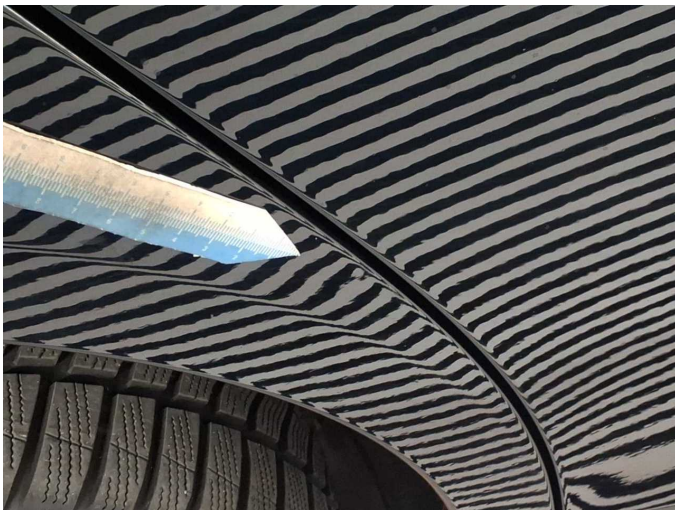
**Damage 4:** Side panel - rear right side: Side panel - dent(s) - Smart repair

| No. | Component group | Description |
|---|---|---|
| 4 | Side panel - rear right side | Side panel - dent(s) - Smart repair |

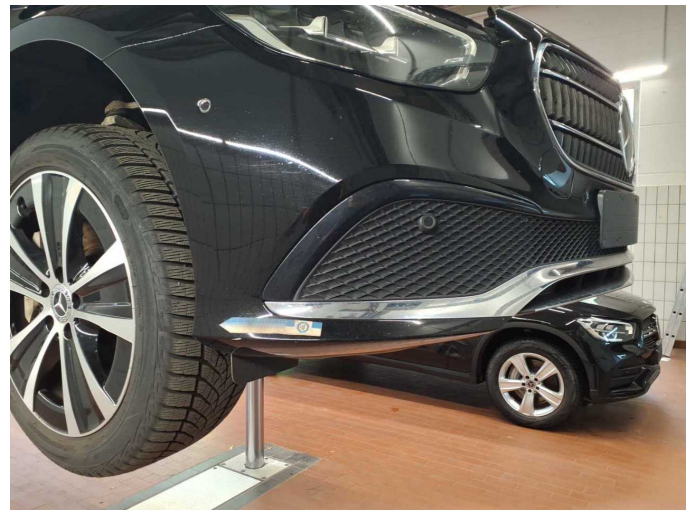
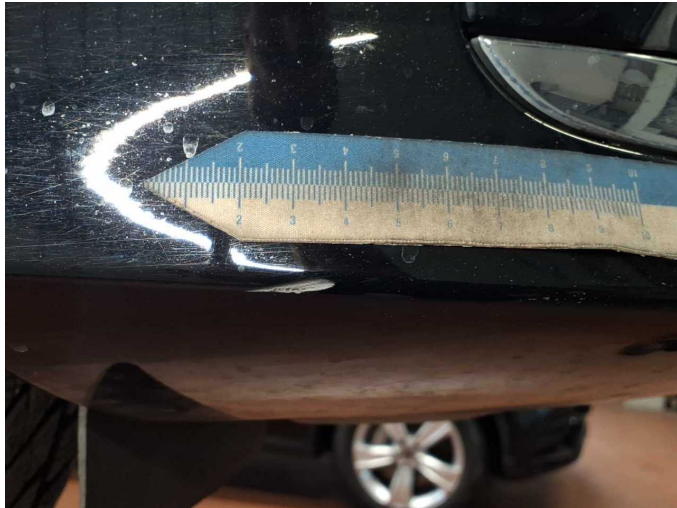
**Damage 6:** Front bumper: Front bumper - Scratched - Smart repair

| No. | Component group | Description |
|---|---|---|
| 6 | Front bumper | Front bumper - Scratched - Smart repair |

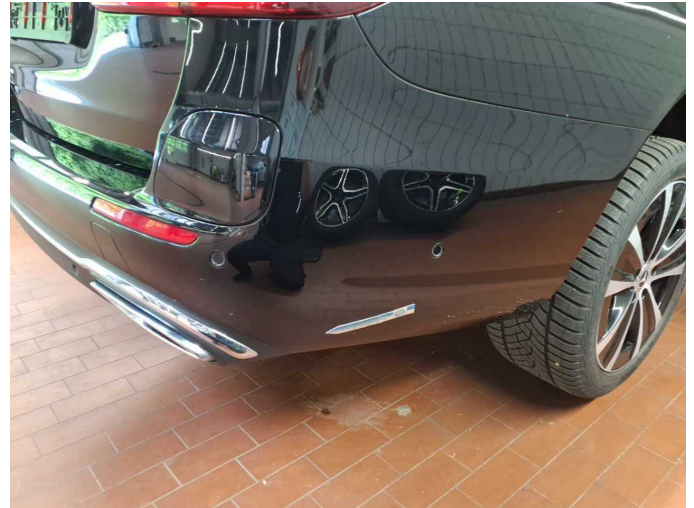
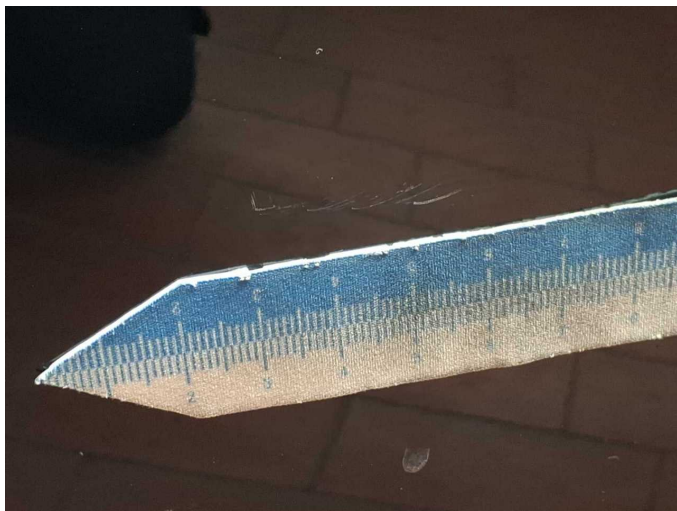
**Damage 7:** Rear bumper: Rear bumper - Scratch(es) - Smart repair

| No. | Component group | Description |
|---|---|---|
| 7 | Rear bumper | Rear bumper - Scratch(es) - Smart repair |

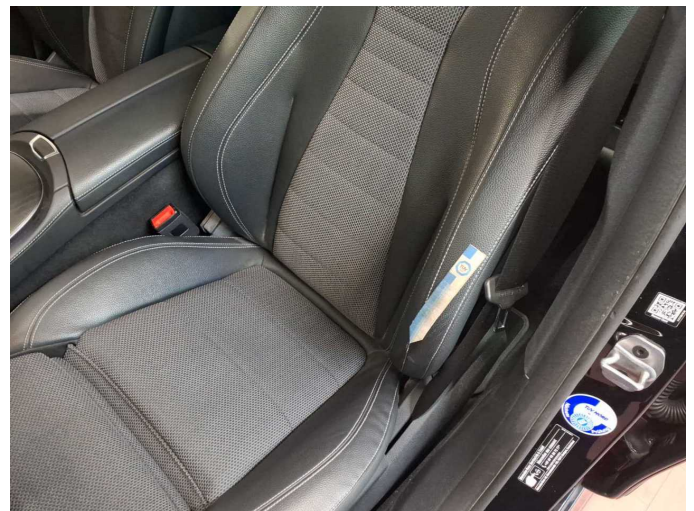
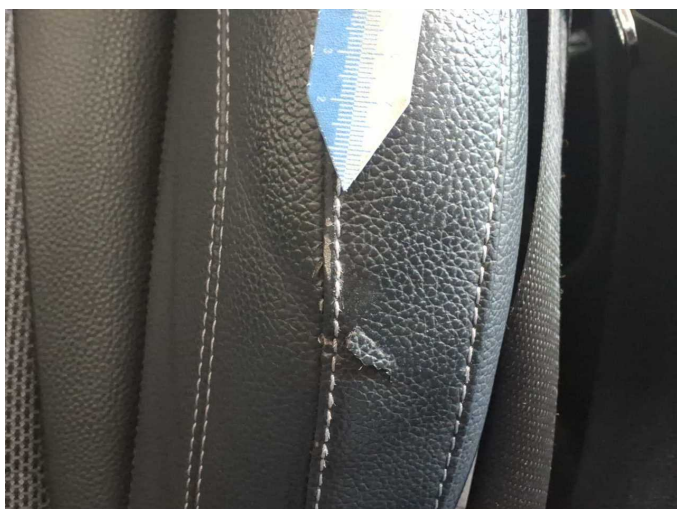
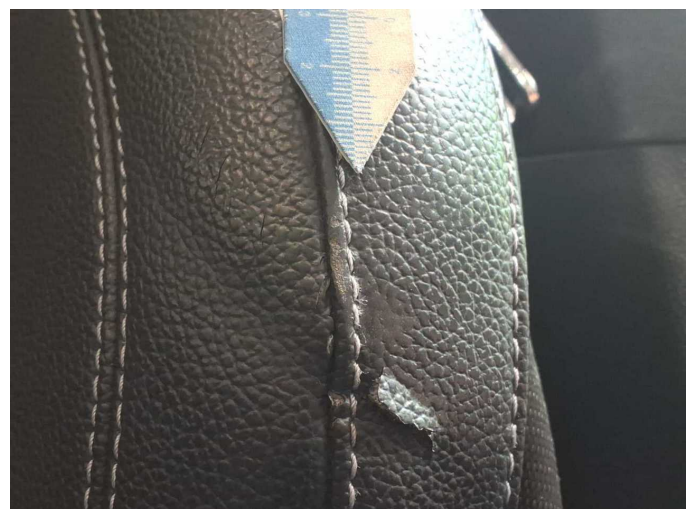
**Damage 8:** Seat - front: Backrest cover - left side - Broken / torn - Smart repair

| No. | Component group | Description |
|---|---|---|
| 8 | Seat - front | Backrest cover - left side - Broken / torn - Smart repair |

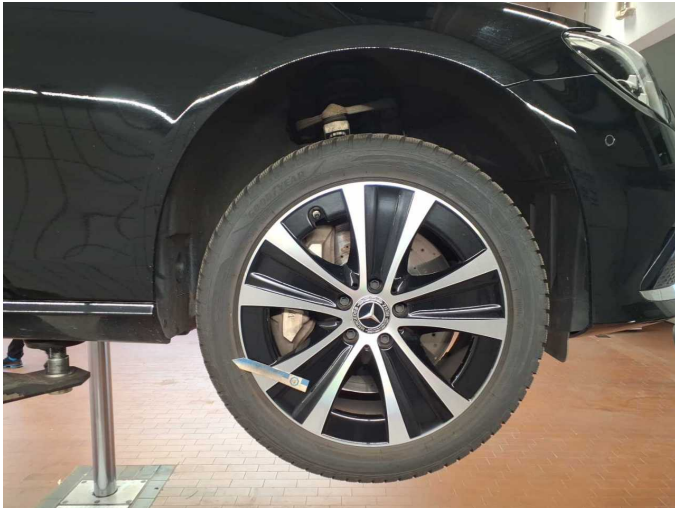
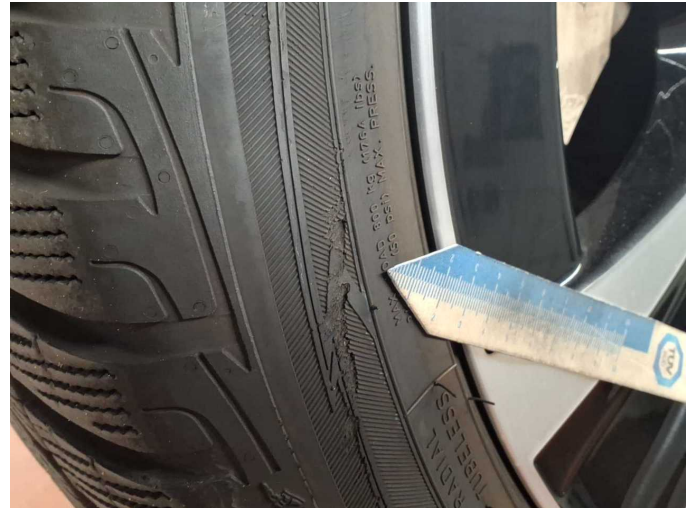
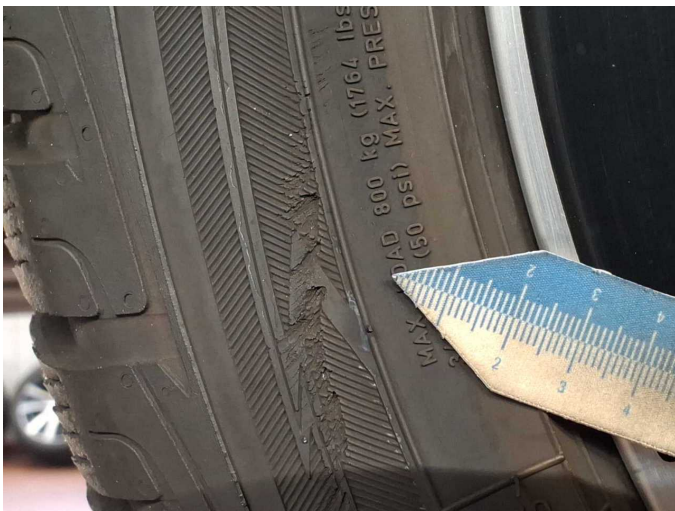
**Damage 9:** Wheel / tyres: Tyre - front right side - Broken / torn - Replace

| No. | Component group | Description |
|---|---|---|
| 9 | Wheel / tyres | Tyre - front right side - Broken / torn - Replace |

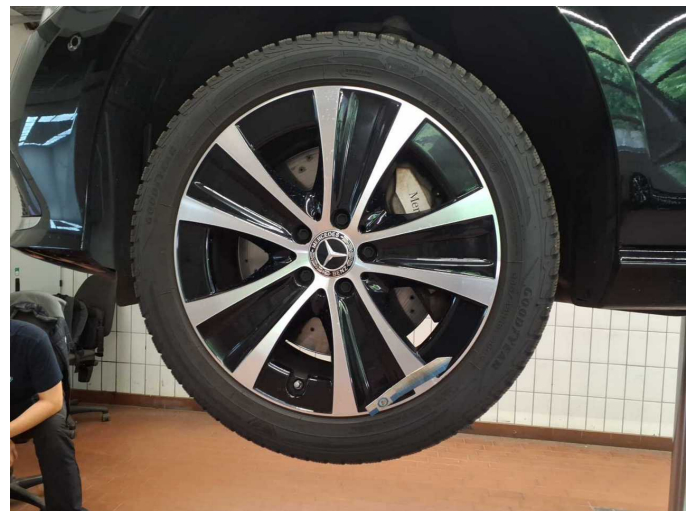
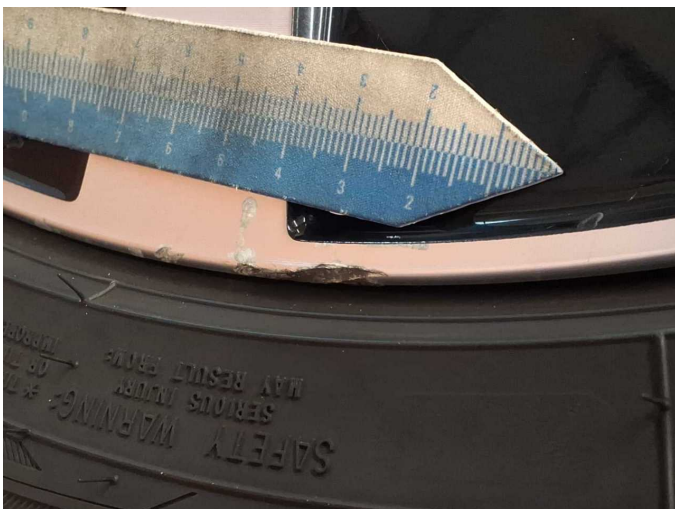
**Damage 10:** Wheel / tyres: Alloy rim - front left side - Scratched - Loss in value

| No. | Component group | Description |
|---|---|---|
| 10 | Wheel / tyres | Alloy rim - front left side - Scratched - Loss in value |

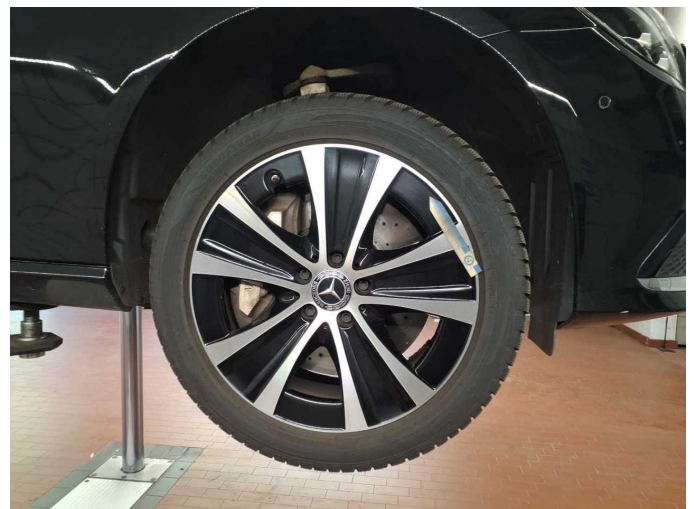
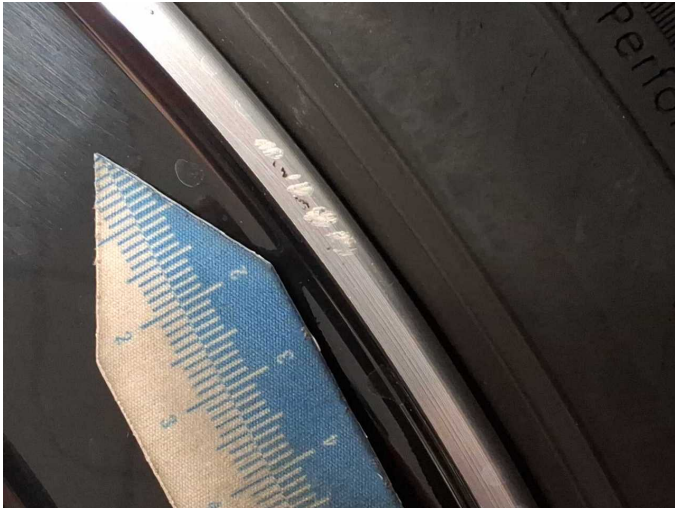
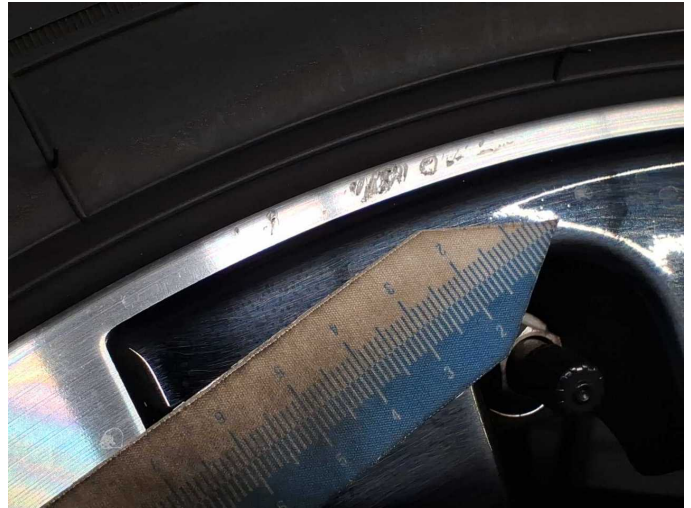
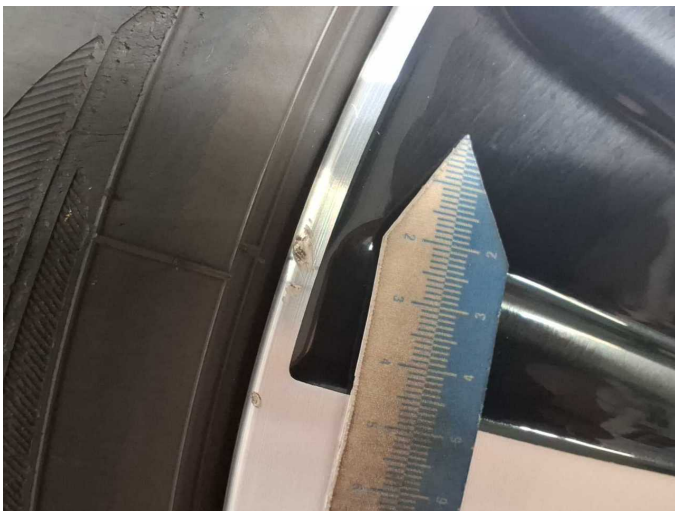
**Damage 11:** Wheel / tyres: Alloy rim - front right side - Scratch(es) - Loss in value

| No. | Component group | Description |
|---|---|---|
| 11 | Wheel / tyres | Alloy rim - front right side - Scratch(es) - Loss in value |

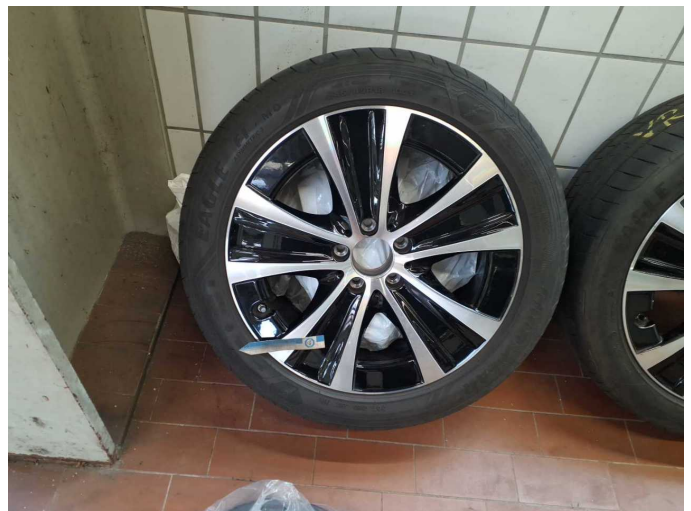
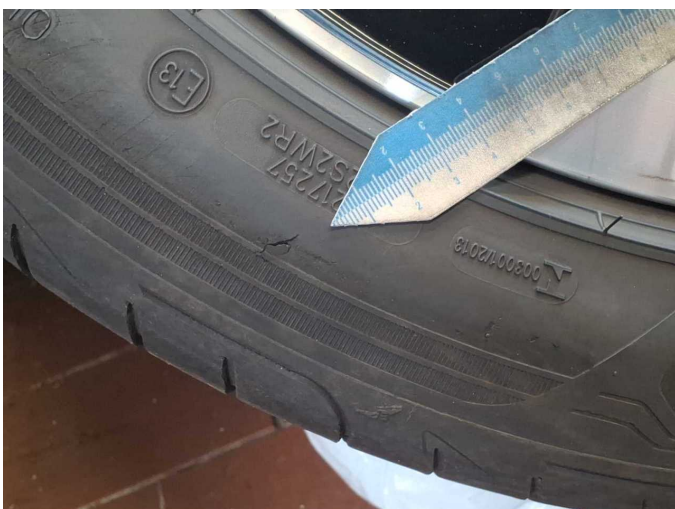
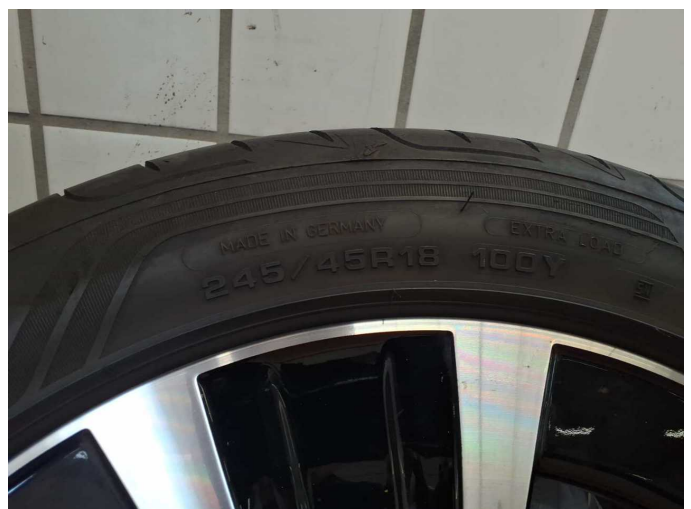
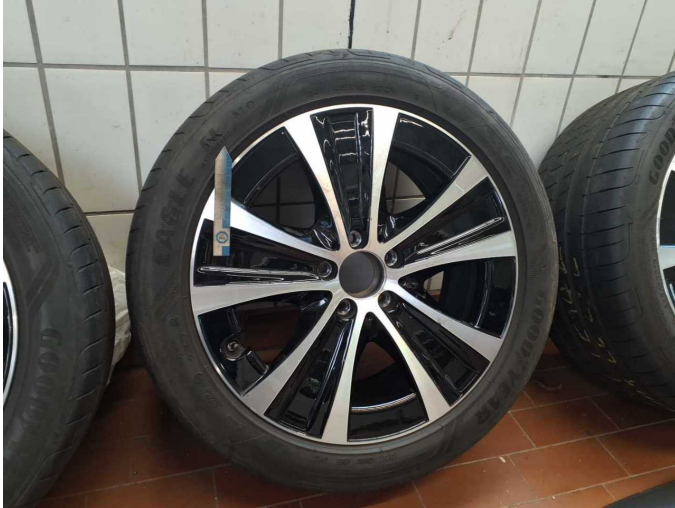
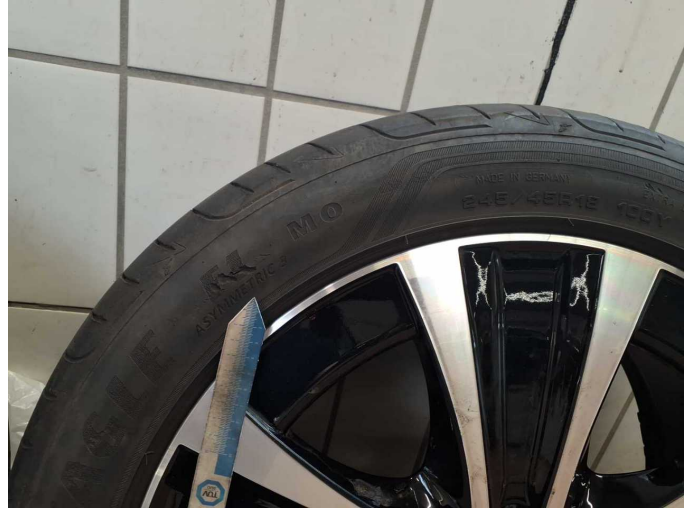
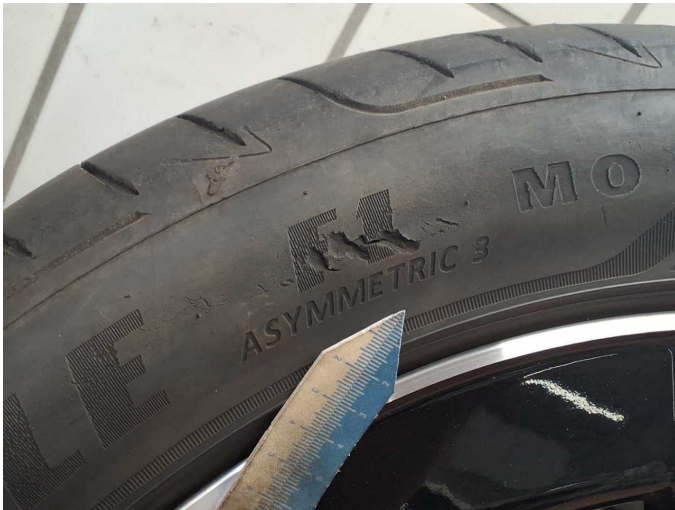
**Damage 12:** 2nd wheel set: 2 tyres - Broken / torn - Replace

| No. | Component group | Description |
|---|---|---|
| 12 | 2nd wheel set | 2 tyres - Broken / torn - Replace |

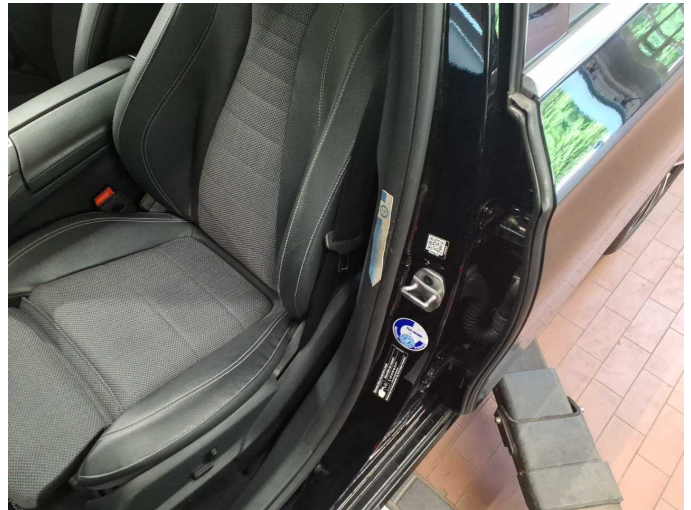
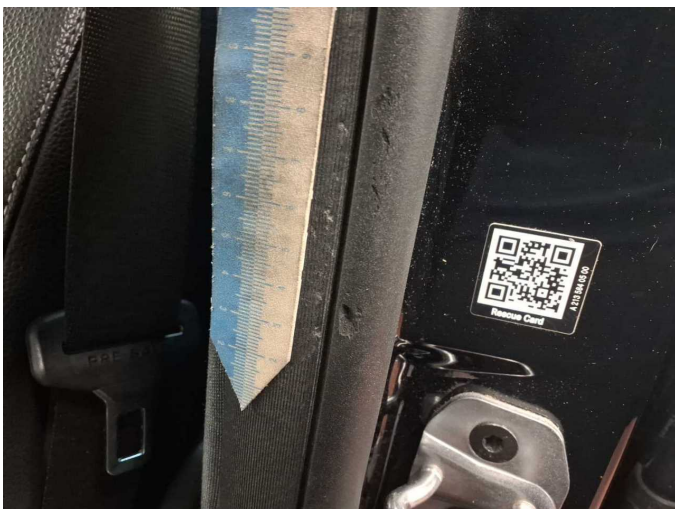
**Damage 13:** Door - front left side: Door seal - Abrasion - Replace

| No. | Component group | Description |
|---|---|---|
| 13 | Door - front left side | Door seal - Abrasion - Replace |

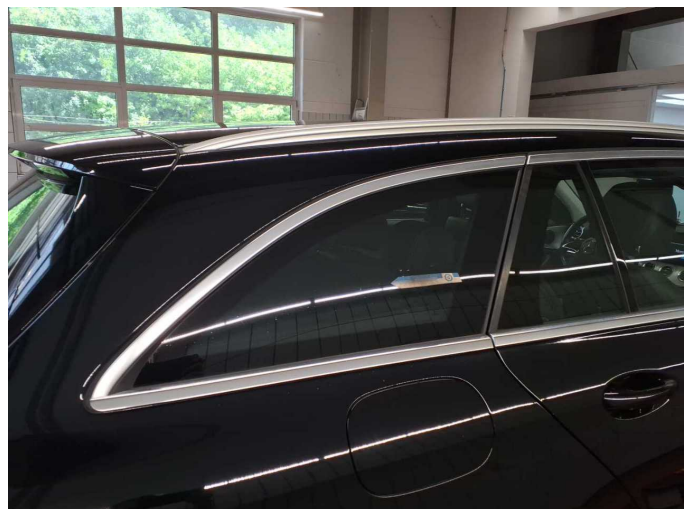
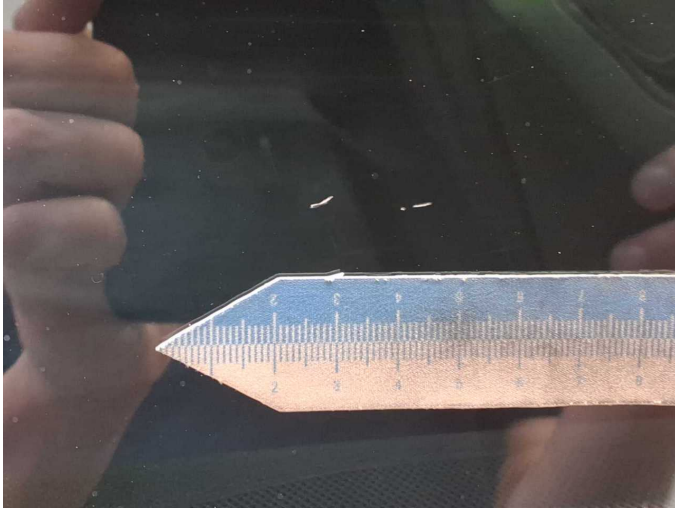
**Wear and tear 2:** Vehicle glazing: Side window - rear right side - Scratch(es) - No deduction

| No. | Component group | Description |
|---|---|---|
| 2 | Vehicle glazing | Side window - rear right side - Scratch(es) - No deduction |

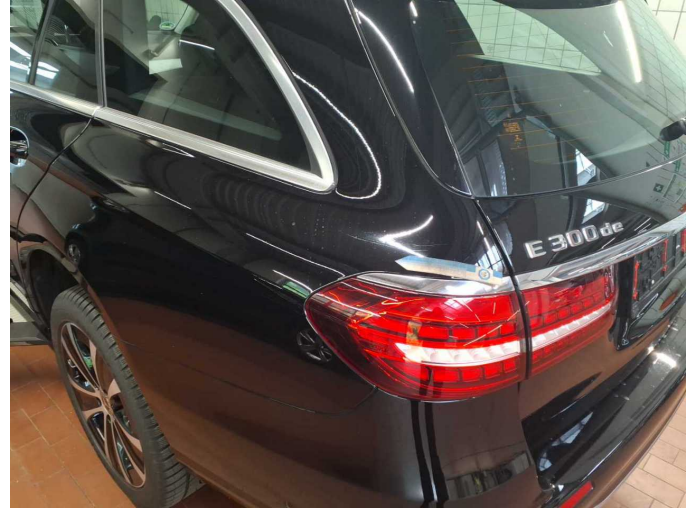
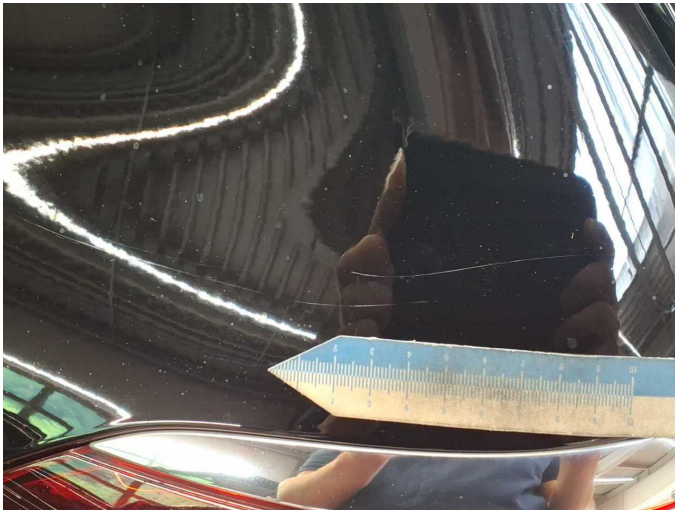
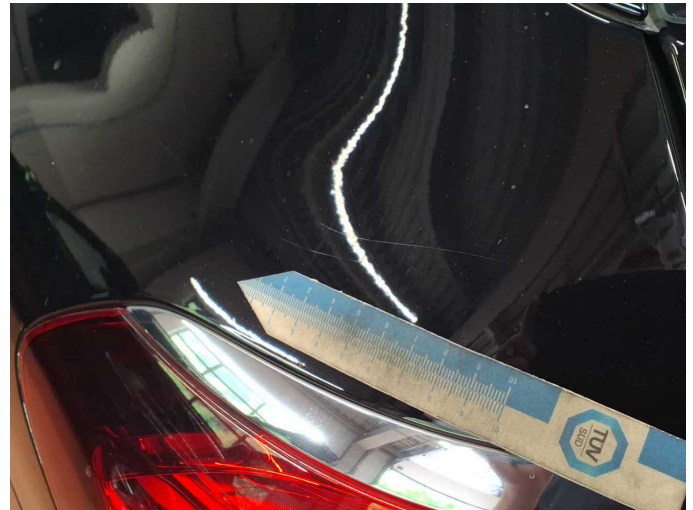
**Wear and tear 3:** Side panel - rear left side: Side panel - Scratch(es) - Cover / polish

| No. | Component group | Description |
|---|---|---|
| 3 | Side panel - rear left side | Side panel - Scratch(es) - Cover / polish |

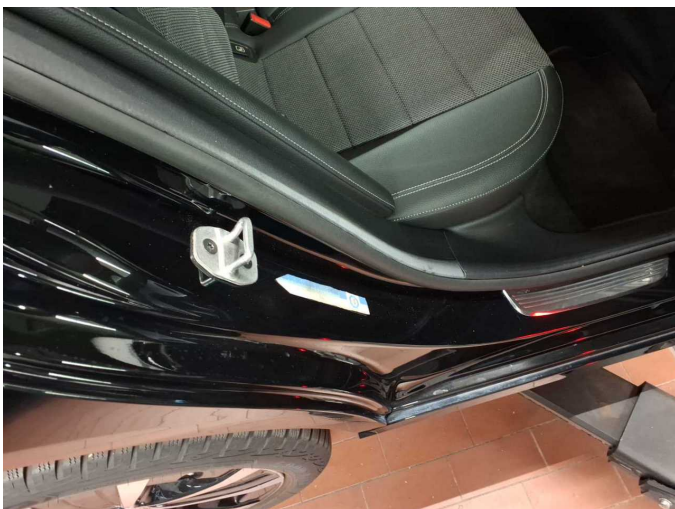
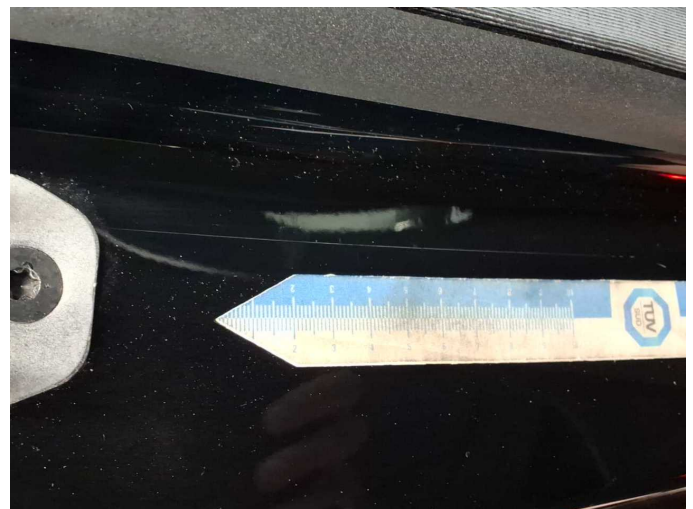
**Wear and tear 4:** Side panel - rear right side: Sill - Scratch(es) - Cover / polish

| No. | Component group | Description |
|---|---|---|
| 4 | Side panel - rear right side | Sill - Scratch(es) - Cover / polish |

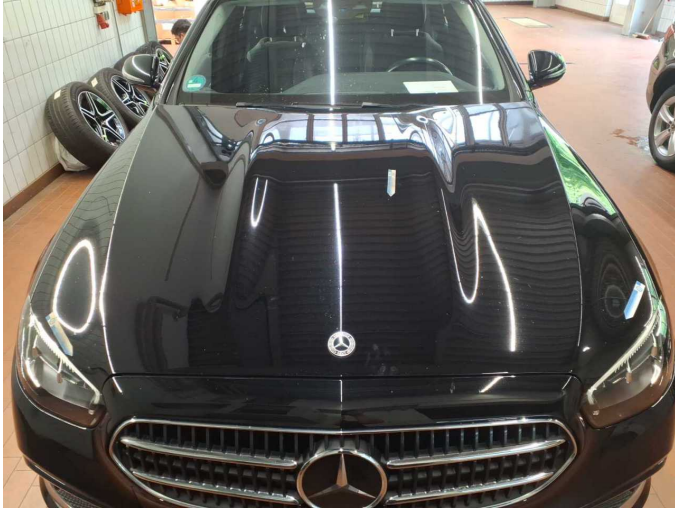
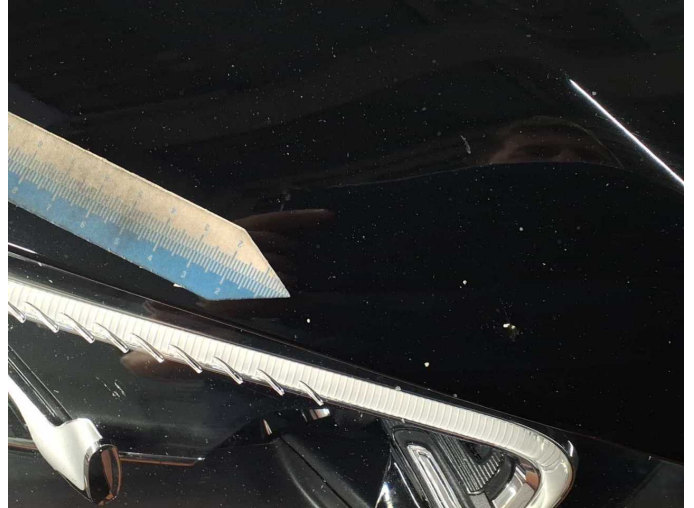
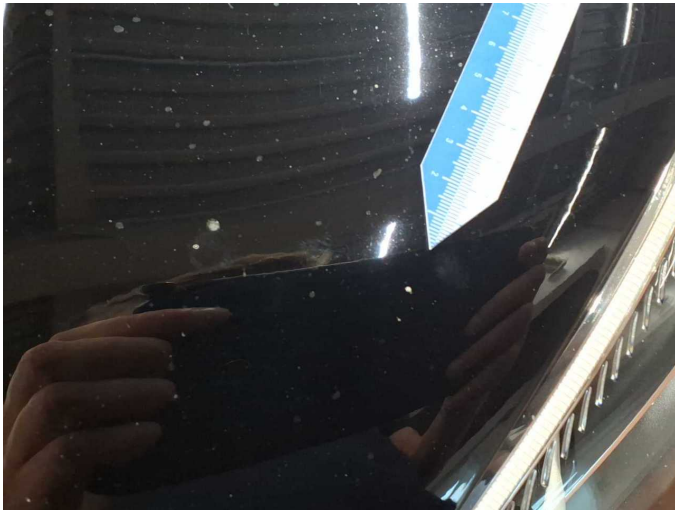
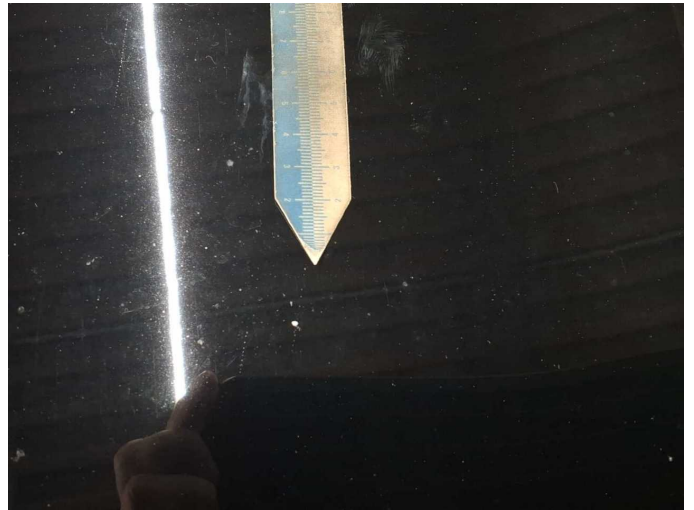
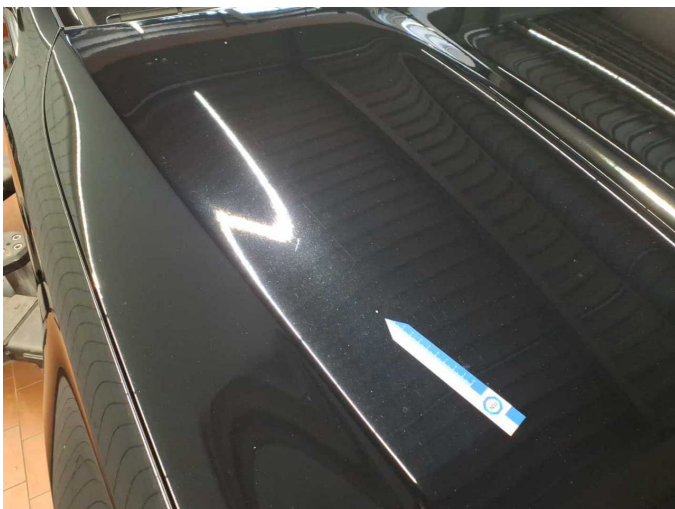
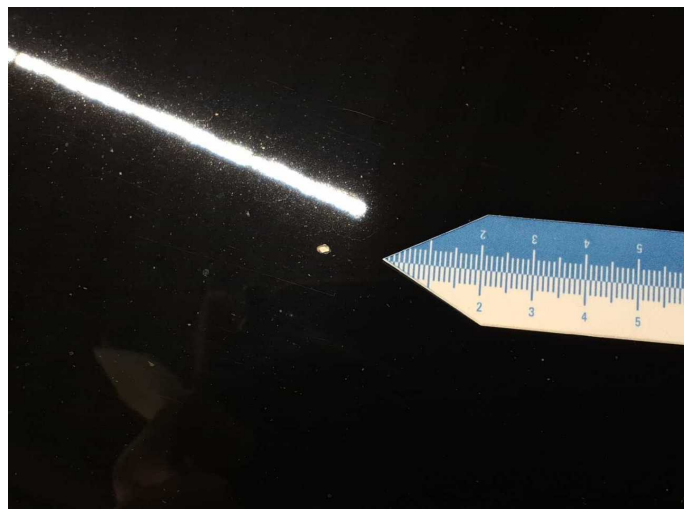
**Wear and tear 5:** Bonnet: Bonnet - Stone chips - No deduction

| No. | Component group | Description |
|---|---|---|
| 5 | Bonnet | Bonnet - Stone chips - No deduction |

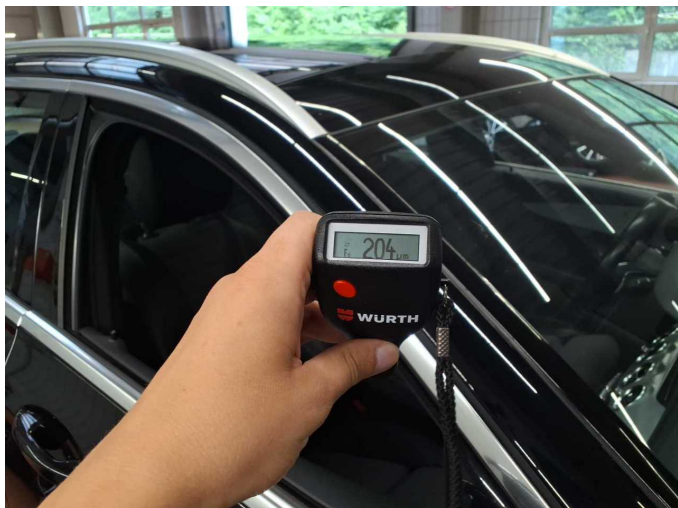
| Roof rail - right side | 204 µm | Mudguard - right side | 177 µm |

**Repainting 1:** Roof rail - right side

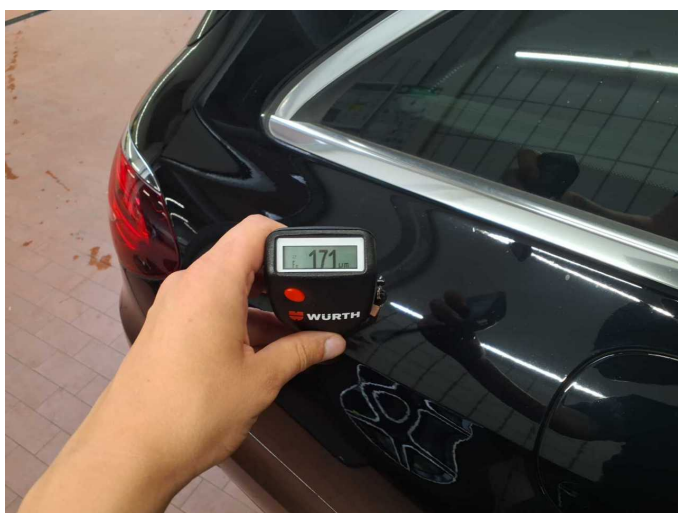
| Side panel - rear right side | 171 µm | Door - rear right side | 177 µm |

**Repainting 3:** Side panel - rear right side

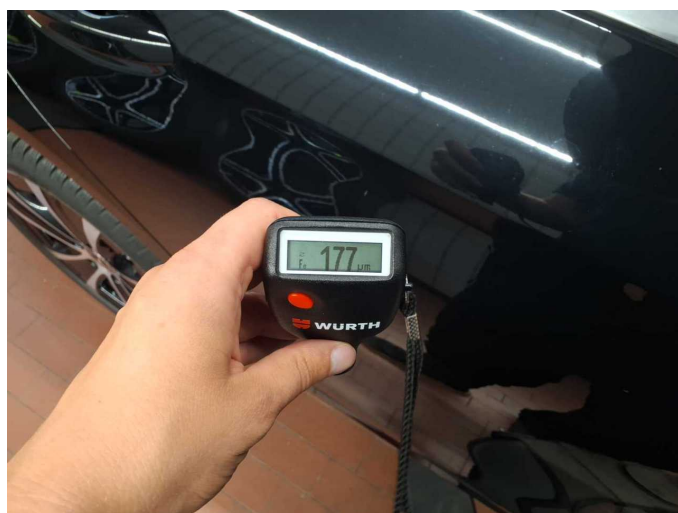
**Repainting 4:** Door - rear right side

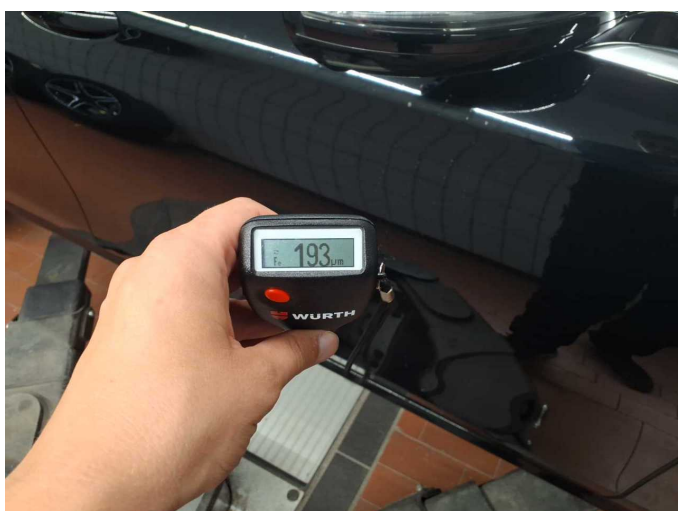
| Door - front right side | 193 µm | | |

**Repainting 5:** Door - front right side
