## Expertise

Protocol number: 45813407  
Order No. / Reference: 26356945  
Inspection date: 2 Jun 2026

Manufacturer: Mercedes-Benz

Model: C 300 e T 9G-TRONIC Avantgarde

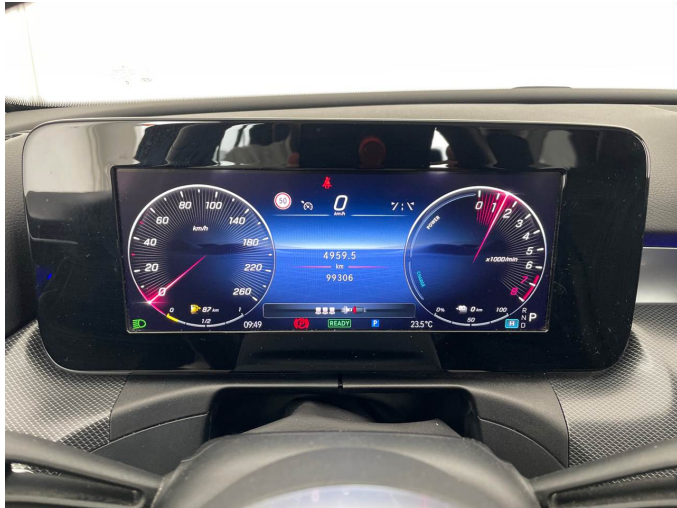
Figure 7: Instrument cluster

**Mileage (Read)** 99,306 km

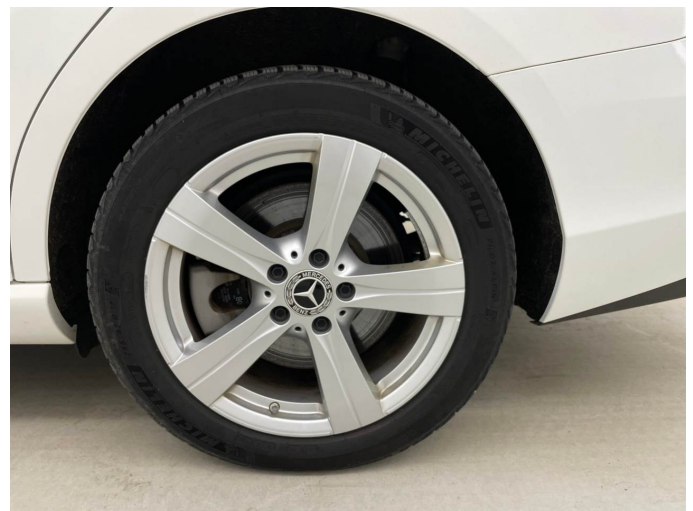
Figure 12: Mounted tyres

#	Tyre size	Type of tyre	Manufacturer	Tread depth
1)	225/50 R17 98H	Winter tyres on Light alloy	Michelin	7mm / 7mm
2)	225/50 R17 98H	Winter tyres on Light alloy	Michelin	6mm / 6mm

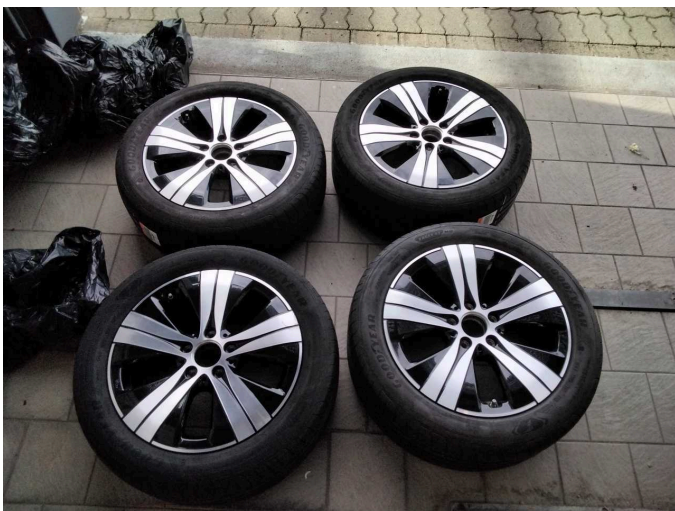
Figure 17: Additional tyres

#	Tyre size	Type of tyre	Manufacturer	Tread depth
1)	225/50 R17 94Y	Summer tyres on Light alloy	Goodyear	5mm / 5mm
2)	225/50 R17 94Y	Summer tyres on Light alloy	Goodyear	4mm / 4mm

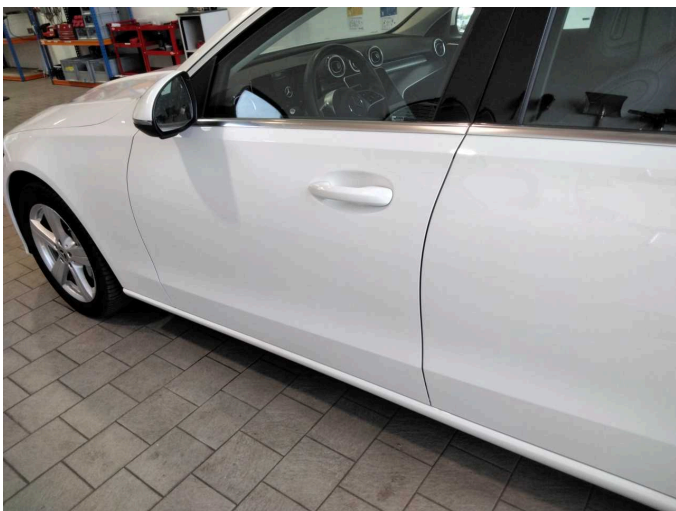
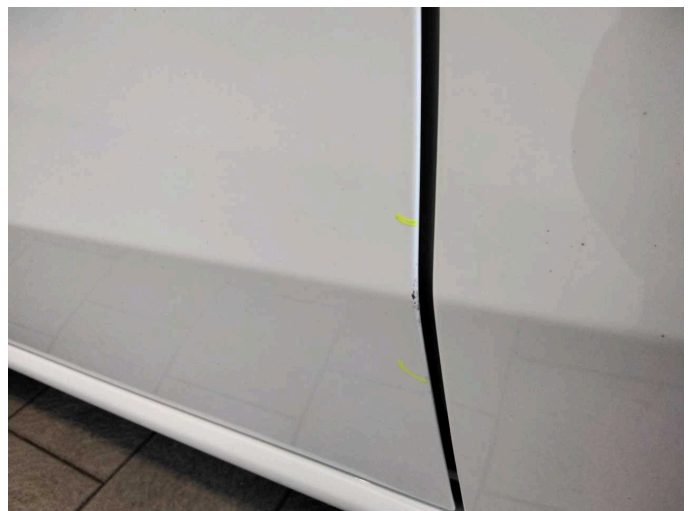
Damage 1: Door - front left side: Door edge - Scratch(es) - Smart repair

No.	Component group	Description
1	Door - front left side	Door edge - Scratch(es) - Smart repair
2	Wheel / tyres	Alloy rim - rear left side - Damaged - Loss in value
3	2nd wheel set	1 alloy rim - Scratch(es) - Replace

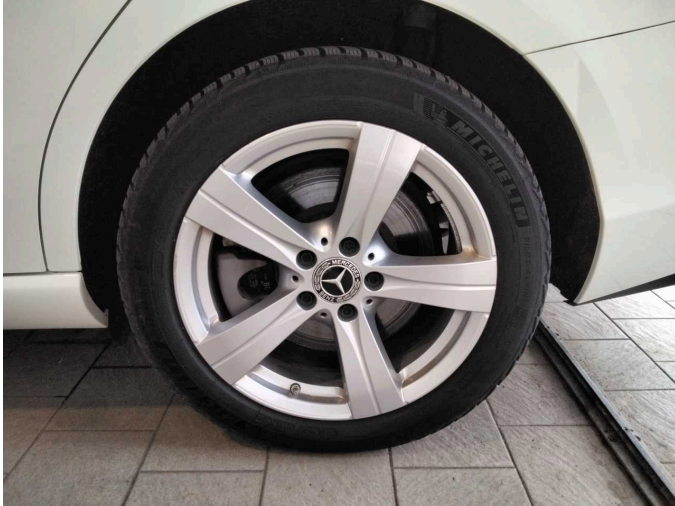
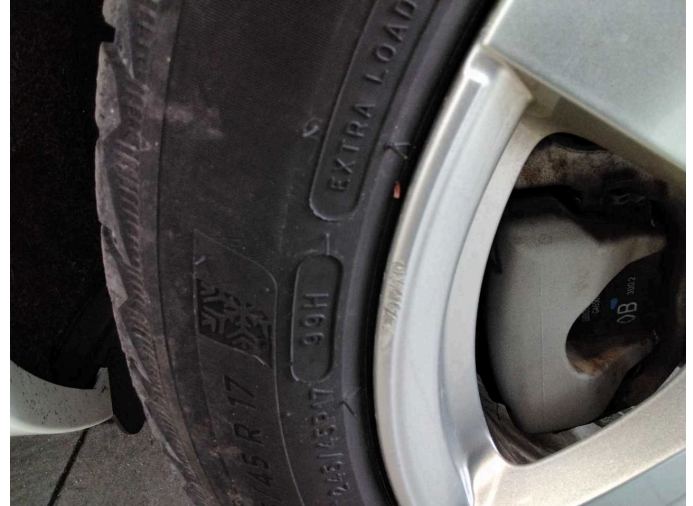
**Damage 2:** Wheel / tyres: Alloy rim - rear left side - Damaged - Loss in value

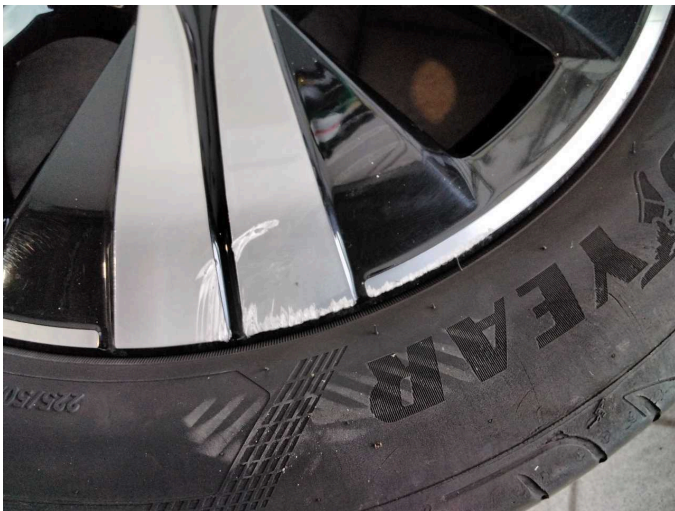
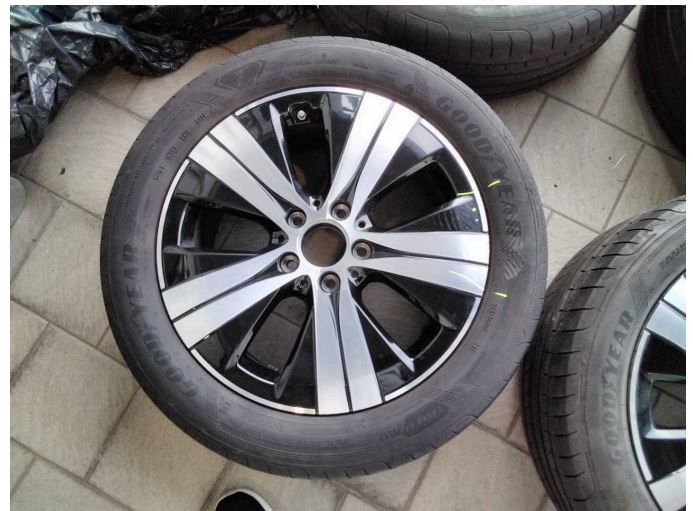
**Damage 3:** 2nd wheel set: 1 alloy rim - Scratch(es) - Replace

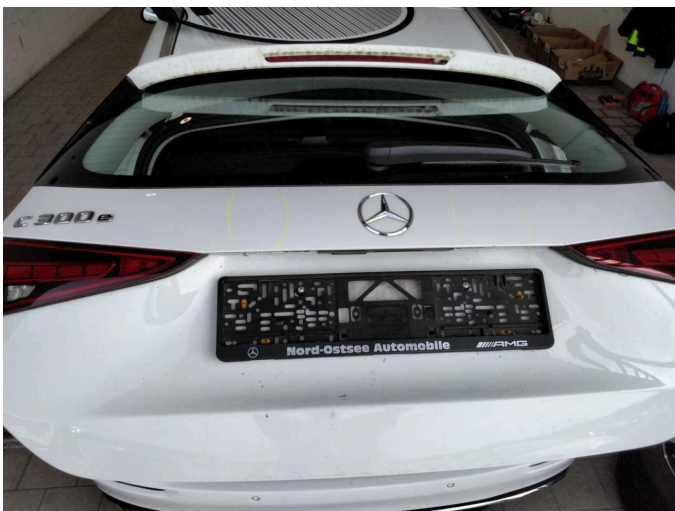
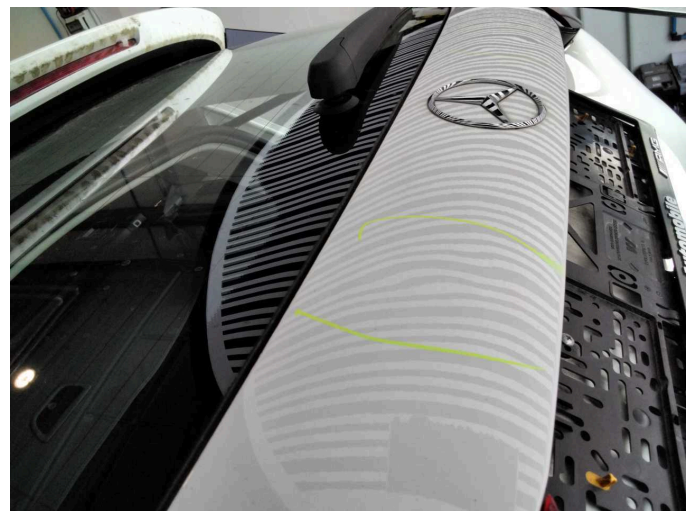
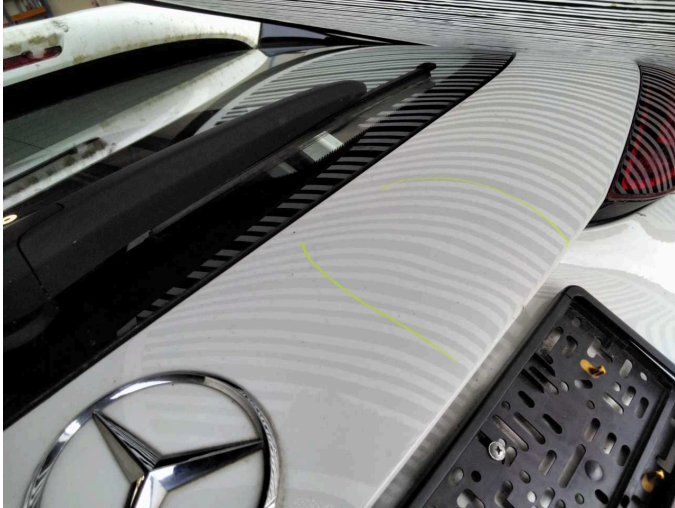
**Wear and tear 5:** Boot lid / rear door: Boot lid - dent(s) - No deduction

No.	Component group	Description
1	Sill - left side	Sill - Scratch(es) - No deduction
2	Front bumper	Front bumper - Scratch(es) - No deduction
3	Rear bumper	Rear bumper - Scratch(es) - No deduction
4	Vehicle glazing	Windscreen - Stone chips - No deduction
5	Boot lid / rear door	Boot lid - dent(s) - No deduction
