Expertise

Protocol number: 46375515  
Order No. / Reference: 26604806  
Inspection date: 7 Jul 2026

Manufacturer: Mercedes-Benz  
VIN: W1NKM0FB4PU002822

Model: GLC 220 d 4Matic 9G-TRONIC Avantgarde Advanced

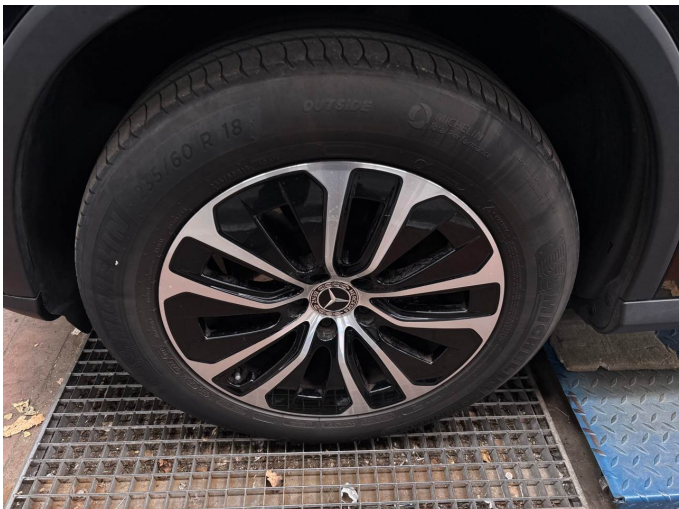
| # | Tyre size | Type of tyre | Manufacturer | Tread depth |
|---|---|---|---|---|
| 1) | 235/60 R18 103W | Summer tyres on Light alloy | Michelin | 3mm / 3mm |
| 2) | 235/60 R18 103W | Summer tyres on Light alloy | Michelin | 3mm / 3mm |

Figure 12: Mounted tyres

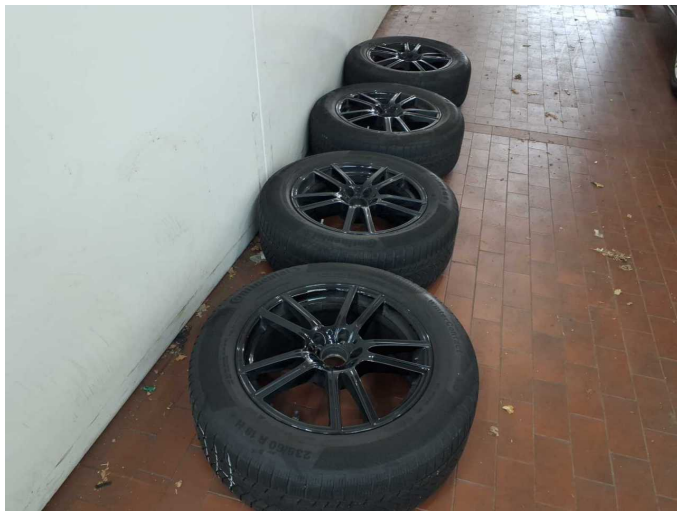
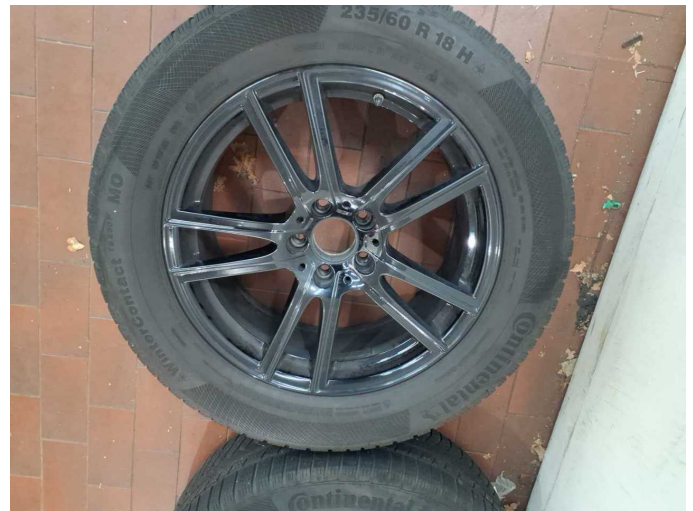
| # | Tyre size | Type of tyre | Manufacturer | Tread depth |
|---|---|---|---|---|
| 1) | 235/60 R18 103H | Winter tyres on Light alloy | Continental | 3mm / 3mm |
| 2) | 235/60 R18 103H | Winter tyres on Light alloy | Continental | 3mm / 3mm |

Figure 15: Additional tyres

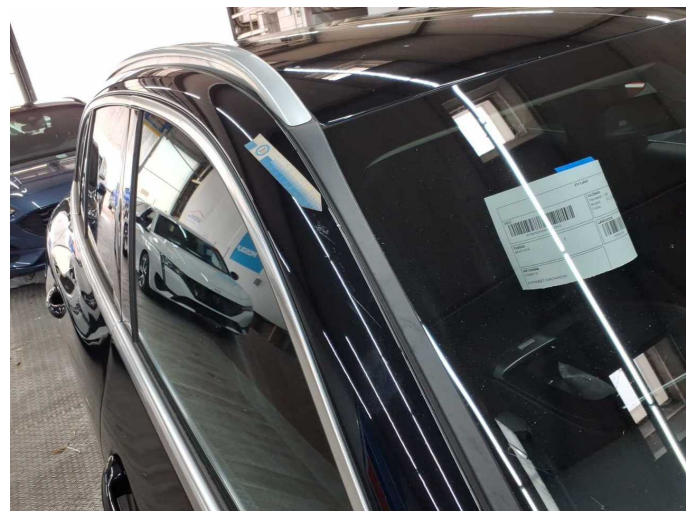
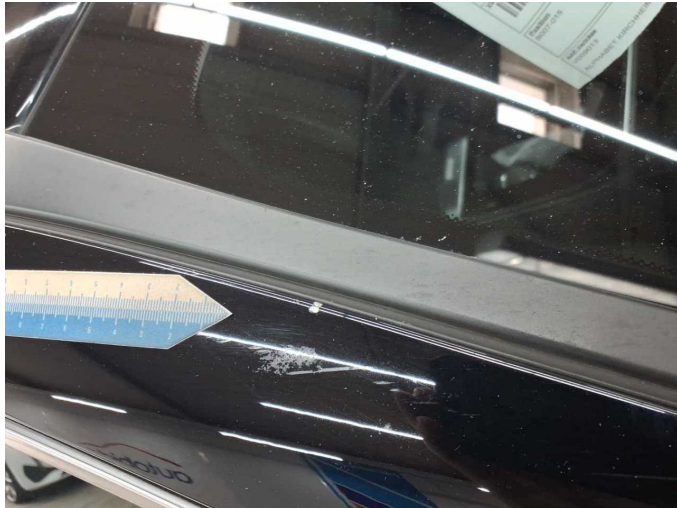
| No. | Component group | Description |
|---|---|---|
| 1 | Roof | Roof rail - right side - Stone chips - Smart repair |

Damage 1: Roof: Roof rail - right side - Stone chips - Smart repair

**Damage 1:** Roof: Roof rail - right side - Stone chips - Smart repair

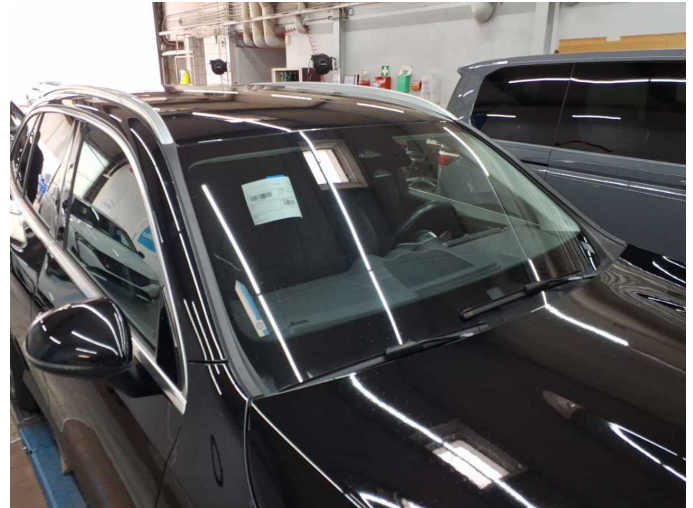
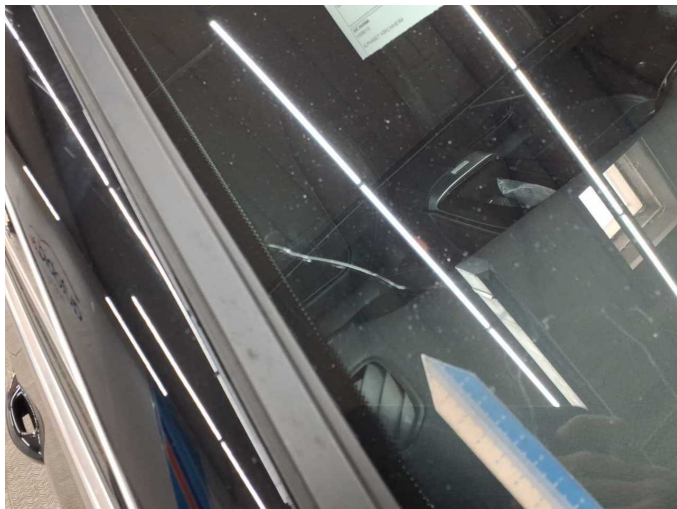
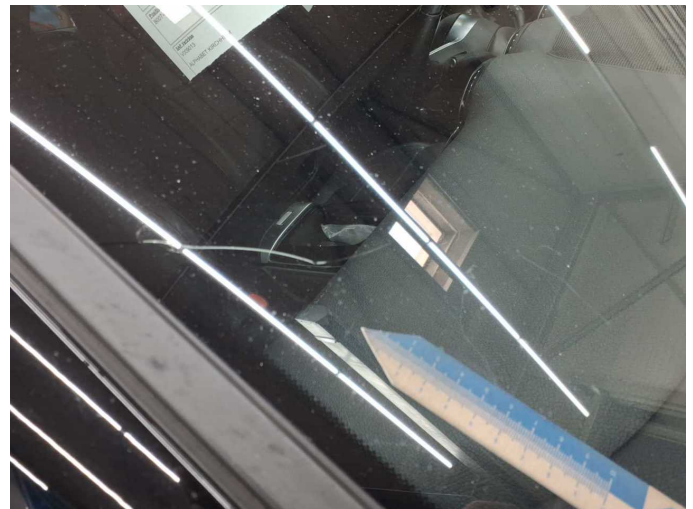
| No. | Component group | Description |
|---|---|---|
| 2 | Vehicle glazing | Windscreen - Stone chips - Replace |

**Damage 2:** Vehicle glazing: Windscreen - Stone chips - Replace

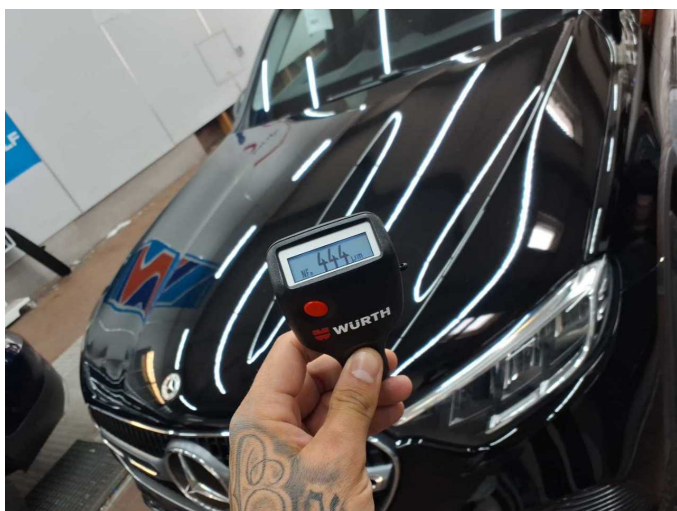
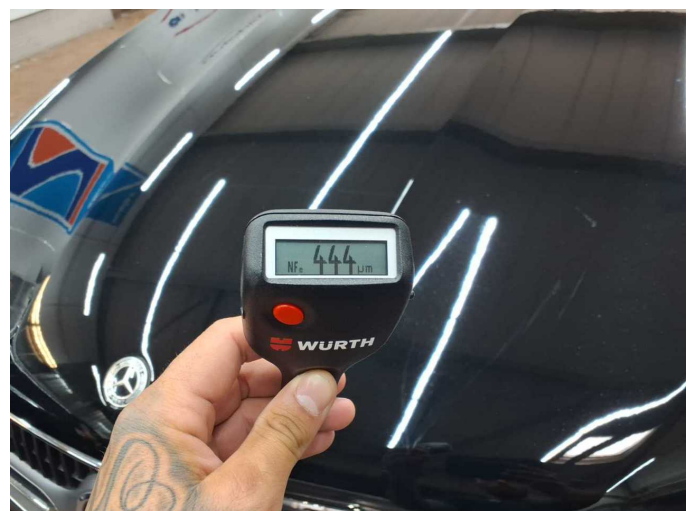
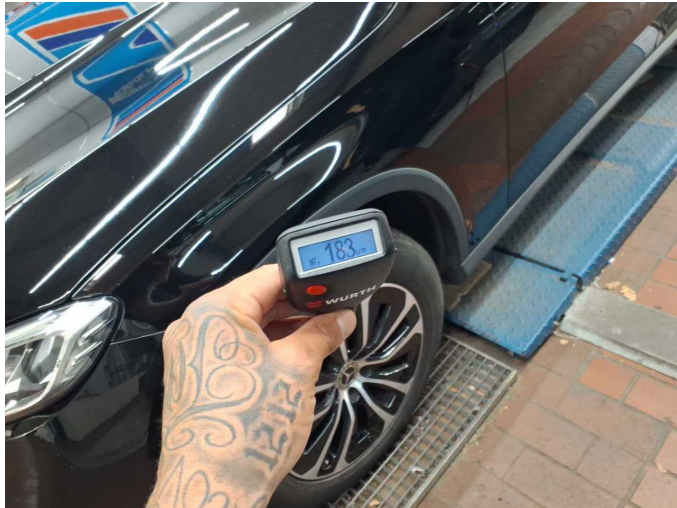
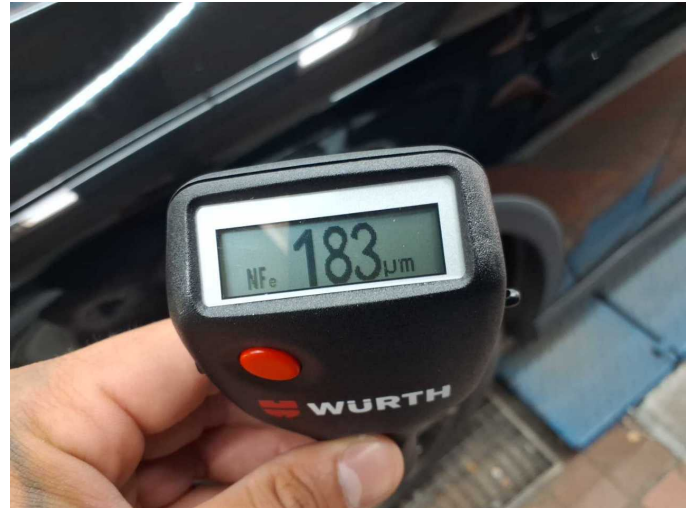
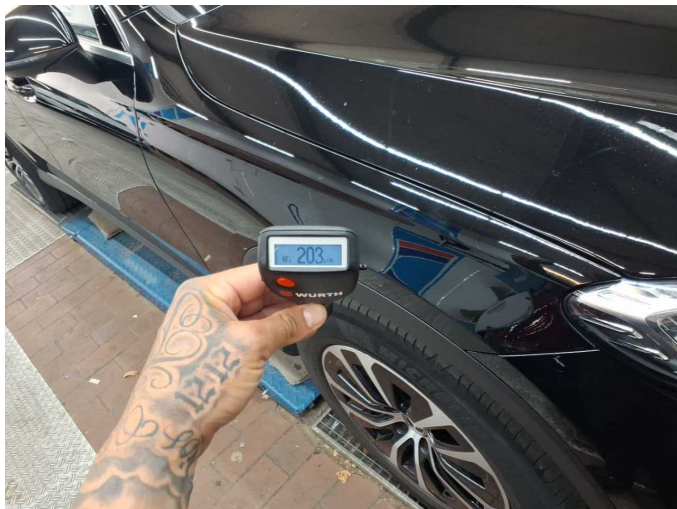
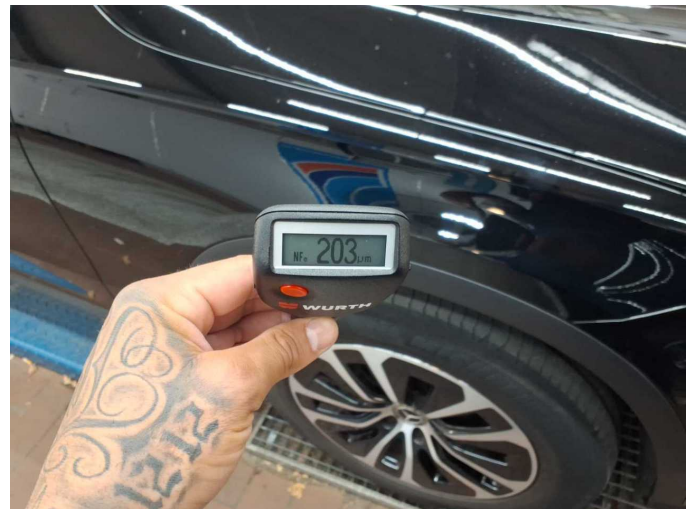
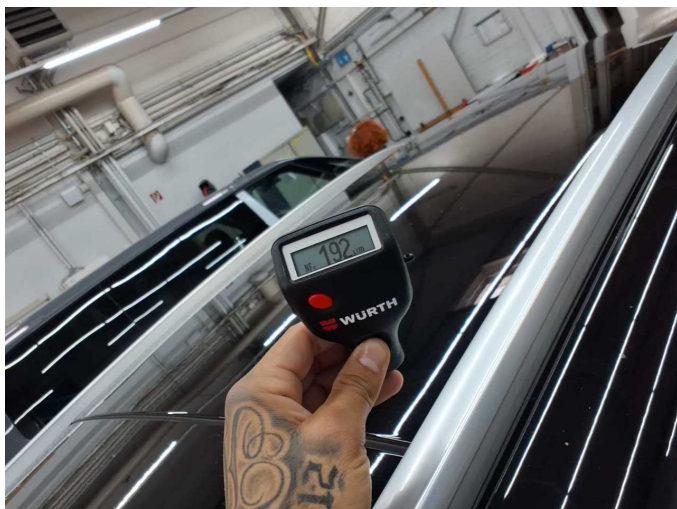
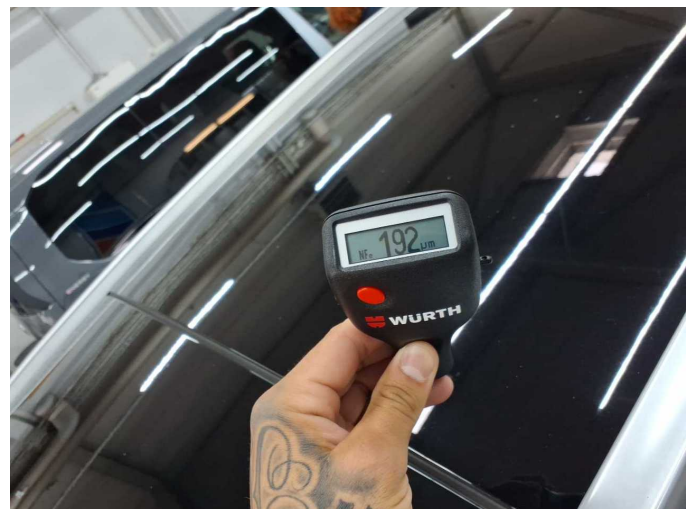
| No. | Repainting |
|---|---|
| 1 | Roof, Mudguard - left side, Mudguard - right side, Bonnet, Professionally carried out |

**Repainting 1:** Roof, Mudguard - left side, Mudguard - right side, Bonnet
