Peugeot 5008:

| Vinnumber: | <b>VF3MCYHZMMS148104</b> | Versionname: | |

## Limited Technical Inspection

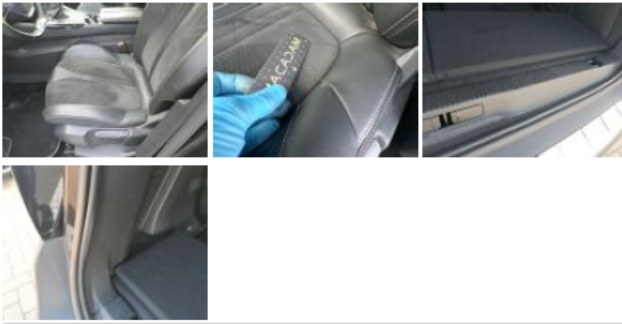
Interior, Damaged, Acceptable

Bonnet, Dent(s), Paintless dent repair

Bumper F, Scratch(es), Acceptable

Bumper moulding F, Scratch(es), Acceptable

Door FL, Dent(s), Paintless dent repair

0,00

95,47

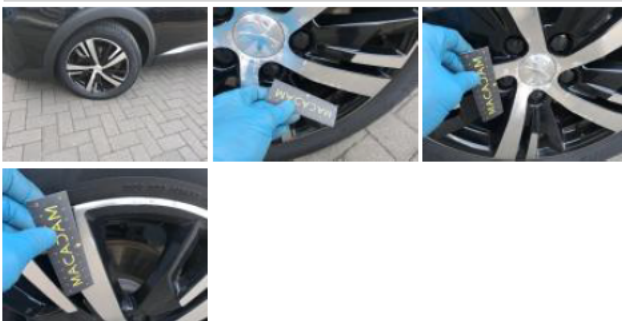
| Spare wheel, Missing, Replace | 271,72 |
| Bumper R, Scratch(es), Acceptable | 0,00 |
| Wing RR, Dent(s) and scratch(es), Acceptable | 0,00 |
| Door RR, Dent(s) and scratch(es), Repair and paint (complete) | 475,54 |
| Alloy rim FR polished, Scratch(es), Acceptable | 0,00 |
| Alloy rim RR polished, Scratch(es), Acceptable | 0,00 |
| Step R, Scratch(es), Acceptable | 0,00 |
| Roof pillar R, Dent(s), Paintless dent repair | 95,47 |
