Expertise

Protocol number: 46781075  
Order No. / Reference: 26794776  
Inspection date: 29 Jul 2026

Model: E 220 d 9G-TRONIC Avantgarde

VIN: W1KZF0EB3PB152441

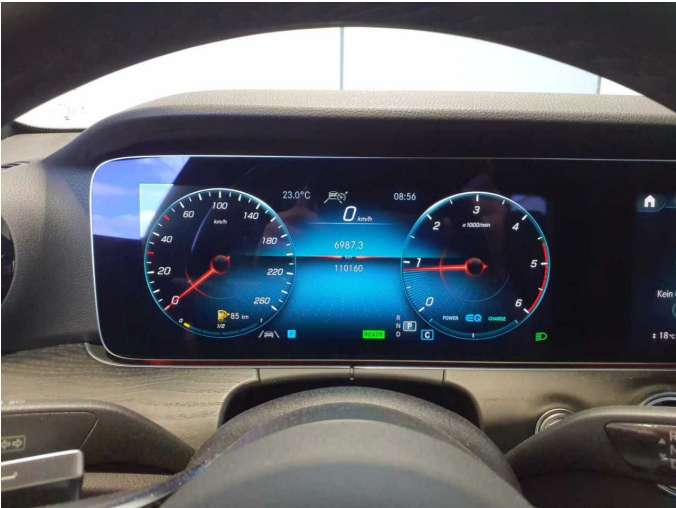
| Vehicle details | |
|---|---|
| Mileage (Read) | 110,160 km |

Figure 7: Instrument cluster

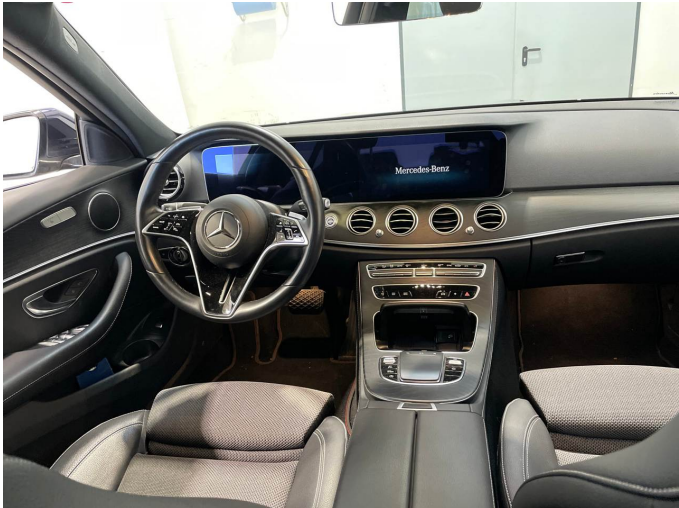
Figure 8: Instrument panel

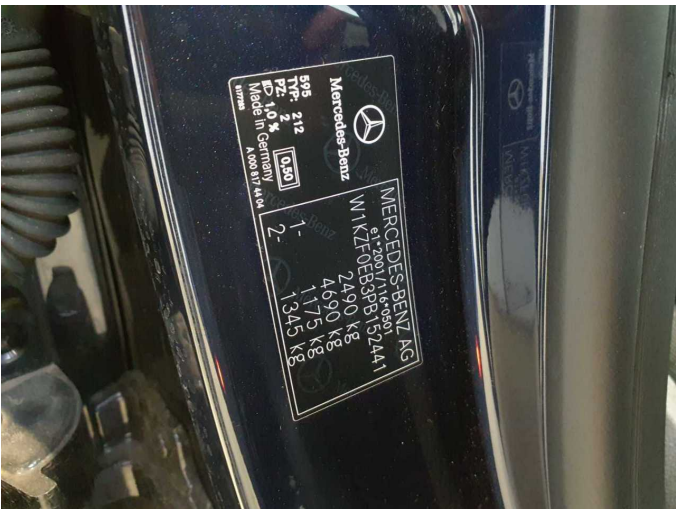
| VIN comparison | The vehicle identification number (VIN) was read from the vehicle and its conformity with the submitted documents was confirmed by the undersigned during the inspection. |

Figure 11: VIN

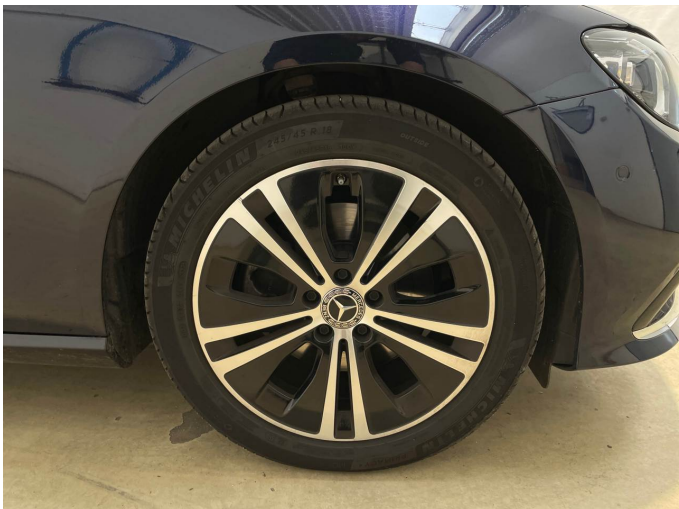
| Tyres | | | | |
|---|---|---|---|---|
| 1) | 245/45 R18 100Y | Summer tyres on Light alloy | Michelin | 6mm / 6mm |
| 2) | 245/45 R18 100Y | Summer tyres on Light alloy | Michelin | 6mm / 6mm |

Figure 12: Mounted tyres

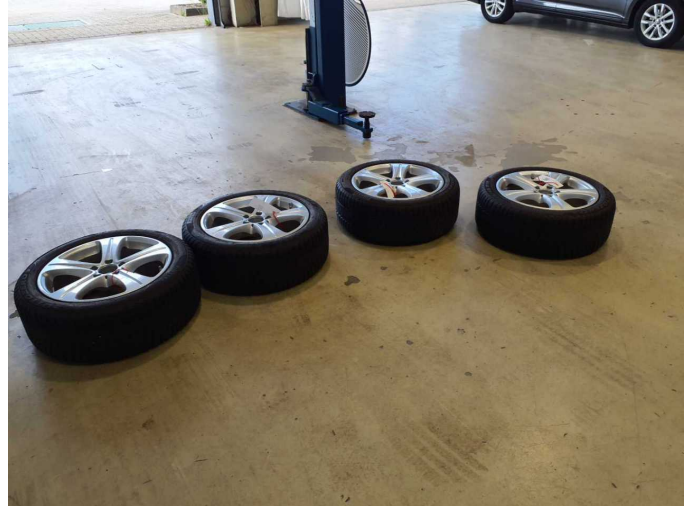
| Tyres | | | | |
|---|---|---|---|---|
| 1) | 245/45 R18 100V | Winter tyres on Light alloy | Pirelli | 6mm / 6mm |
| 2) | 245/45 R18 100V | Winter tyres on Light alloy | Pirelli | 6mm / 6mm |

Figure 14: Additional tyres

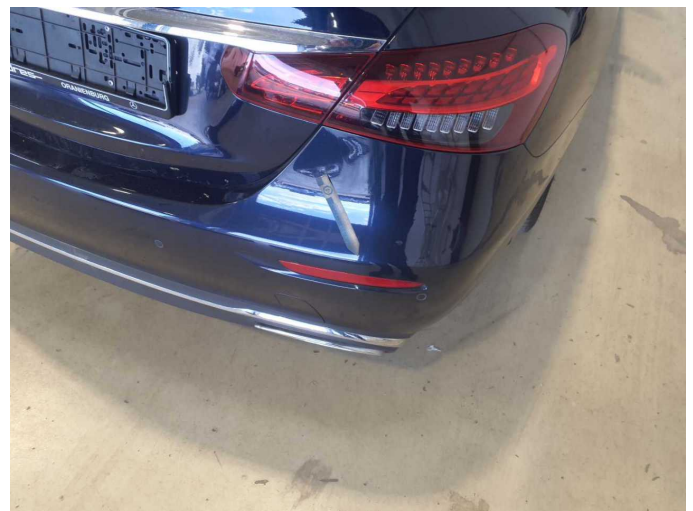
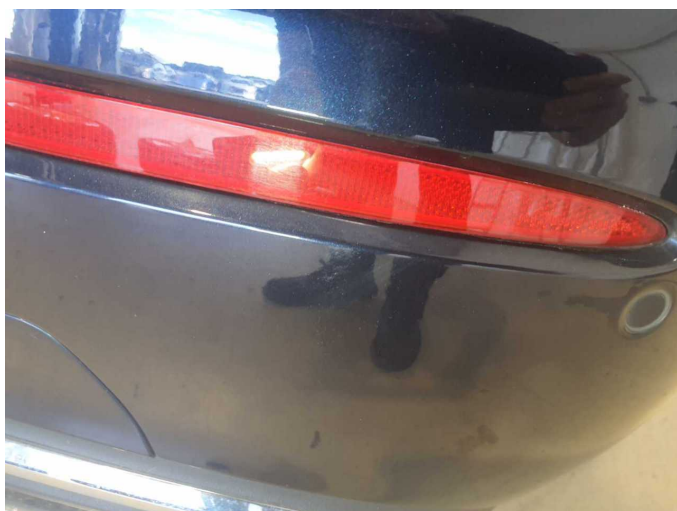
| No. | Component group | Description |
|---|---|---|
| 1 | Rear bumper | Rear bumper - Scratch(es) - Smart repair |

Damage 1: Rear bumper: Rear bumper - Scratch(es) - Smart repair

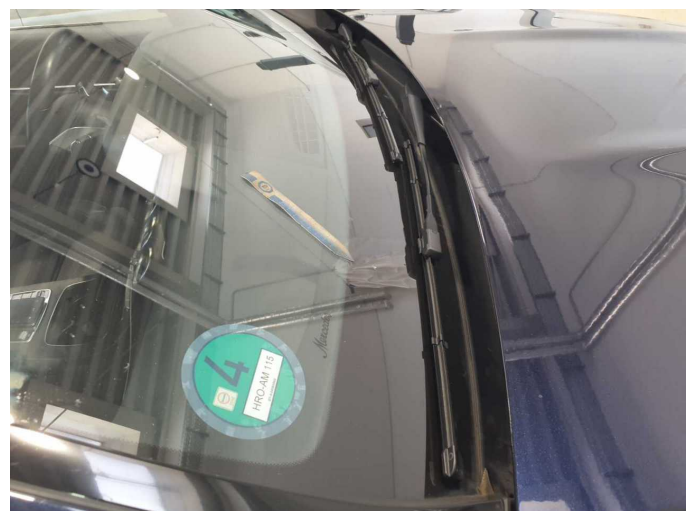
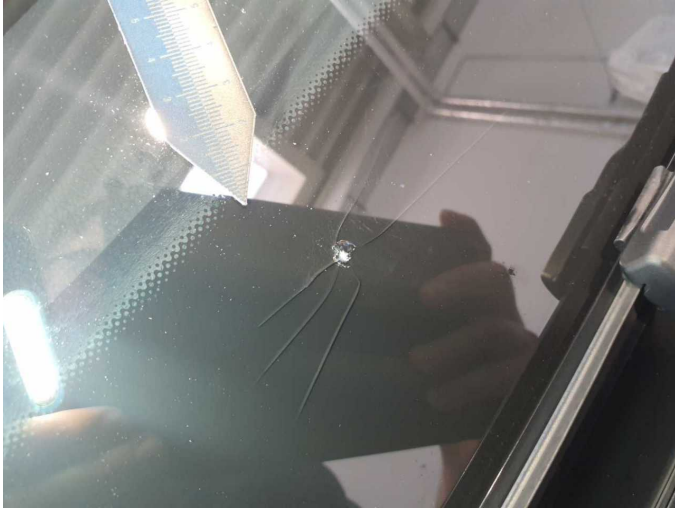
| No. | Component group | Description |
|---|---|---|
| 2 | Vehicle glazing | Windscreen (kein Staubschutz) - Stone chips - Replace |

Damage 2: Vehicle glazing: Windscreen (kein Staubschutz) - Stone chips  
- Replace

**Damage 2:** Vehicle glazing: Windscreen (kein Staubschutz) - Stone chips  
- Replace
