Expertise

Protocol number: 46534028  
Order No. / Reference: 26528765  
Inspection date: 10 Jul 2026

Model: A4 40 TDI S tronic S line

VIN: WAUZZZF48NA046492

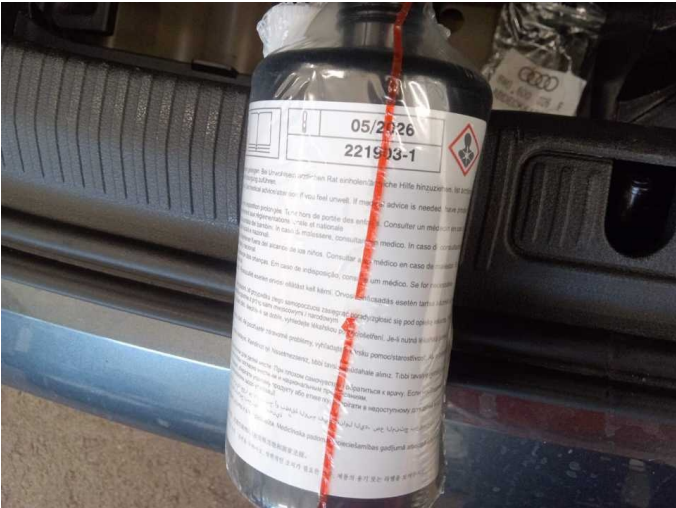
| No. | Component group | Description |
|---|---|---|
| 1 | Equipment | Tirefit filler - Expired - Replace |

Damage 1: Equipment: Tirefit filler - Expired - Replace

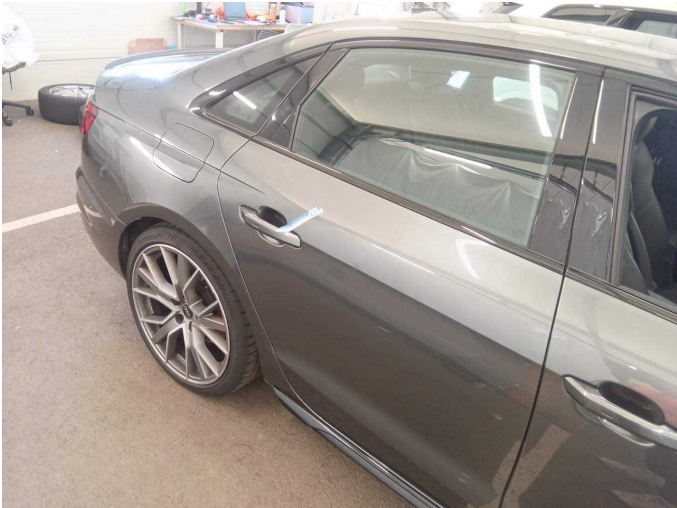
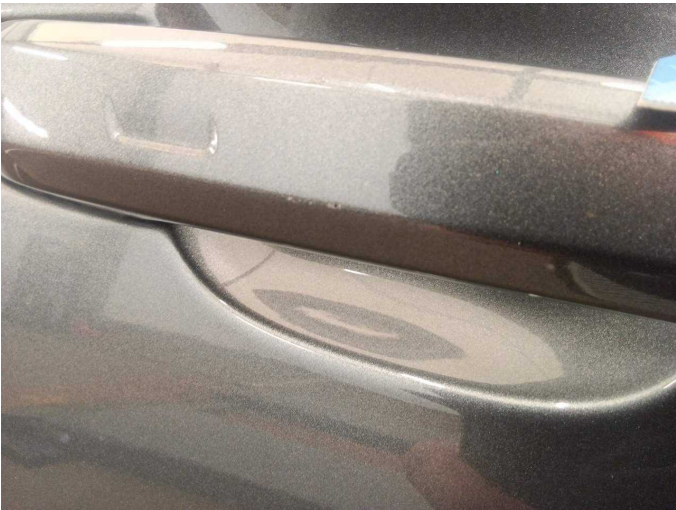
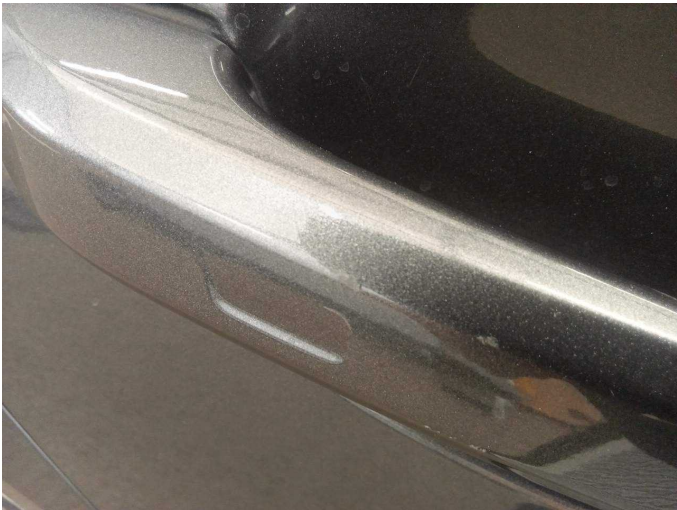
| No. | Component group | Description |
|---|---|---|
| 2 | Door - rear right side | Door handle - outside - Scratch(es) - Smart repair |

Damage 2: Door - rear right side: Door handle - outside - Scratch(es) - Smart repair

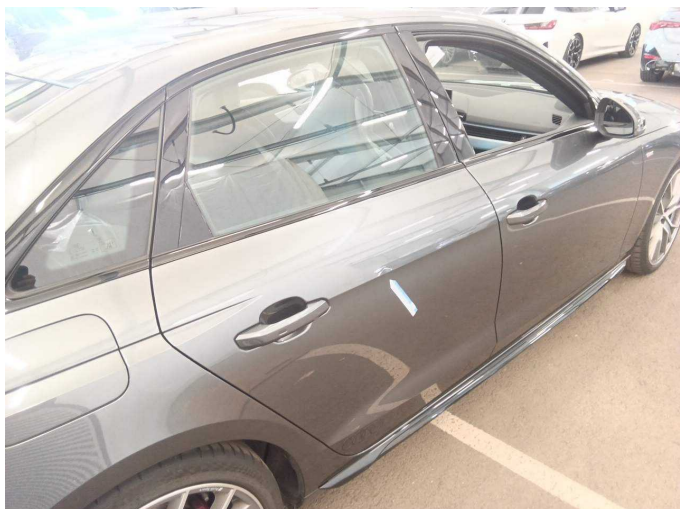
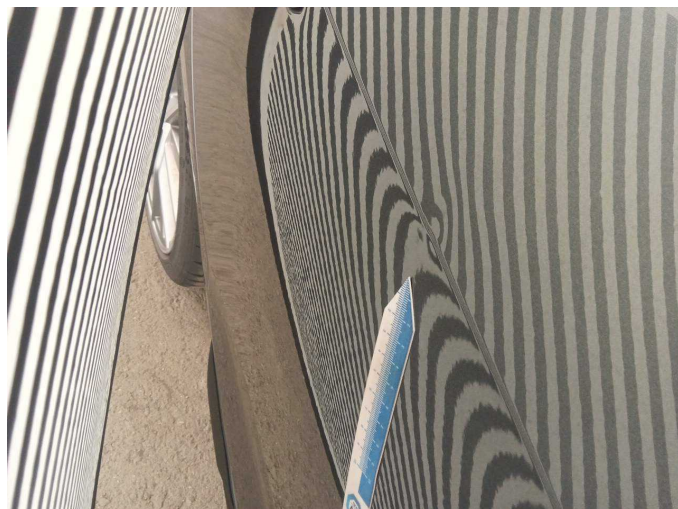
| No. | Component group | Description |
|---|---|---|
| 3 | Door - rear right side | Door (2) - dent(s) - Smooth repair work |

**Damage 3:** Door - rear right side: Door (2) - dent(s) - Smooth repair work

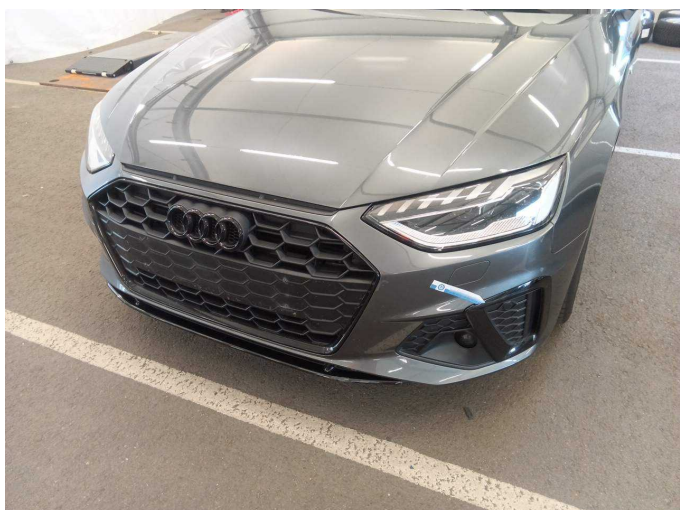
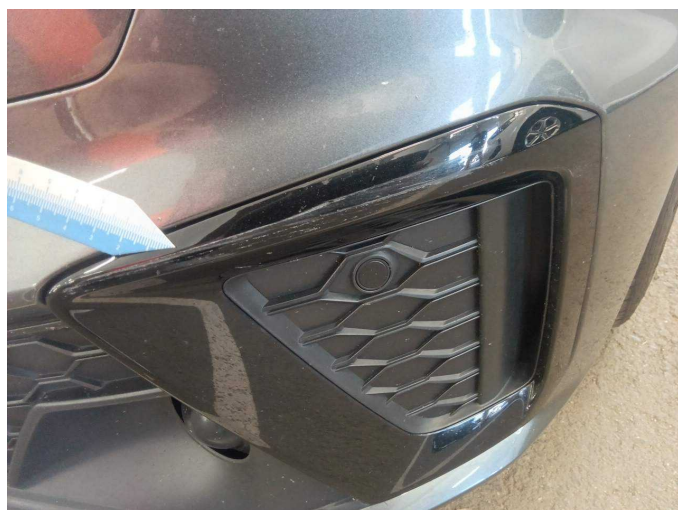
| No. | Component group | Description |
|---|---|---|
| 4 | Front bumper | Air-inlet grille (Blende Links) - Scratch(es) - Replace |

**Damage 4:** Front bumper: Air-inlet grille (Blende Links) - Scratch(es) - Replace

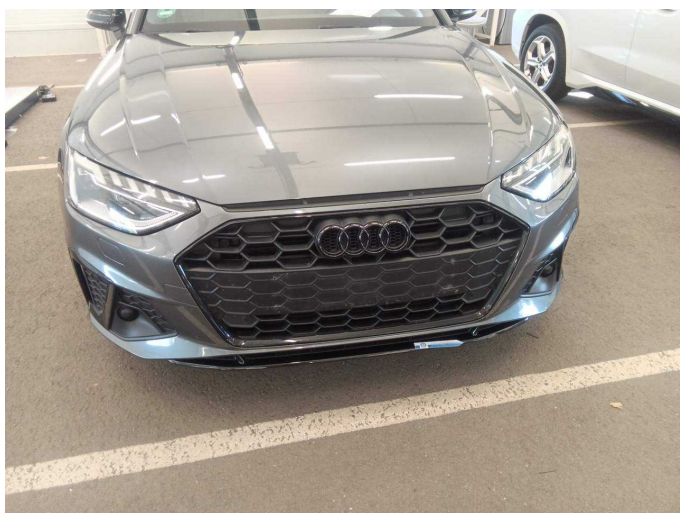
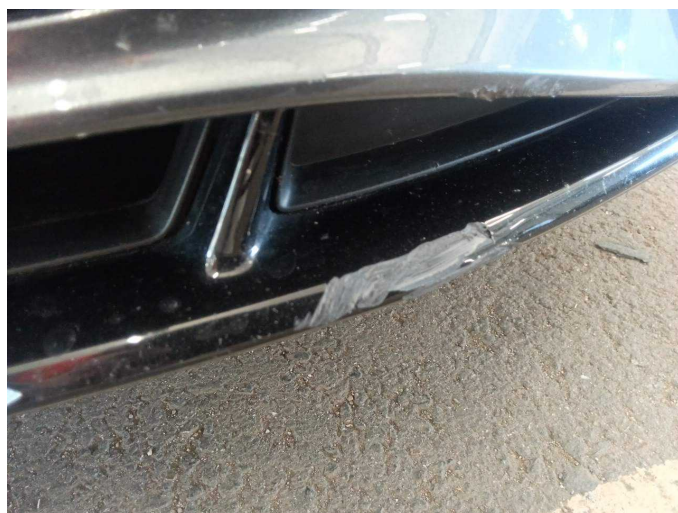
| No. | Component group | Description |
|---|---|---|
| 5 | Front bumper | Spoiler - Scratch(es) - Replace |

**Damage 5:** Front bumper: Spoiler - Scratch(es) - Replace

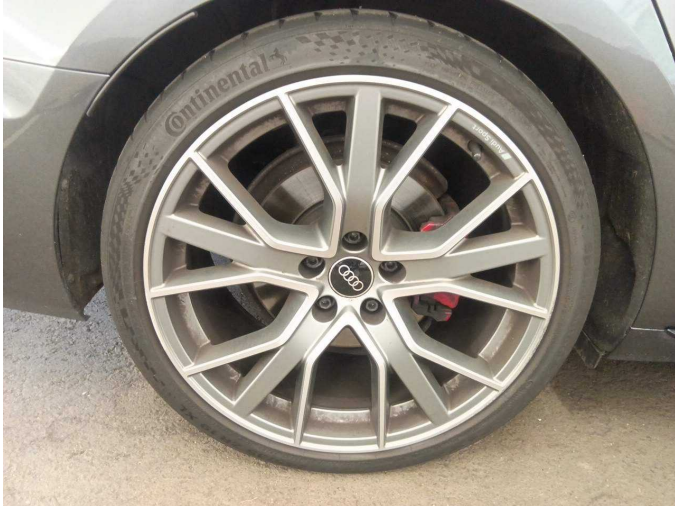
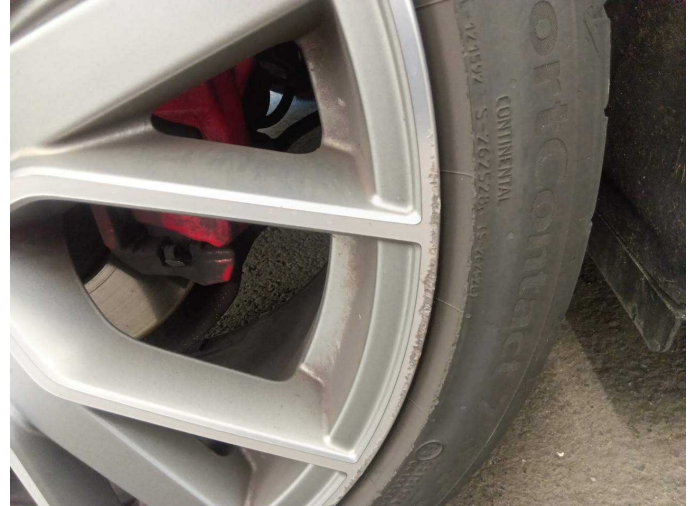
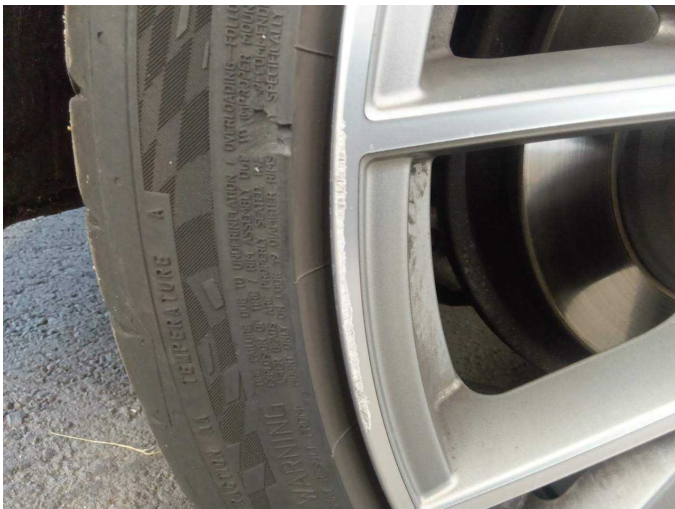
| No. | Component group | Description |
|---|---|---|
| 6 | Wheel / tyres | Alloy rim - rear right side - Scratch(es) - Loss in value |

**Damage 6:** Wheel / tyres: Alloy rim - rear right side - Scratch(es) - Loss in value

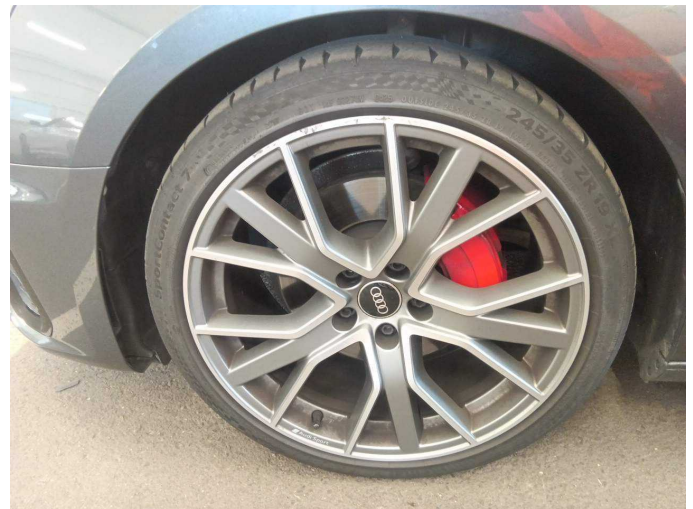
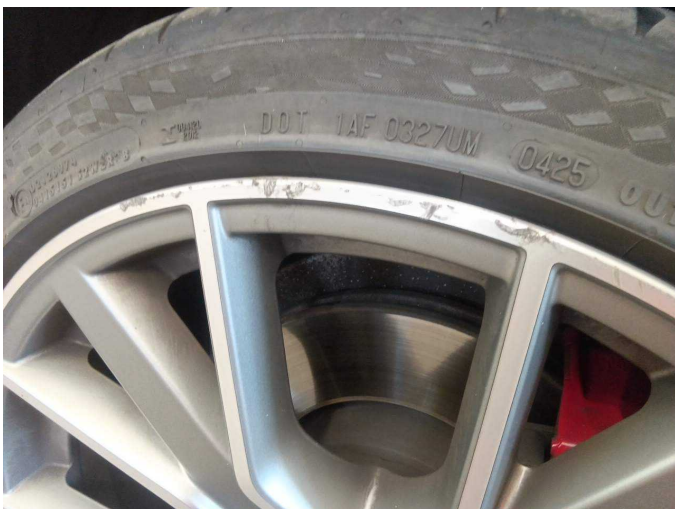
| No. | Component group | Description |
|---|---|---|
| 7 | Wheel / tyres | Alloy rim - front left side - Scratch(es) - Loss in value |

**Damage 7:** Wheel / tyres: Alloy rim - front left side - Scratch(es) - Loss in value

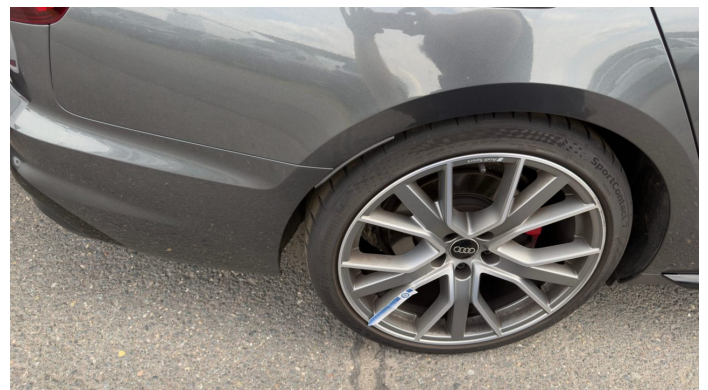
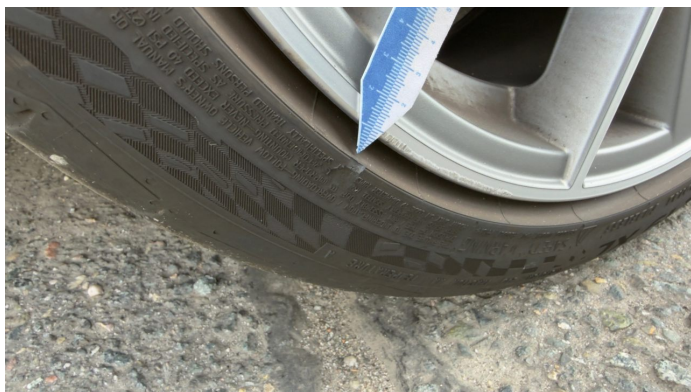
| No. | Component group | Description |
|---|---|---|
| 8 | Wheel / tyres | Tyre - rear right side (Flankenbeschädigung) - Damaged - Replace |

**Damage 8:** Wheel / tyres: Tyre - rear right side (Flankenbeschädigung) - Damaged - Replace

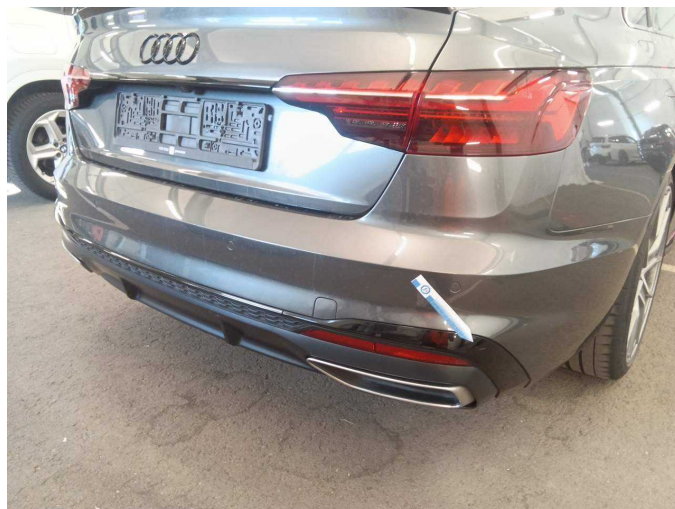
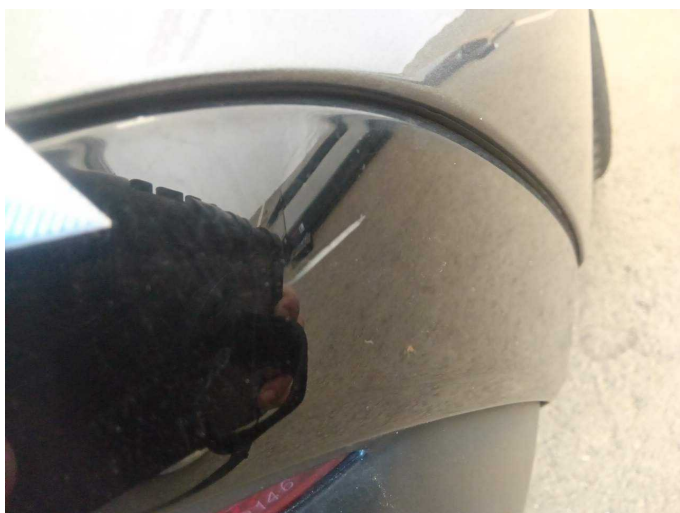
| No. | Component group | Description |
|---|---|---|
| 9 | Rear bumper | Spoiler - Scratch(es) - Replace |

**Damage 9:** Rear bumper: Spoiler - Scratch(es) - Replace

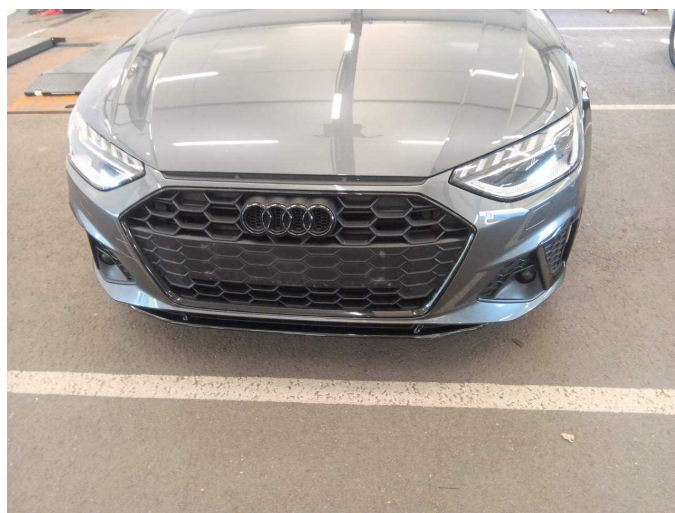
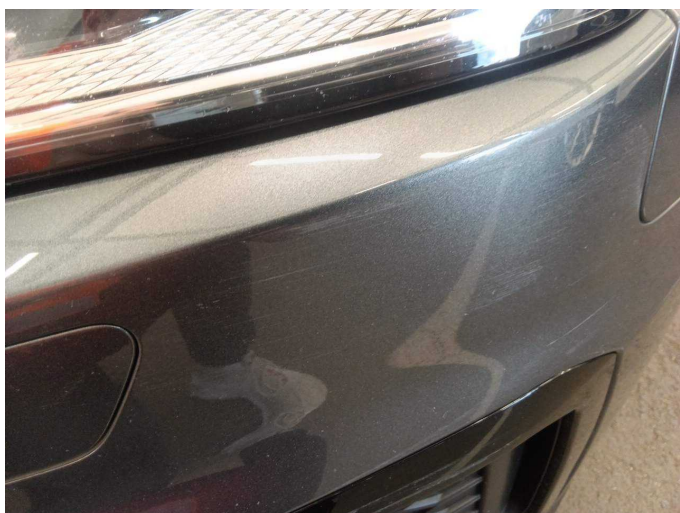
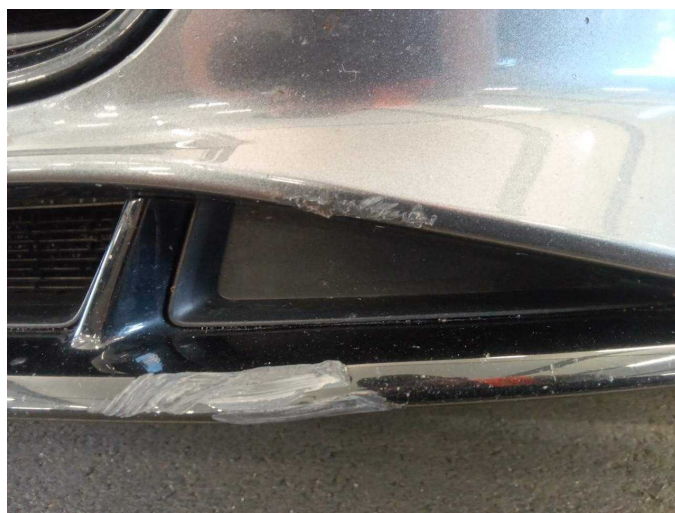
| No. | Component group | Description |
|---|---|---|
| 10 | Front bumper | Front bumper - Scratch(es) - Paint |

**Damage 10:** Front bumper: Front bumper - Scratch(es) - Paint

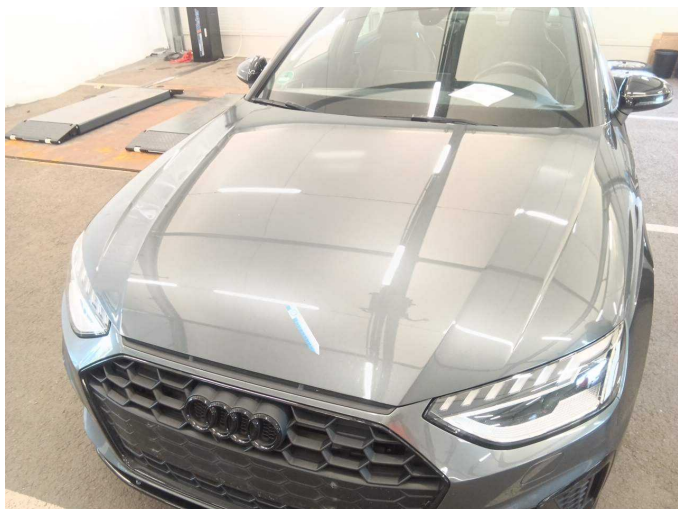
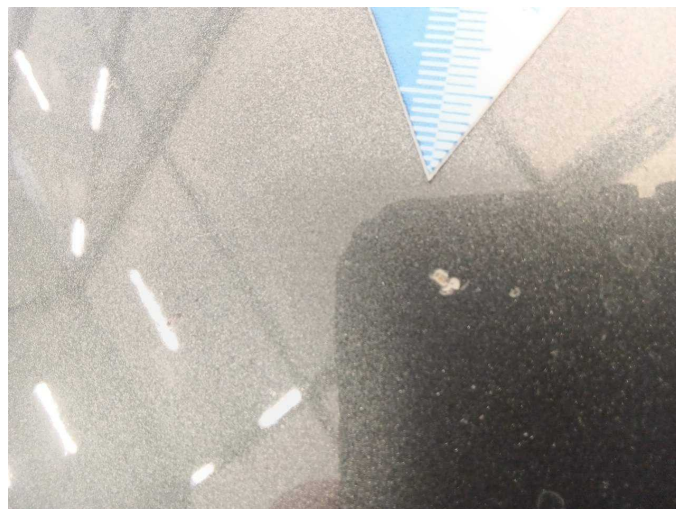
| No. | Component group | Description |
|---|---|---|
| 1 | Bonnet | Bonnet - Stone chips - No deduction |

**Wear and tear 1:** Bonnet: Bonnet - Stone chips - No deduction

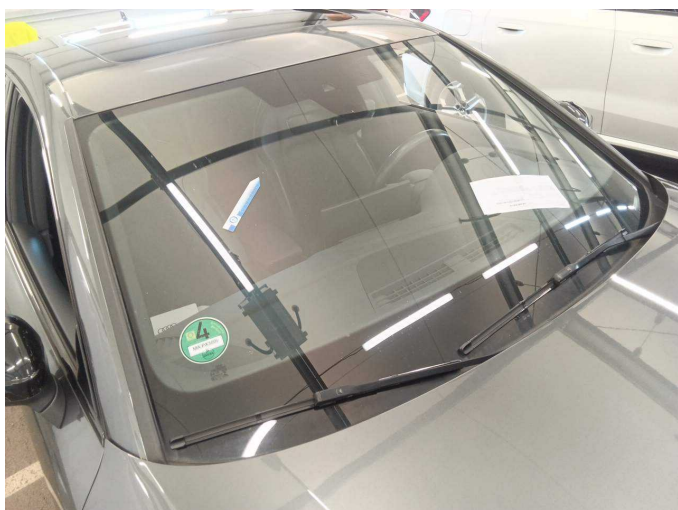
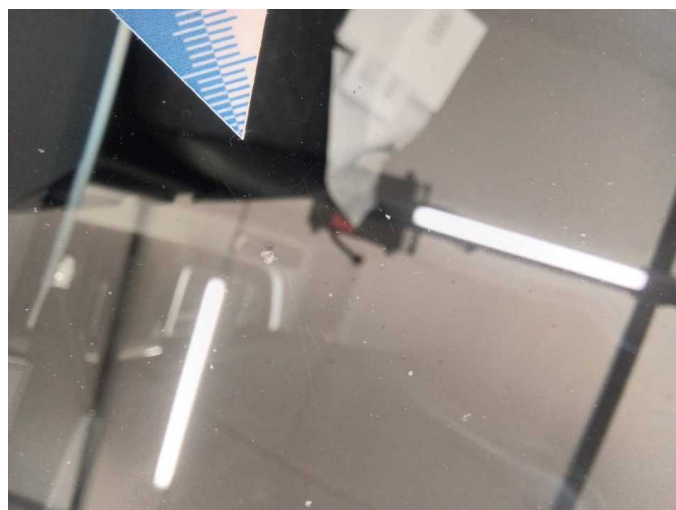
| No. | Component group | Description |
|---|---|---|
| 2 | Vehicle glazing | Windscreen - Stone chips - No deduction |

**Wear and tear 2:** Vehicle glazing: Windscreen - Stone chips - No deduction

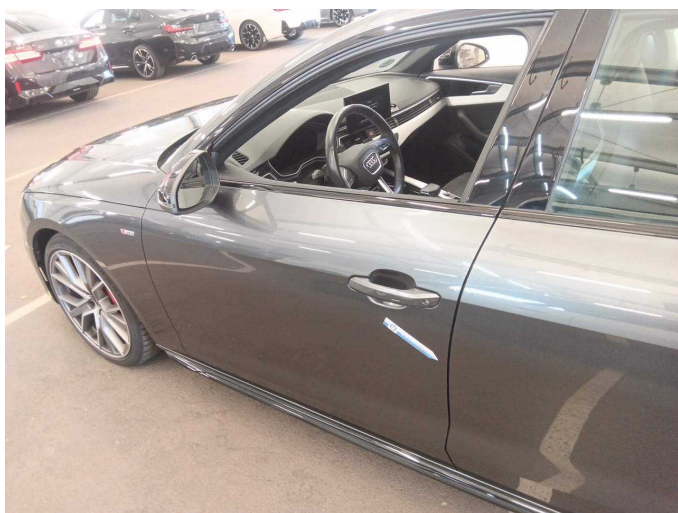
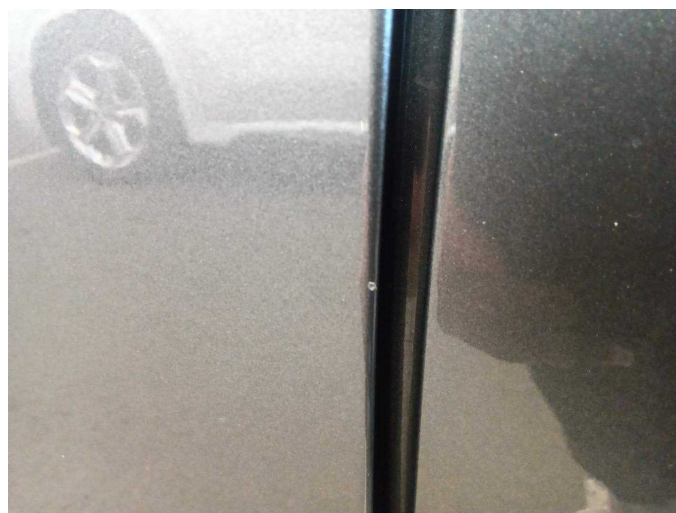
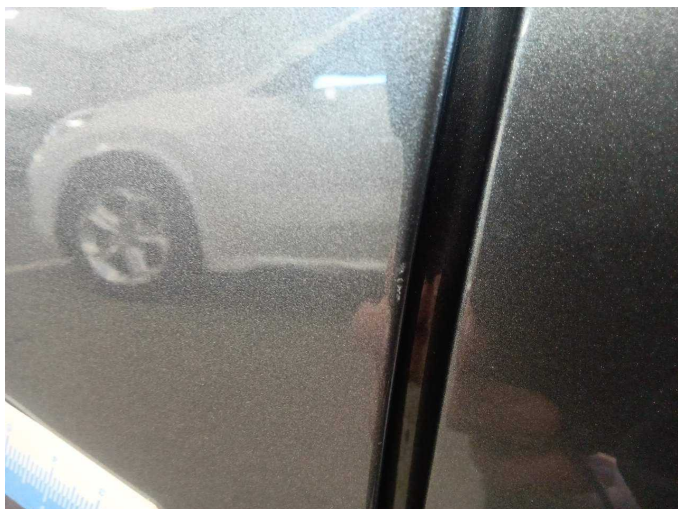
| No. | Component group | Description |
|---|---|---|
| 5 | Door - front left side | Door edge - Scratch(es) - No deduction |

**Wear and tear 5:** Door - front left side: Door edge - Scratch(es) - No deduction
