Expertise

Protocol number: 46367394  
Order No. / Reference: 26663750  
Inspection date: 3 Jul 2026

Manufacturer: Mercedes-Benz

Model: E 300de 4Matic 9G-TRONIC AMG Line Advanced Plus

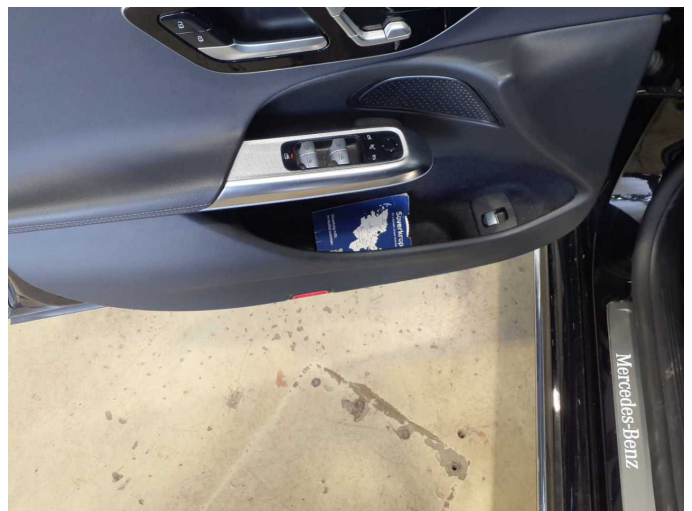
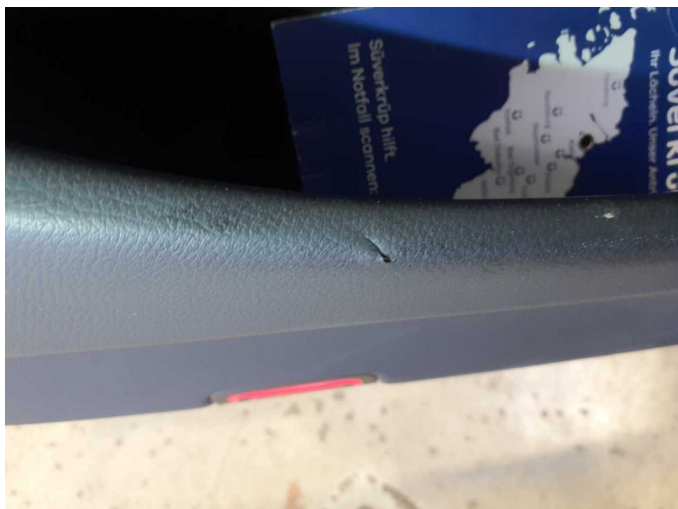
| No. | Component group | Description |
|---|---|---|
| 1 | Trim / covers | Door trim - front left side - Scratch(es) - Smart repair |

Damage 1: Trim / covers: Door trim - front left side - Scratch(es) - Smart repair

**Damage 1:** Trim / covers: Door trim - front left side - Scratch(es) - Smart repair

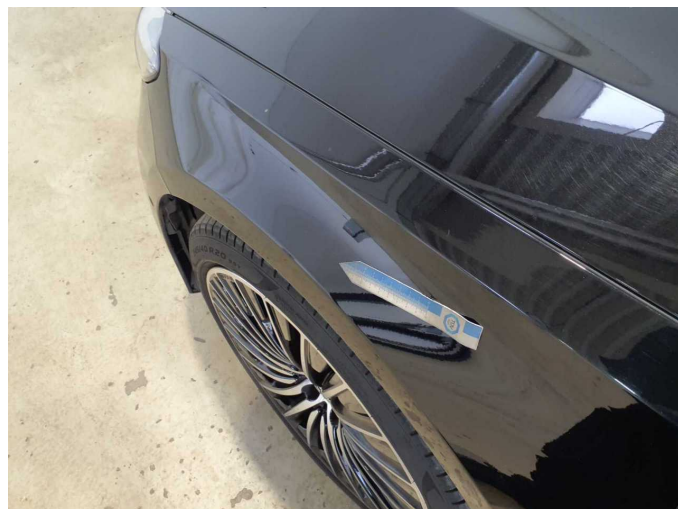
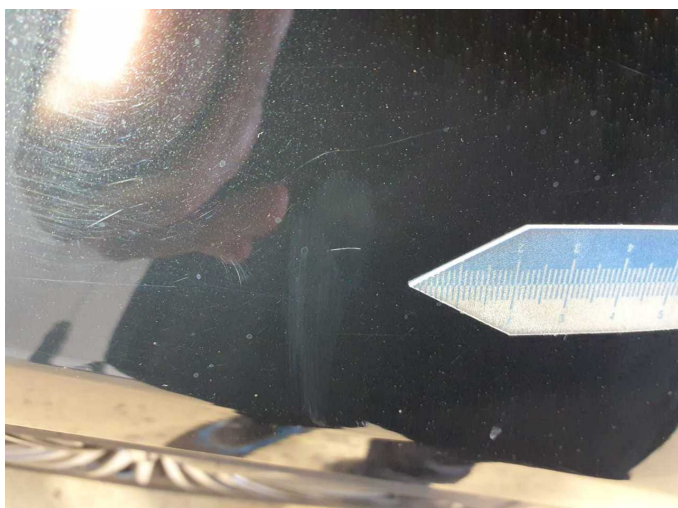
| No. | Component group | Description |
|---|---|---|
| 2 | Mudguard - left side | Mudguard - left side - Scratch(es) - Smart repair |

**Damage 2:** Mudguard - left side: Mudguard - left side - Scratch(es) - Smart repair

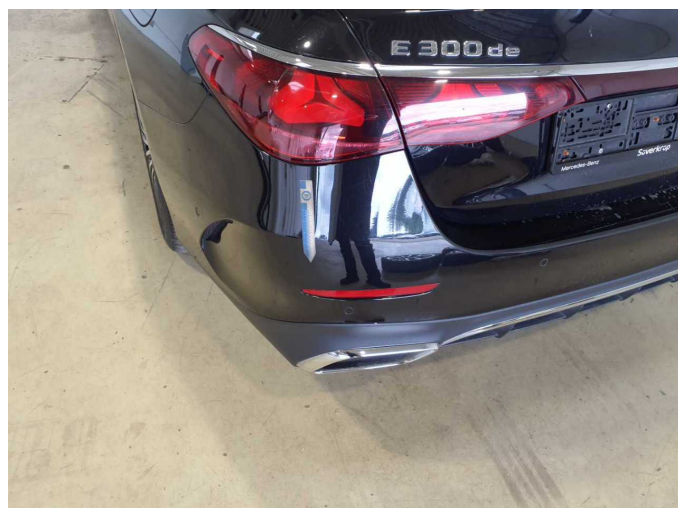
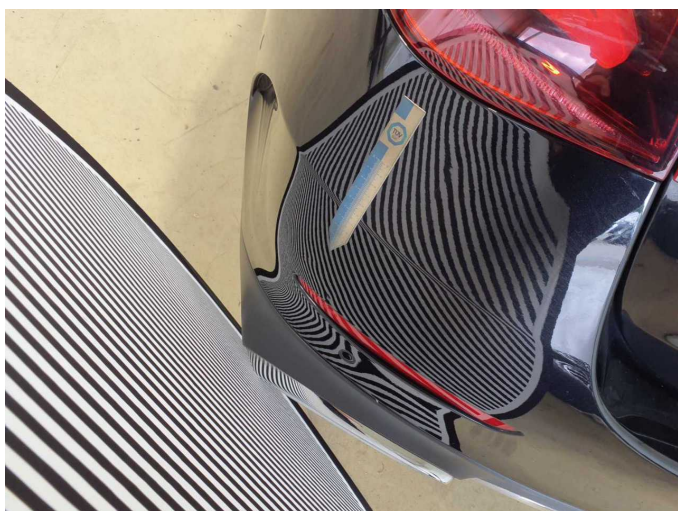
| No. | Component group | Description |
|---|---|---|
| 3 | Rear bumper | Rear bumper - dent(s) - Smart repair |

**Damage 3:** Rear bumper: Rear bumper - dent(s) - Smart repair

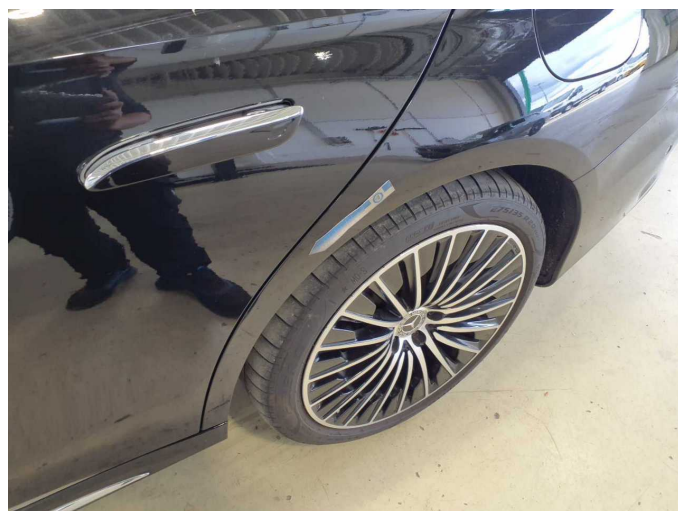
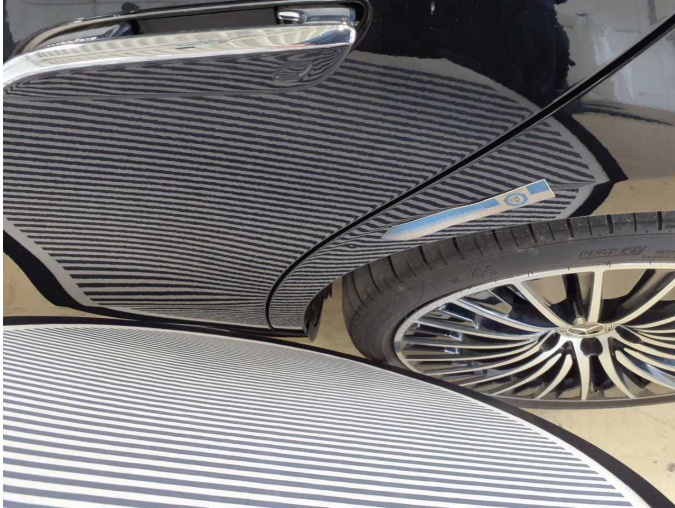
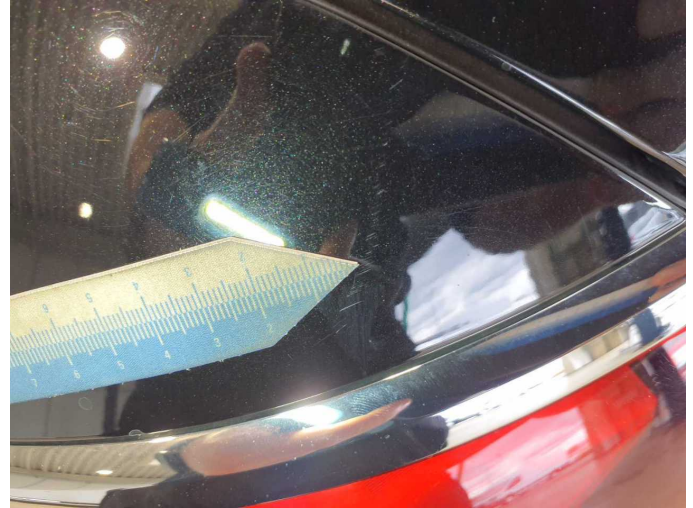
| No. | Component group | Description |
|---|---|---|
| 4 | Side panel - rear left side | Side panel - Dent / paintcoat damage - Smart repair |

**Damage 4:** Side panel - rear left side: Side panel - Dent / paintcoat damage - Smart repair

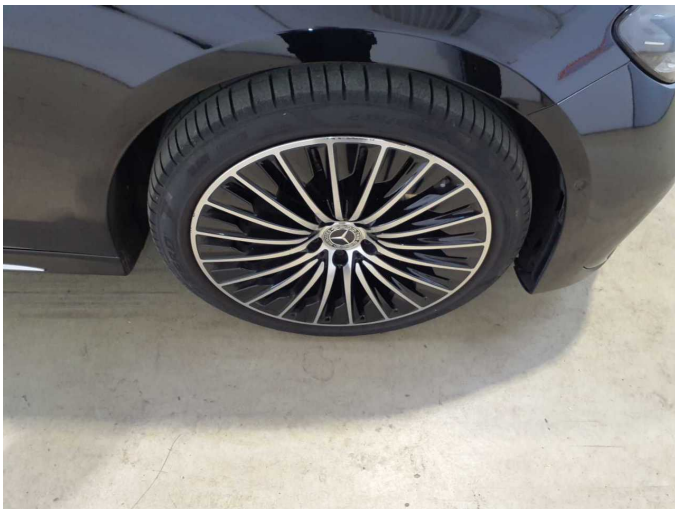
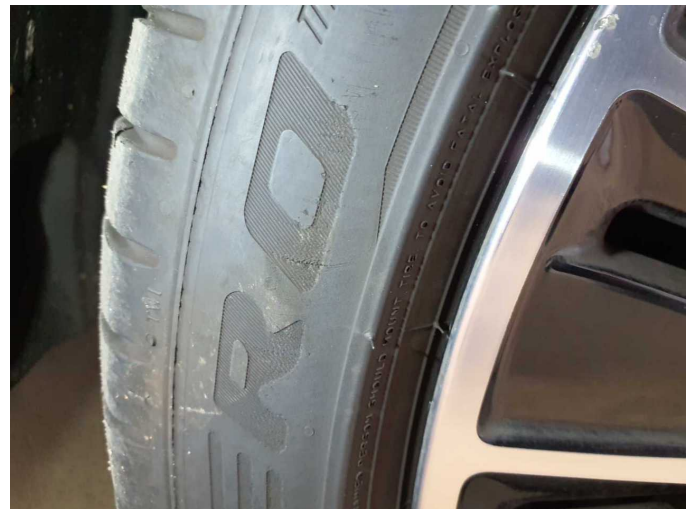
| No. | Component group | Description |
|---|---|---|
| 5 | Wheel / tyres | Tyre - front right side - Broken / torn - Replace |

**Damage 5:** Wheel / tyres: Tyre - front right side - Broken / torn - Replace

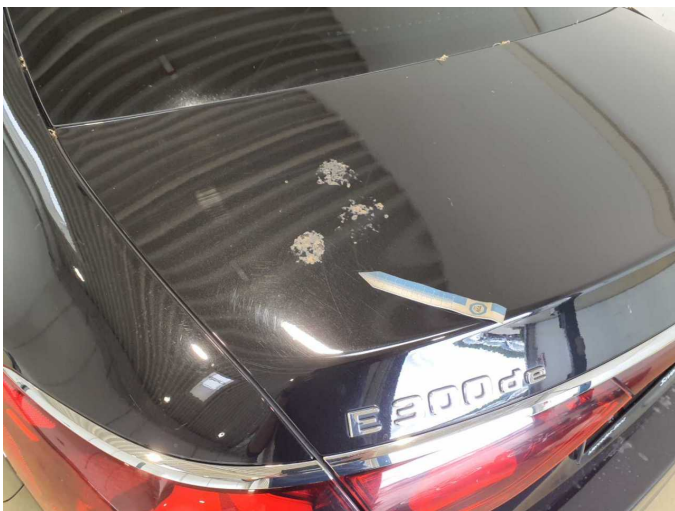
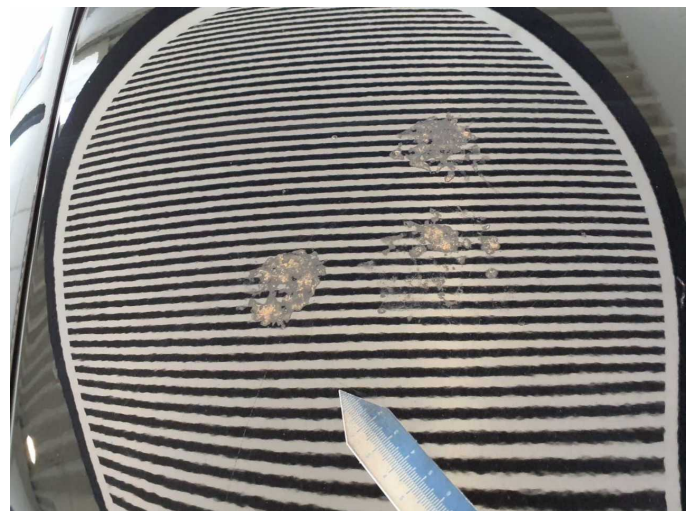
| No. | Component group | Description |
|---|---|---|
| 6 | Boot lid / rear door | Boot lid (Anätzung) - Paint defect - Repair and paint |

**Damage 6:** Boot lid / rear door: Boot lid (Anätzung) - Paint defect - Repair and paint

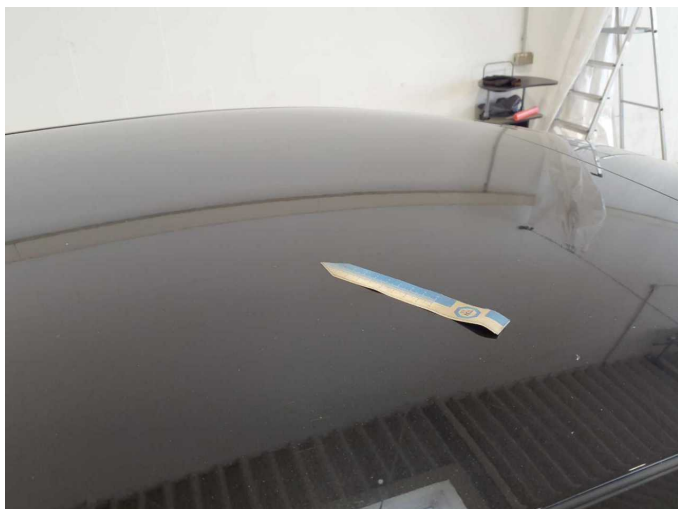
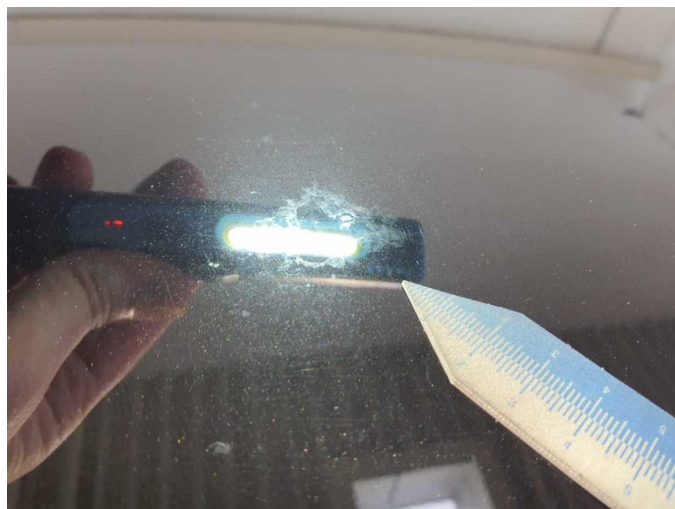
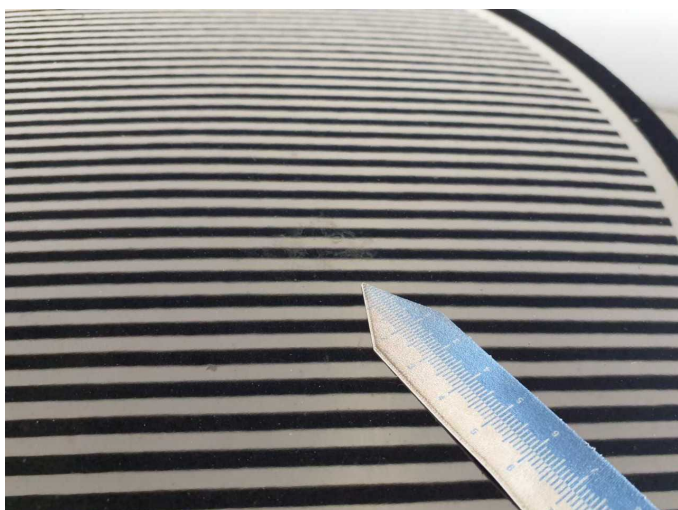
| No. | Component group | Description |
|---|---|---|
| 7 | Roof | Roof (Anätzung) - Paint defect - Repair and paint |

**Damage 7:** Roof: Roof (Anätzung) - Paint defect - Repair and paint

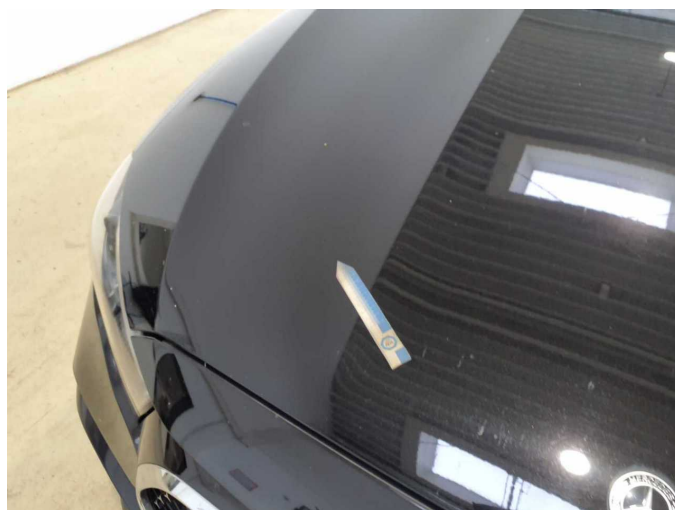
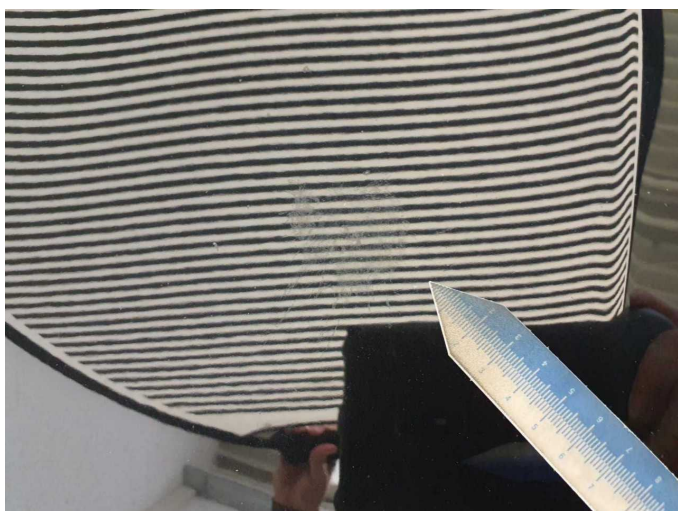
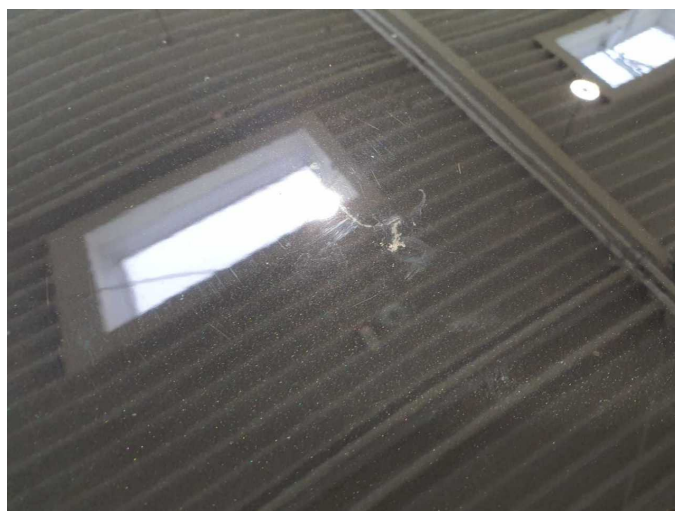
| No. | Component group | Description |
|---|---|---|
| 8 | Bonnet | Bonnet - Paint defect - Repair and paint |

**Damage 8:** Bonnet: Bonnet - Paint defect - Repair and paint

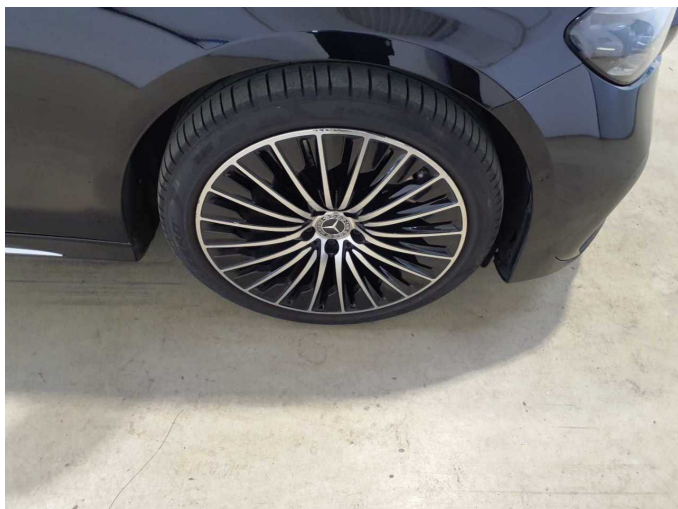
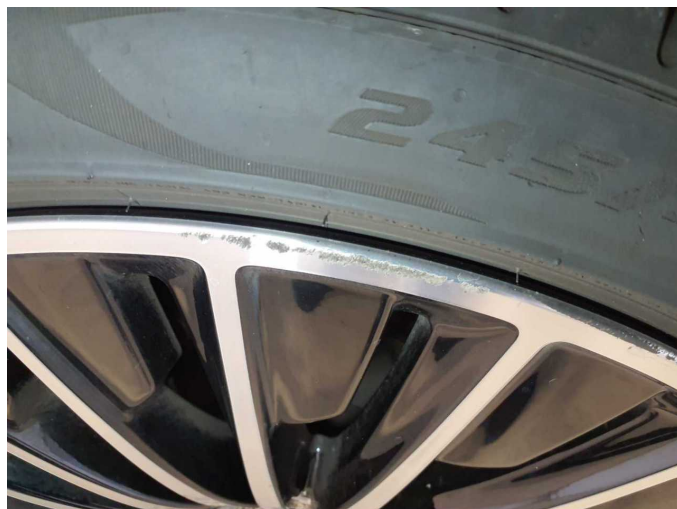
| No. | Component group | Description |
|---|---|---|
| 9 | Wheel / tyres | Alloy rim - front right side - Scratch(es) - Replace |

**Damage 9:** Wheel / tyres: Alloy rim - front right side - Scratch(es) - Replace

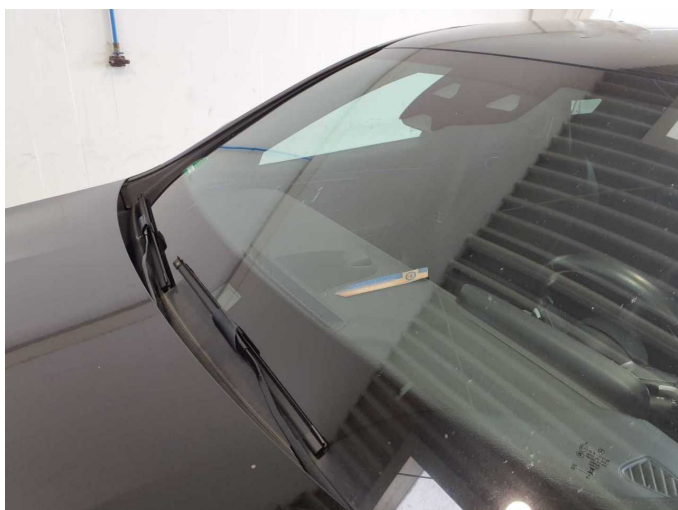
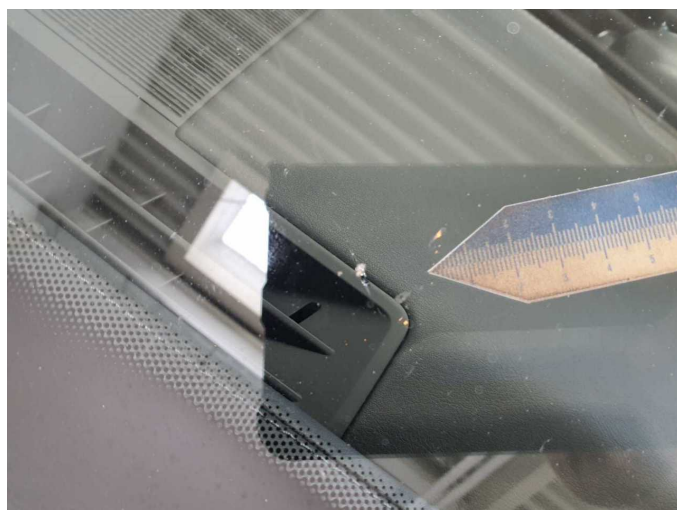
| No. | Component group | Description |
|---|---|---|
| 10 | Vehicle glazing | Windscreen - Broken / torn - Replace |

**Damage 10:** Vehicle glazing: Windscreen - Broken / torn - Replace

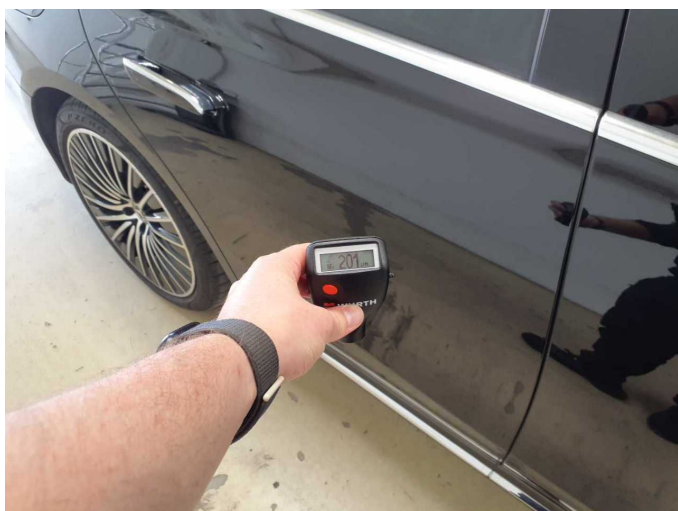
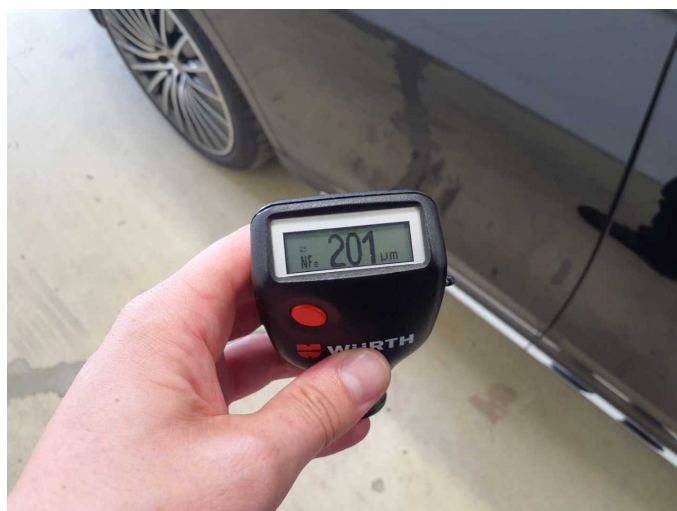
| No. | Repainting |
|---|---|
| 1 | Door - rear right side, Professionally carried out, Invoice of repair done Non-existent |

| Door - rear right side | 201 µm |

**Repainting 1:** Door - rear right side
