MERCEDES C BREAK:

Limited Technical Inspection

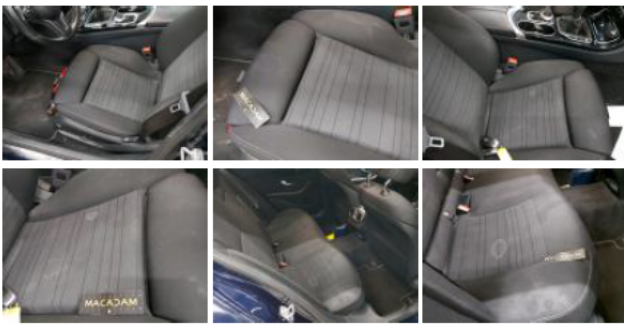
Repair kit	Yes	Compressor	Yes
Number of charging cables (normal)	0		
Number of charging cables (rapid charge)	0		
Total cost ex VAT			2443,17
Interior, Stain, Forfeit			125,00
