Expertise

Protocol number: 45516260
Order No. / Reference: 26309198
Inspection date: 18 May 2026

Model: Kodiaq 2.0 TDI DSG L&K

VIN: TMBJJ9NS9P8029136

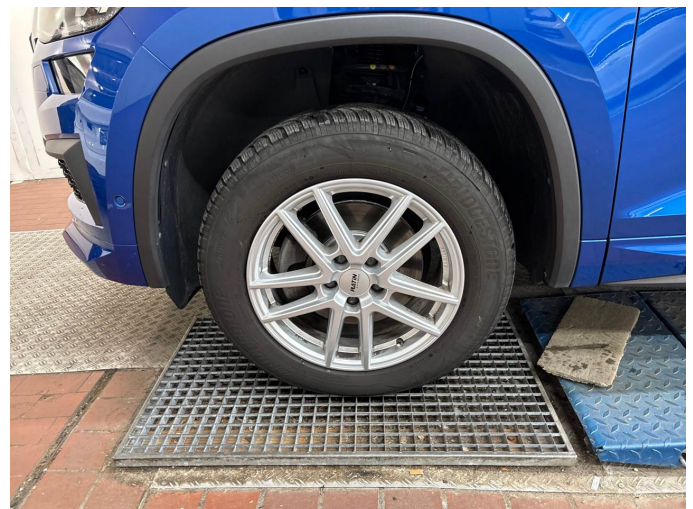
Figure 12: Mounted tyres

#	Tyre size	Type of tyre	Manufacturer	Tread depth
1)	215/65 R17 103H	Winter tyres on Light alloy	Bridgestone	5mm / 5mm
2)	215/65 R17 103H	Winter tyres on Light alloy	Bridgestone	7mm / 7mm

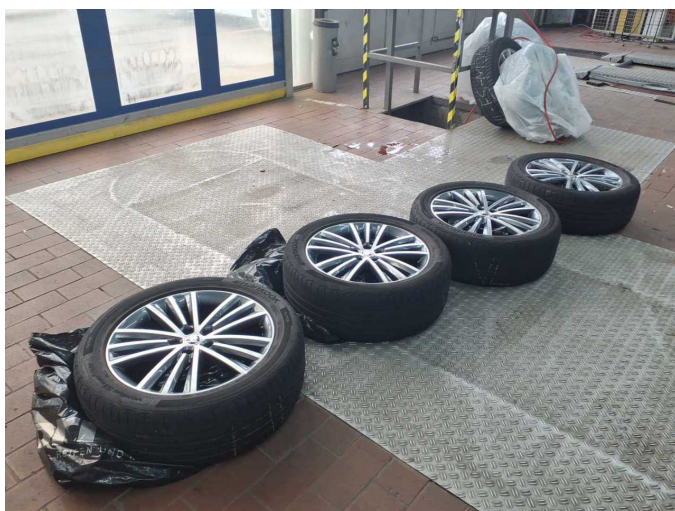
Figure 17: Additional tyres

#	Tyre size	Type of tyre	Manufacturer	Tread depth
1)	235/50 R19 99V	Summer tyres on Light alloy	Hankook	4mm / 4mm
2)	235/50 R19 99V	Summer tyres on Light alloy	Hankook	7mm / 7mm

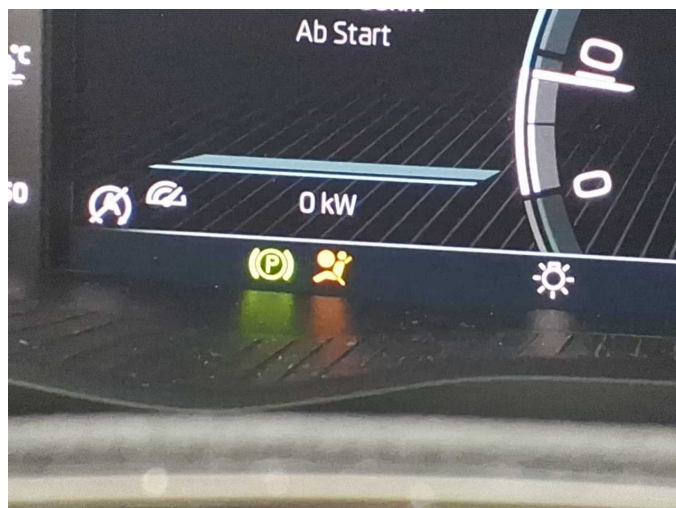
Damage 1: Instrument panel: Indicator light (Airbagsystem) - on - Perform diagnosis

No.	Component group	Description
1	Instrument panel	Indicator light (Airbagsystem) - on - Perform diagnosis
