Expertise

Protocol number: 46475181  
Order No. / Reference: 26637541  
Inspection date: 10 Jul 2026

Manufacturer: Audi  
VIN: WAUZZZGE5PB021652

Model: e-tron 55 quattro S line

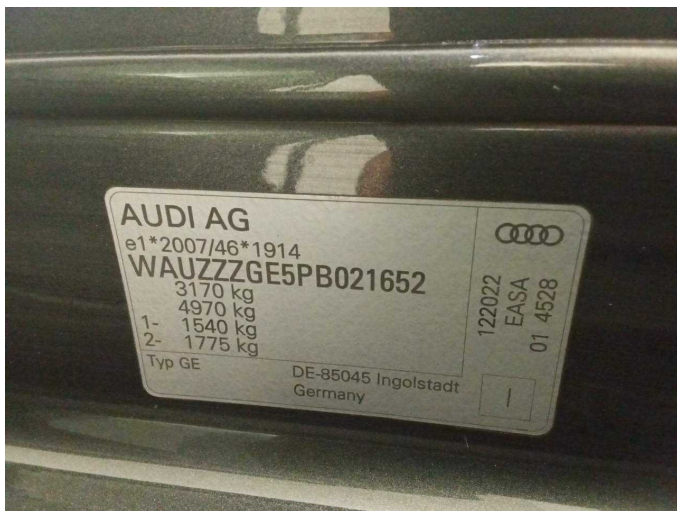
| VIN comparison | The vehicle identification number (VIN) was read from the vehicle and its conformity with the submitted documents was confirmed by the undersigned during the inspection. |

Figure 11: VIN

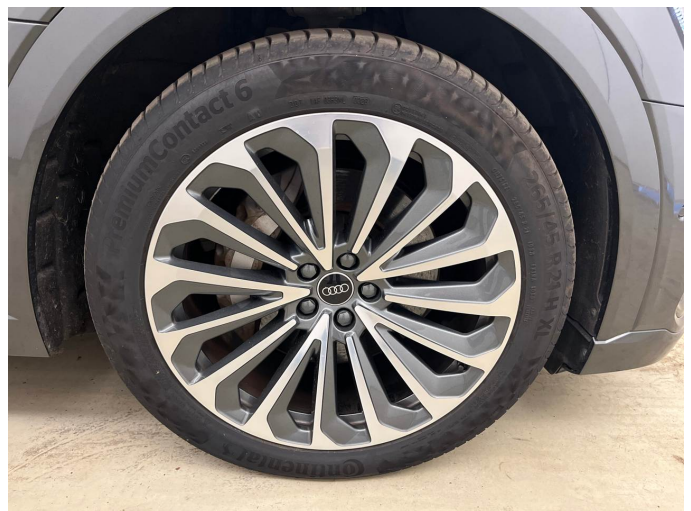
| # | Tyre size | Type of tyre | Manufacturer | Tread depth |
|---|---|---|---|---|
| 1) | 265/45 R21 108H | Summer tyres on Light alloy | Continental | 6mm / 6mm |
| 2) | 265/45 R21 108H | Summer tyres on Light alloy | Continental | 6mm / 6mm |

Figure 12: Mounted tyres

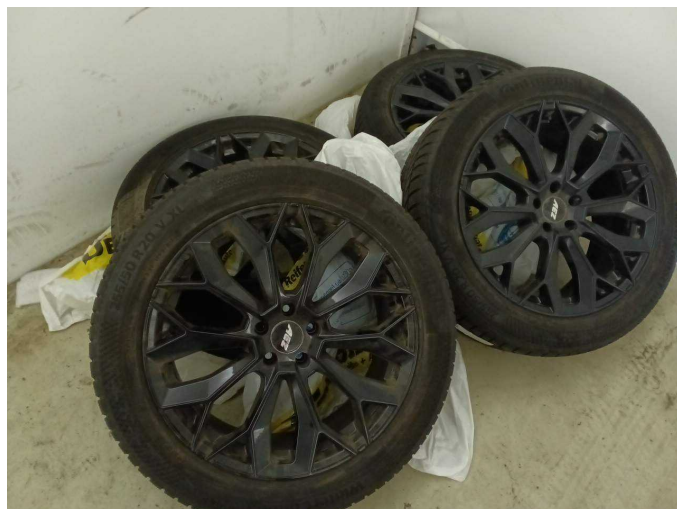
| # | Tyre size | Type of tyre | Manufacturer | Tread depth |
|---|---|---|---|---|
| 1) | 255/50 R20 109V | Winter tyres on Light alloy | Continental | 7mm / 7mm |
| 2) | 255/50 R20 109V | Winter tyres on Light alloy | Continental | 7mm / 7mm |

Figure 14: Additional tyres

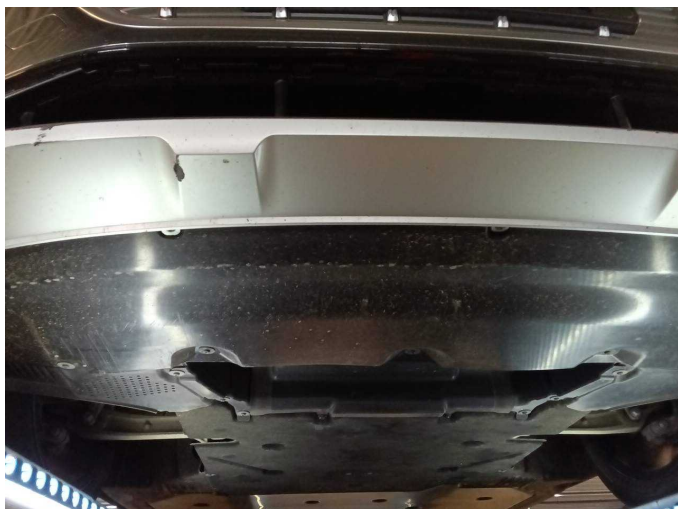
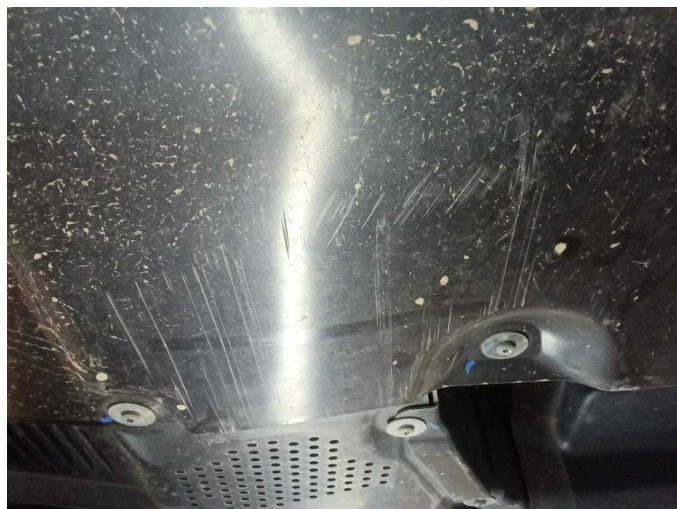
**Damage 1:** Body: Underbody panelling - Scratched - Replace

| No. | Component group | Description |
|---|---|---|
| 1 | Body | Underbody panelling - Scratched - Replace |

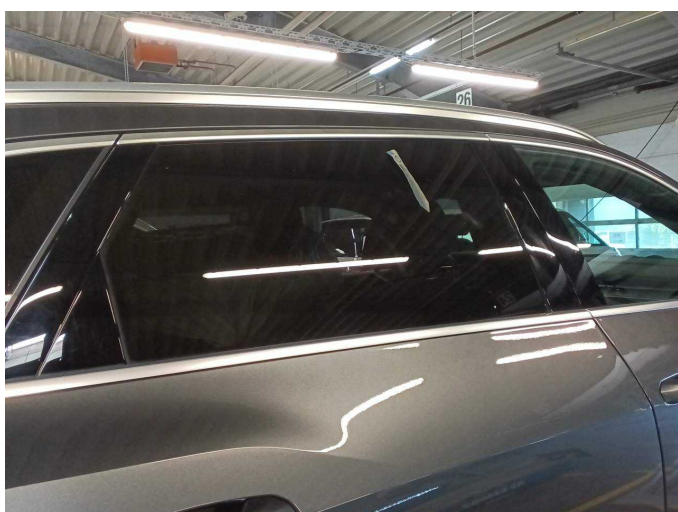
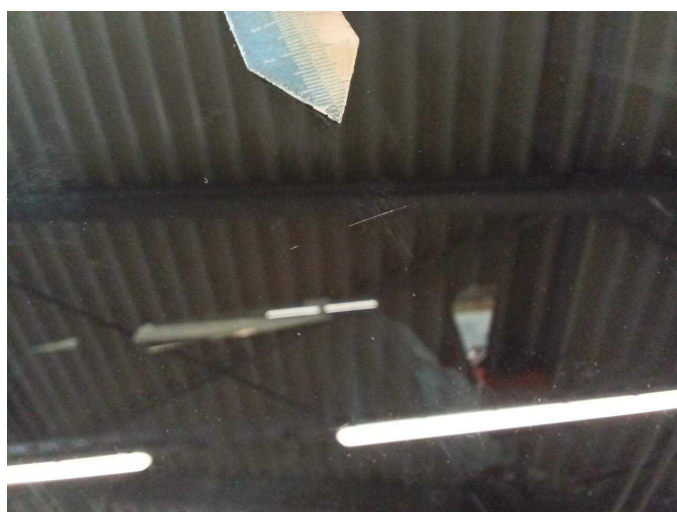
**Damage 2:** Vehicle glazing: Door glass - rear right side - Scratch(es) - Loss in value

| No. | Component group | Description |
|---|---|---|
| 2 | Vehicle glazing | Door glass - rear right side - Scratch(es) - Loss in value |

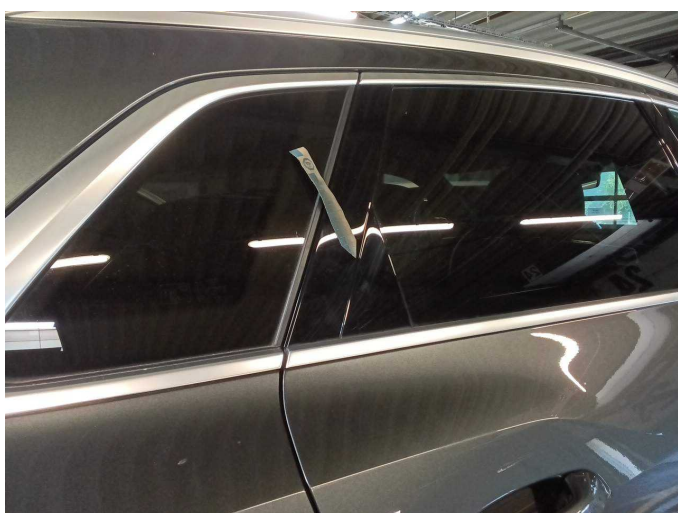
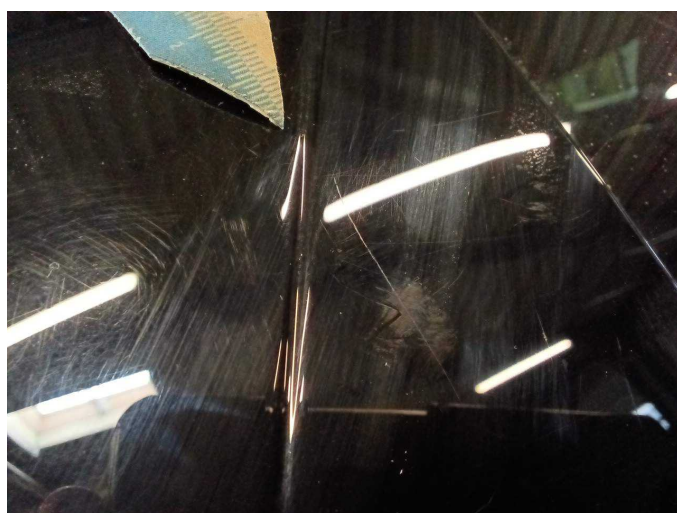
**Damage 3:** Door - rear right side: Brightware - upper - Scratch(es) - Smart repair

| No. | Component group | Description |
|---|---|---|
| 3 | Door - rear right side | Brightware - upper - Scratch(es) - Smart repair |

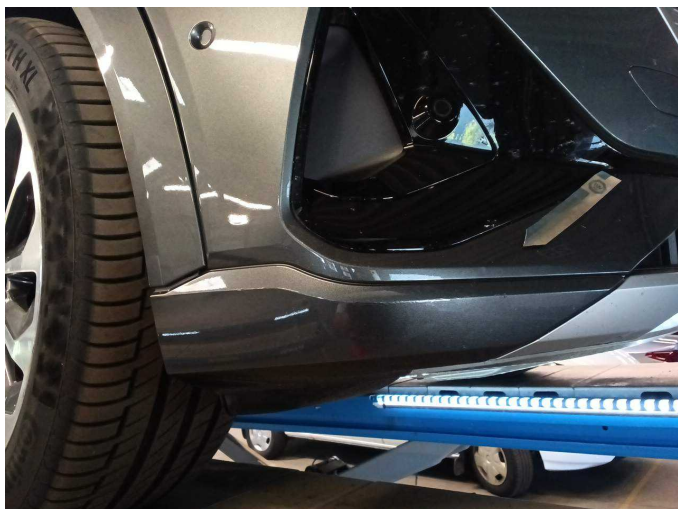
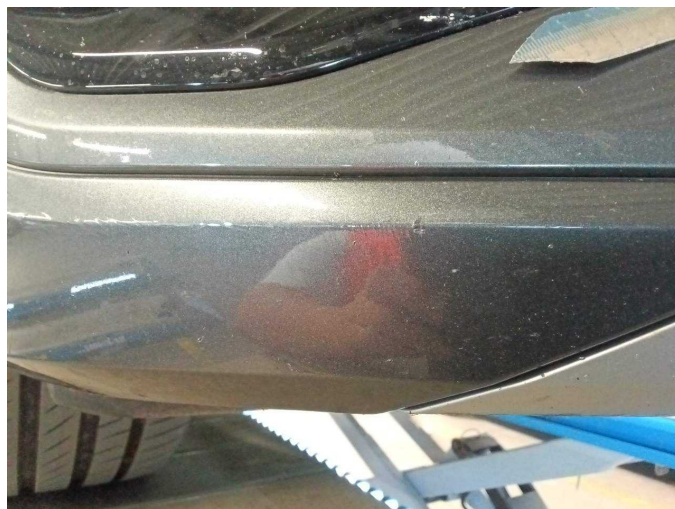
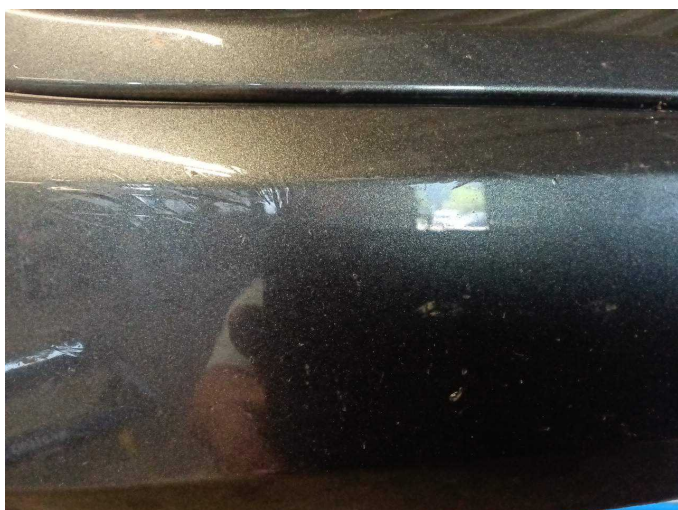
**Damage 4:** Trim / covers: Trim / covers - Scratch(es) - Smart repair

| No. | Component group | Description |
|---|---|---|
| 4 | Trim / covers | Trim / covers - Scratch(es) - Smart repair |

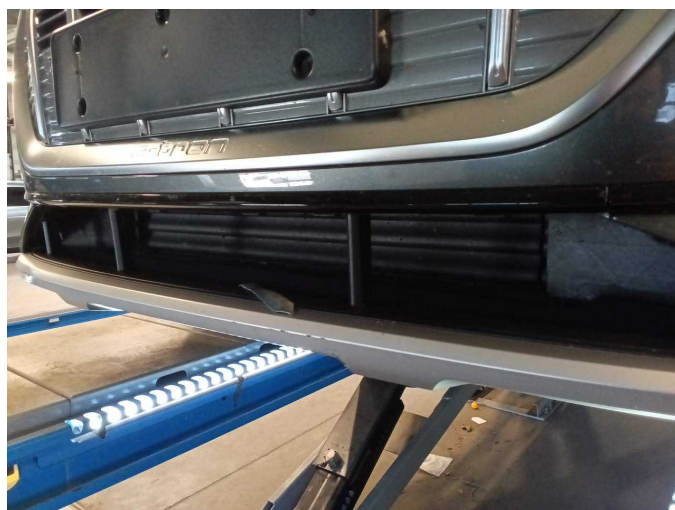
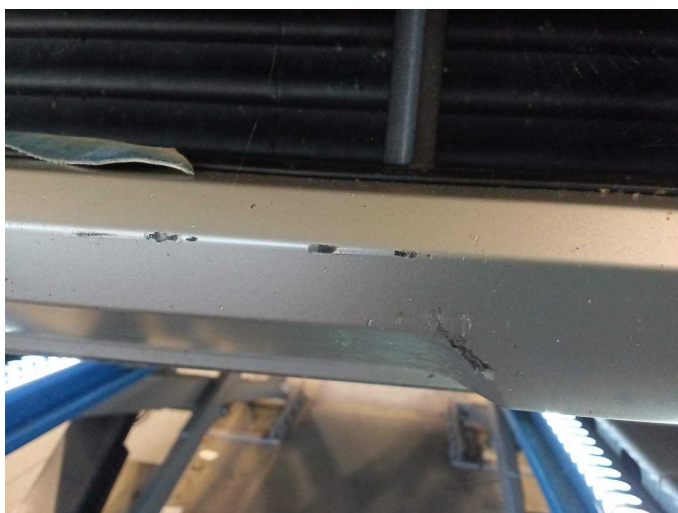
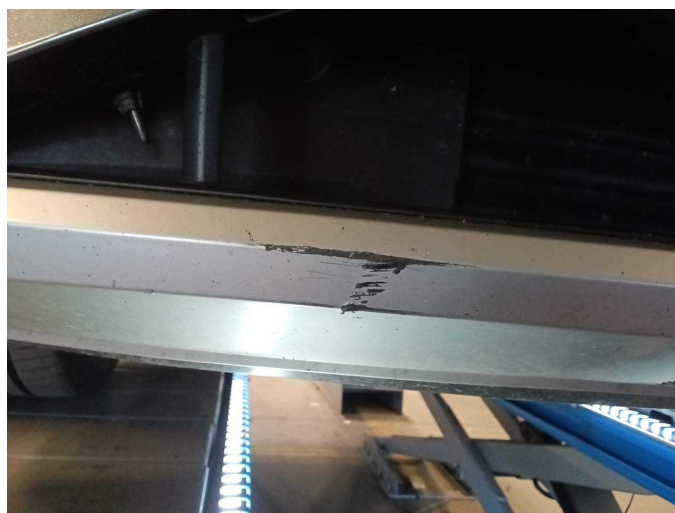
**Damage 5:** Front bumper: Spoiler - Scratched - Smart repair

| No. | Component group | Description |
|---|---|---|
| 5 | Front bumper | Spoiler - Scratched - Smart repair |

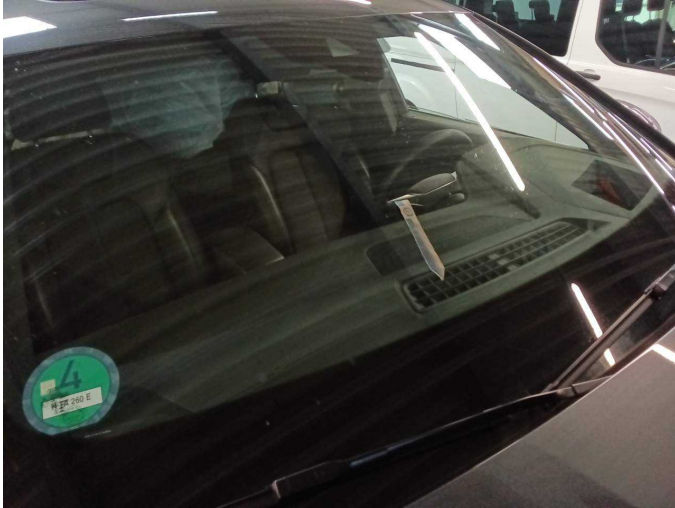
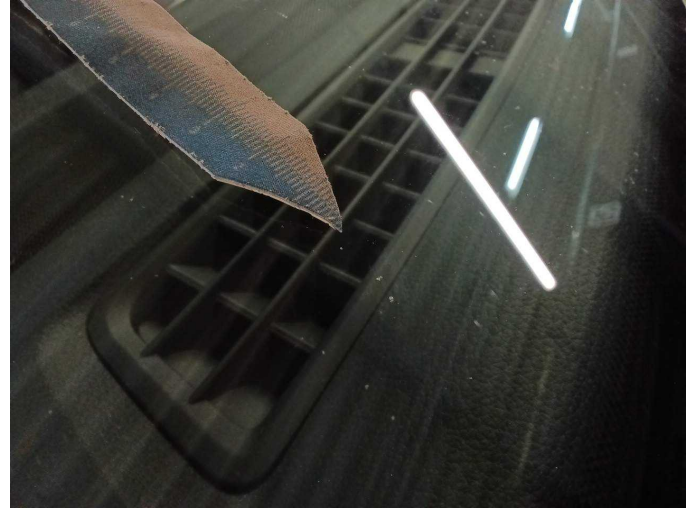
| 1 | Vehicle glazing | Windscreen - Stone chips - No deduction |

**Wear and tear 1:** Vehicle glazing: Windscreen - Stone chips - No deduction
