Expertise

Protocol number: 46606260  
Order No. / Reference: 26740684  
Inspection date: 14 Jul 2026

Manufacturer: Audi

Model: A4 Avant 40 TDI S tronic S line

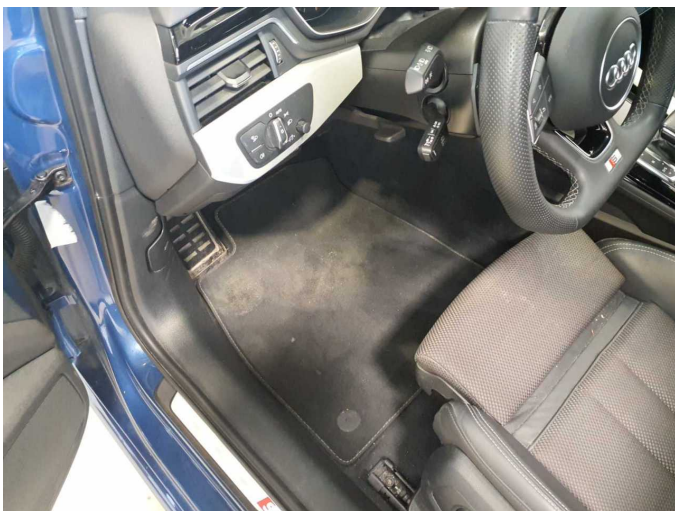
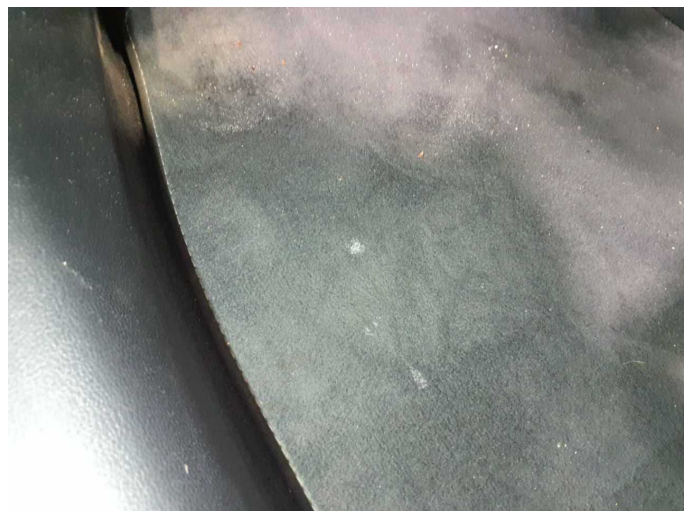
Damage 2: Trim / covers: Floor mats - Burn hole (cigarettes) - Replace

| No. | Component group | Description |
|---|---|---|
| 2 | Trim / covers | Floor mats - Burn hole (cigarettes) - Replace |

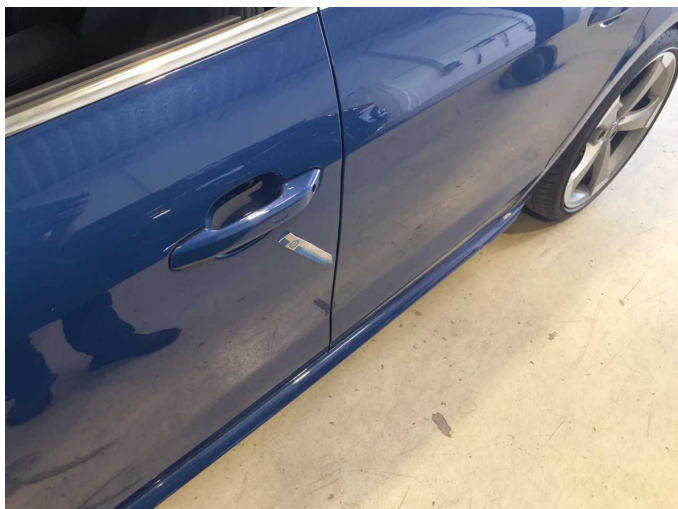
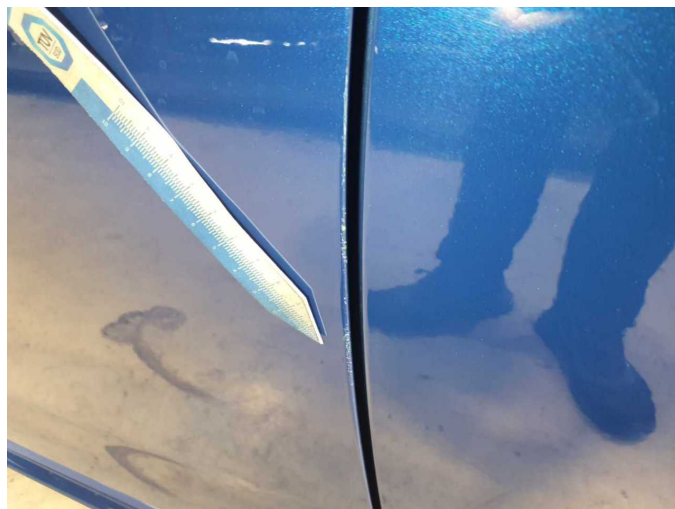
**Damage 3:** Door - front left side: Door edge - Scratch(es) - Smart repair

| No. | Component group | Description |
|---|---|---|
| 3 | Door - front left side | Door edge - Scratch(es) - Smart repair |

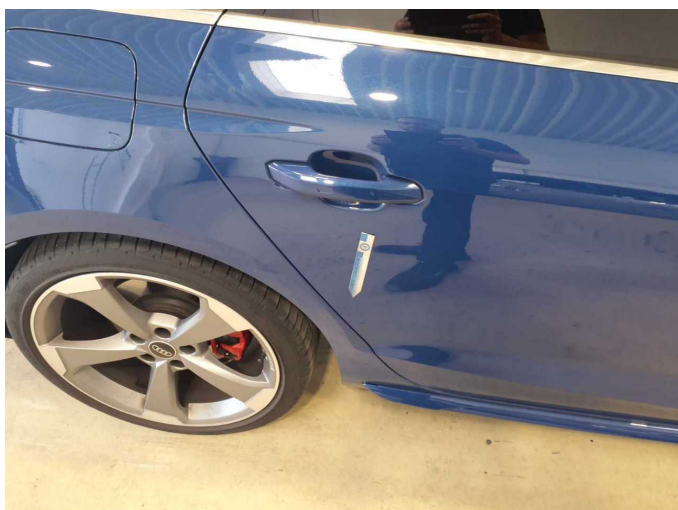
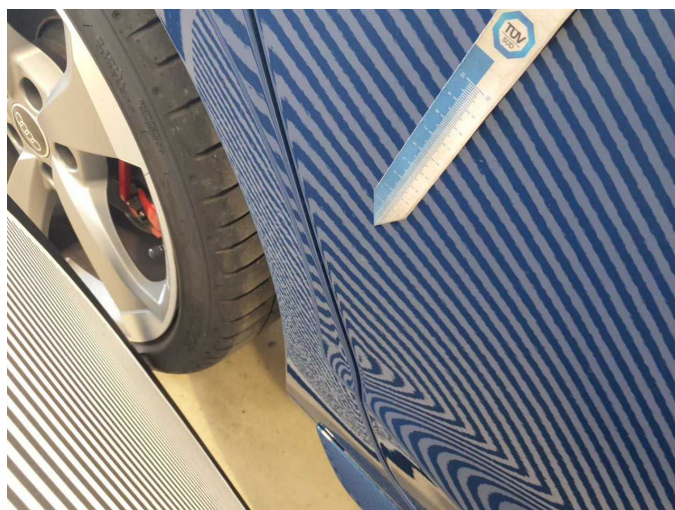
**Damage 4:** Door - rear right side: Door - Dent / paintcoat damage - Smart repair

| No. | Component group | Description |
|---|---|---|
| 4 | Door - rear right side | Door - Dent / paintcoat damage - Smart repair |

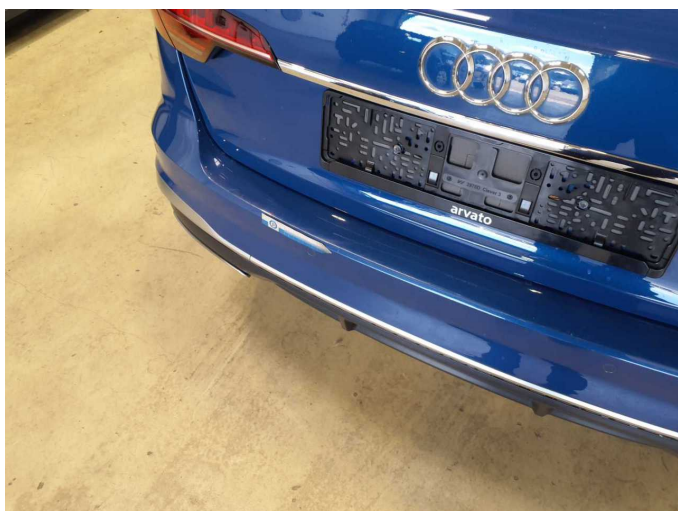
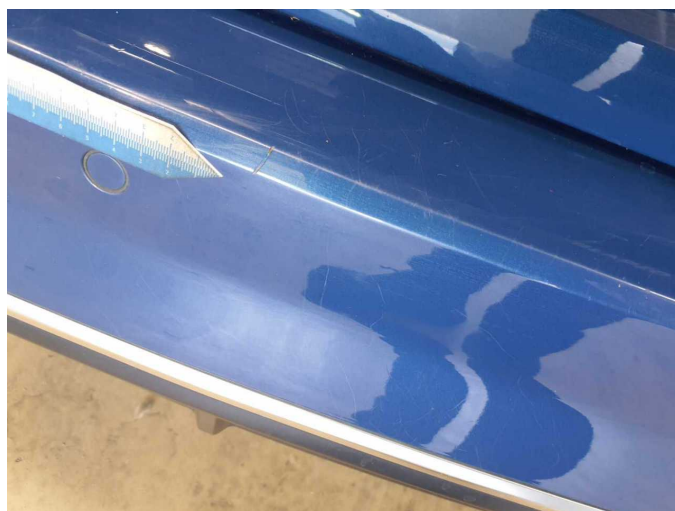
**Damage 5:** Rear bumper: Rear bumper - Scratch(es) - Smart repair

| No. | Component group | Description |
|---|---|---|
| 5 | Rear bumper | Rear bumper - Scratch(es) - Smart repair |

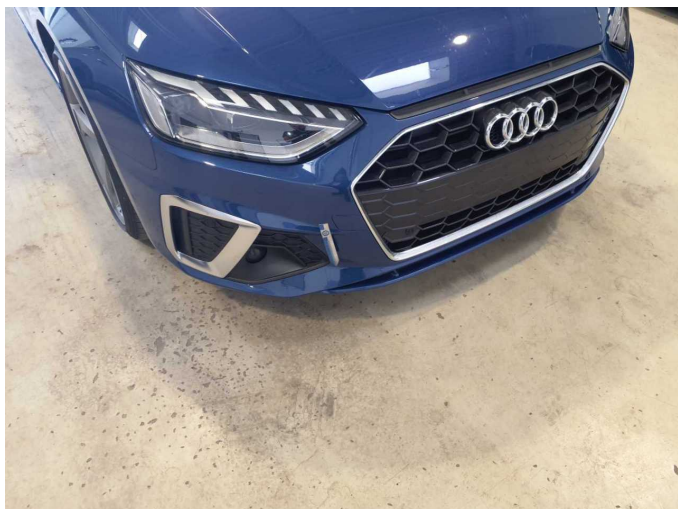
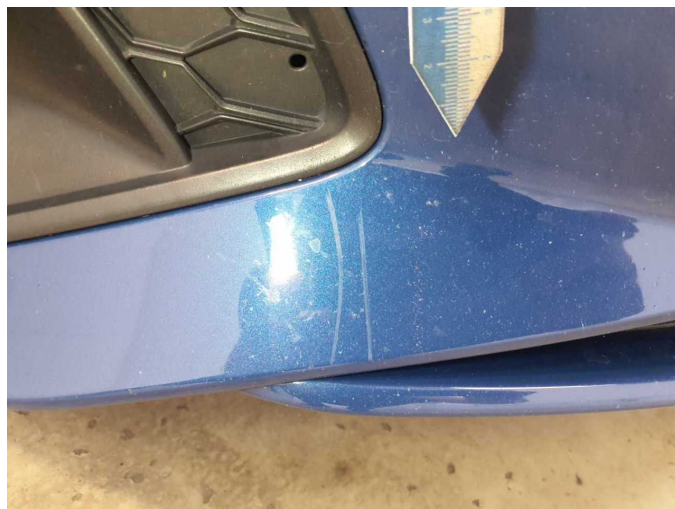
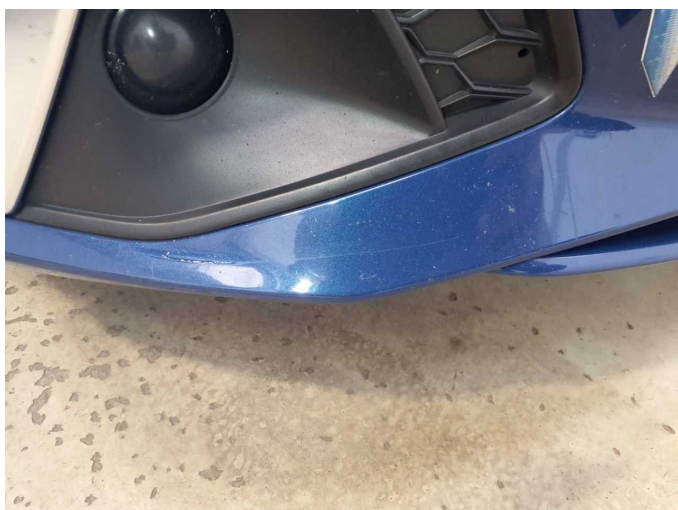
**Damage 6:** Front bumper: Front bumper - Scratch(es) - Smart repair

| No. | Component group | Description |
|---|---|---|
| 6 | Front bumper | Front bumper - Scratch(es) - Smart repair |

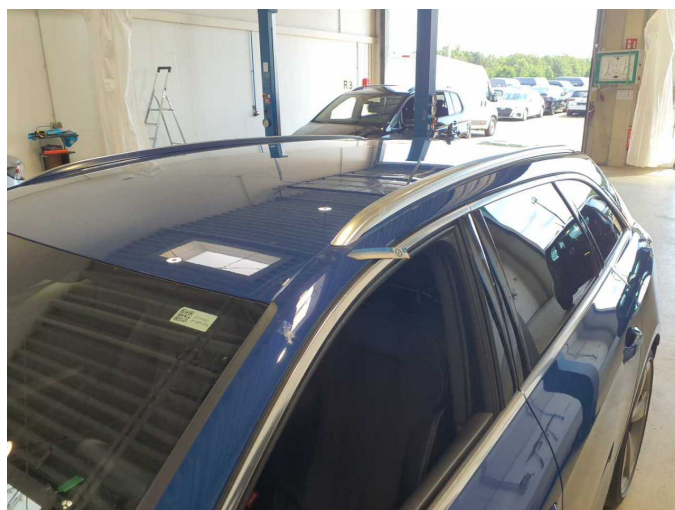
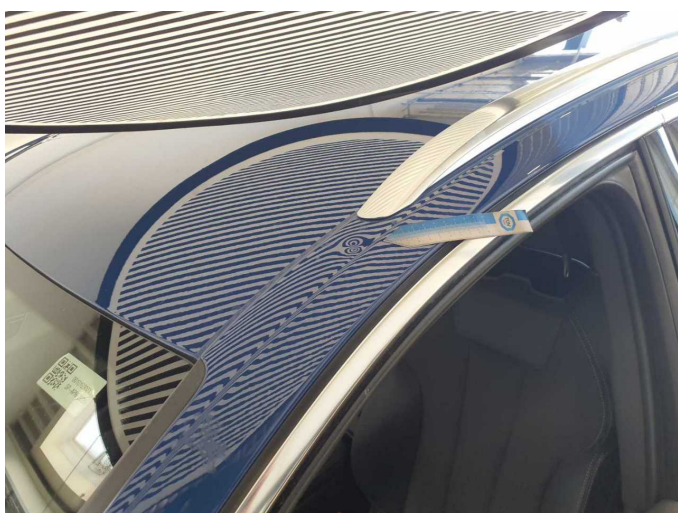
**Damage 7:** Roof: Roof rail - left side - dent(s) - Smart repair

| No. | Component group | Description |
|---|---|---|
| 7 | Roof | Roof rail - left side - dent(s) - Smart repair |

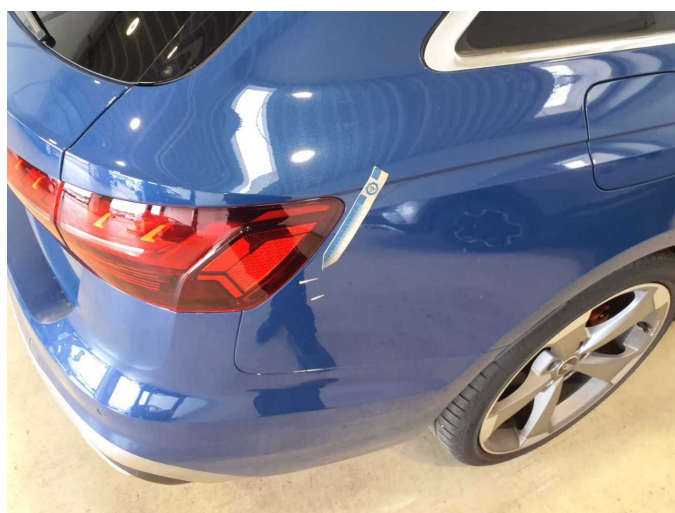
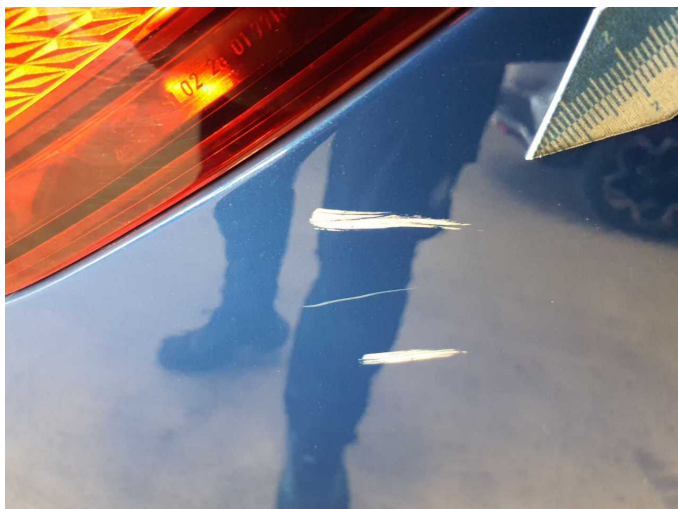
**Damage 8:** Side panel - rear right side: Side panel - Scratch(es) - Smart repair

| No. | Component group | Description |
|---|---|---|
| 8 | Side panel - rear right side | Side panel - Scratch(es) - Smart repair |

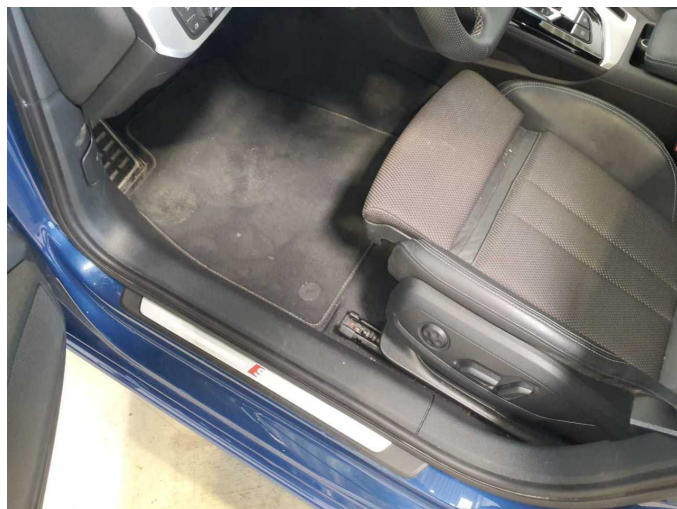
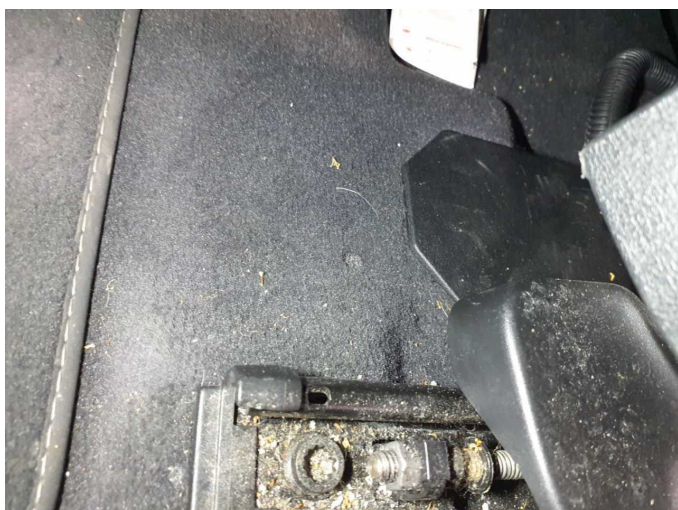
**Damage 10:** Trim / covers: Carpet - front left side - Burn hole (cigarettes) - Smart repair

| No. | Component group | Description |
|---|---|---|
| 10 | Trim / covers | Carpet - front left side - Burn hole (cigarettes) - Smart repair |

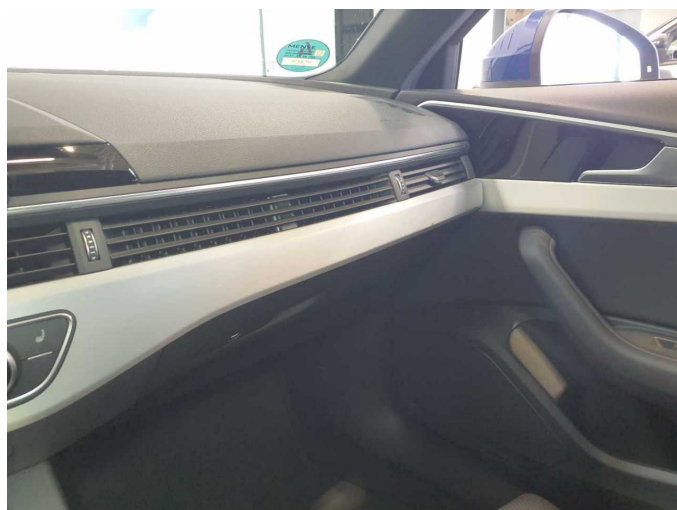
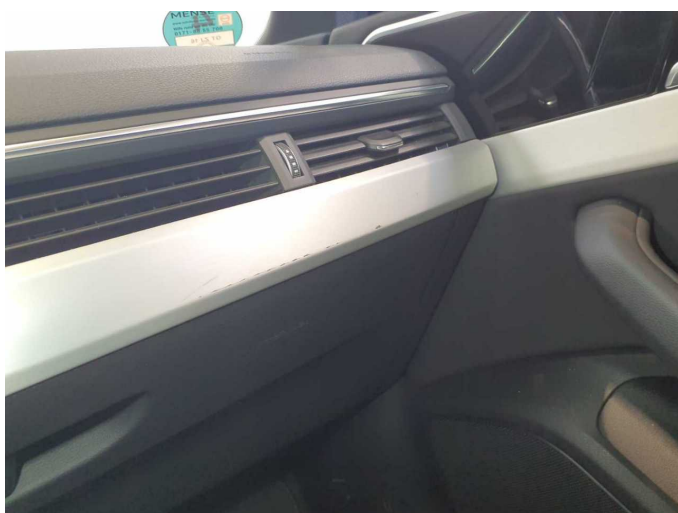
**Damage 11:** Instrument panel: Centre console - front - Scratch(es) - Replace

| No. | Component group | Description |
|---|---|---|
| 11 | Instrument panel | Centre console - front - Scratch(es) - Replace |

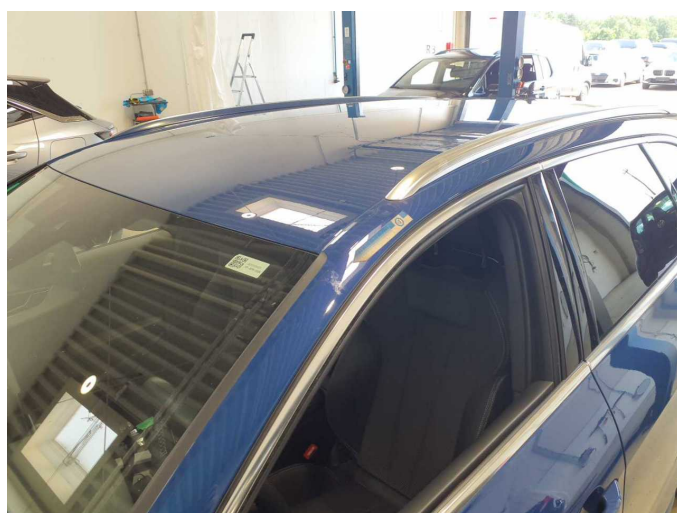
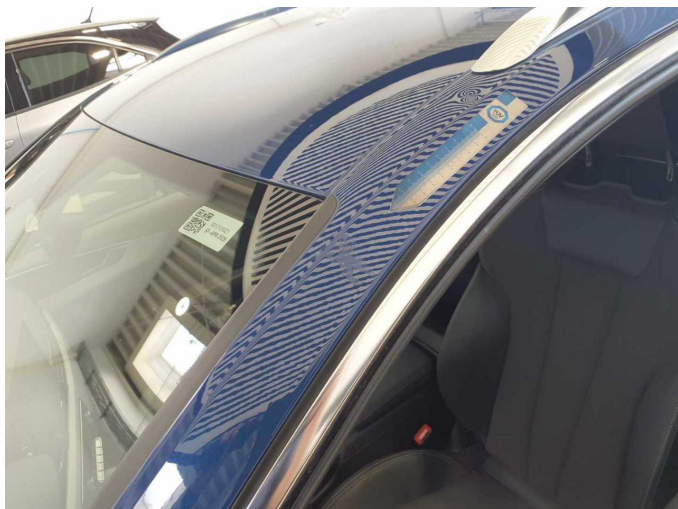
**Damage 12:** Body: A-pillar - left side (Anätzung) - Paint defect - Paint

| No. | Component group | Description |
|---|---|---|
| 12 | Body | A-pillar - left side (Anätzung) - Paint defect - Paint |

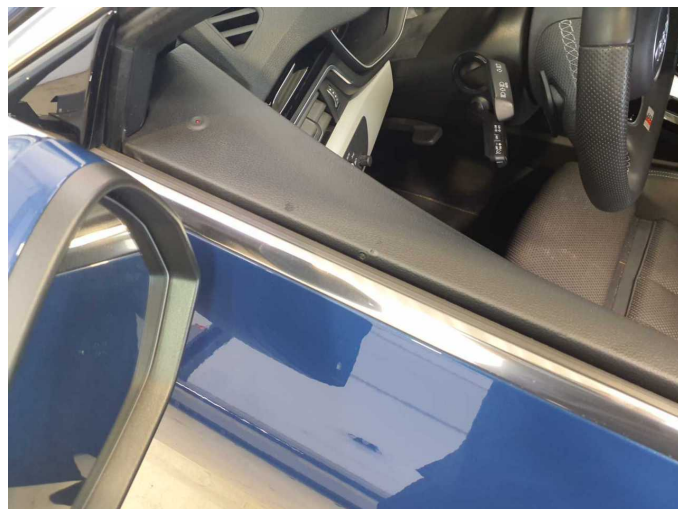
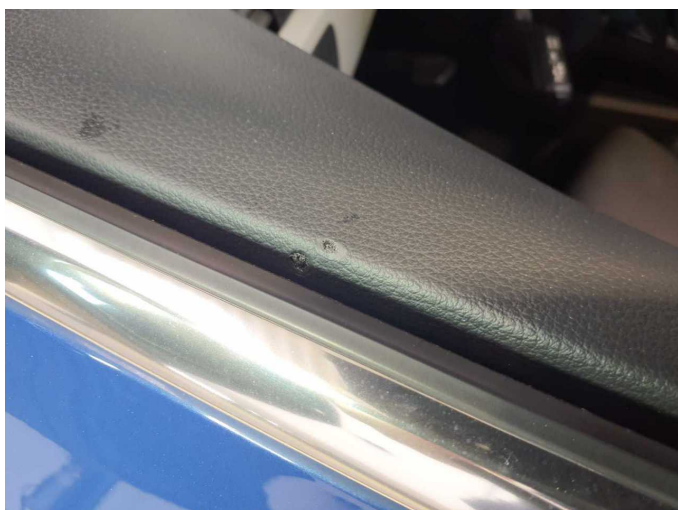
**Damage 13:** Trim / covers: Door trim - front left side - Burn hole (cigarettes) - Replace

| No. | Component group | Description |
|---|---|---|
| 13 | Trim / covers | Door trim - front left side - Burn hole (cigarettes) - Replace |

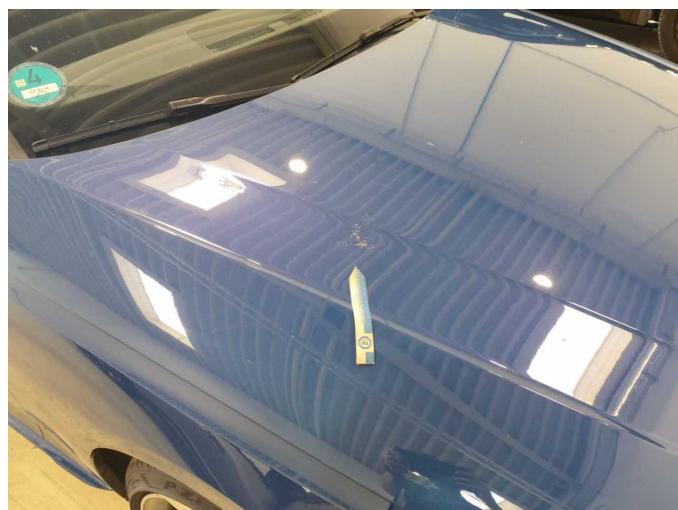
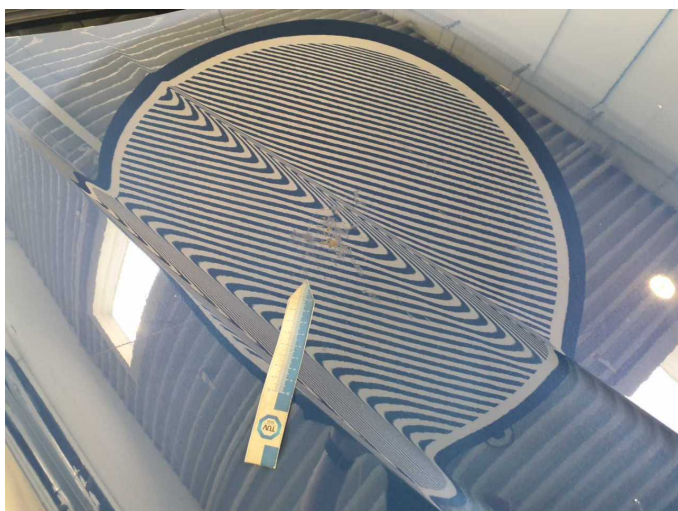
**Damage 14:** Bonnet: Bonnet (Anätzung) - Paint defect - Paint

| No. | Component group | Description |
|---|---|---|
| 14 | Bonnet | Bonnet (Anätzung) - Paint defect - Paint |

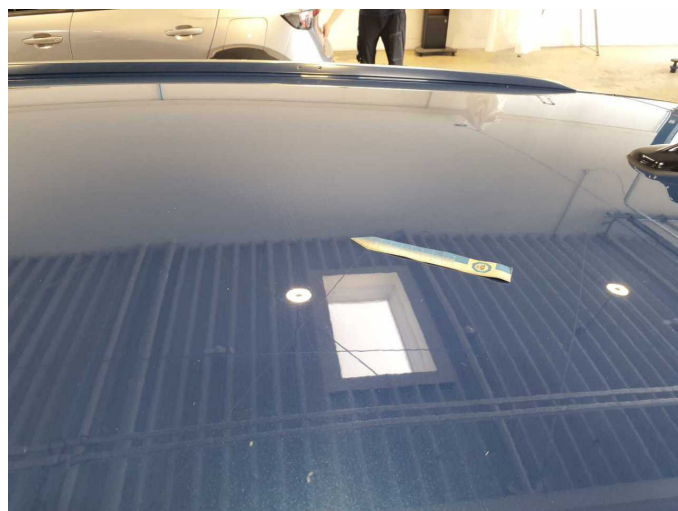
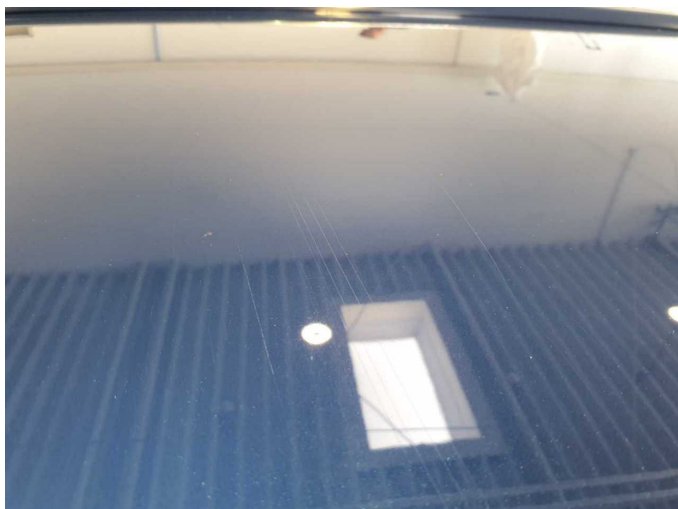
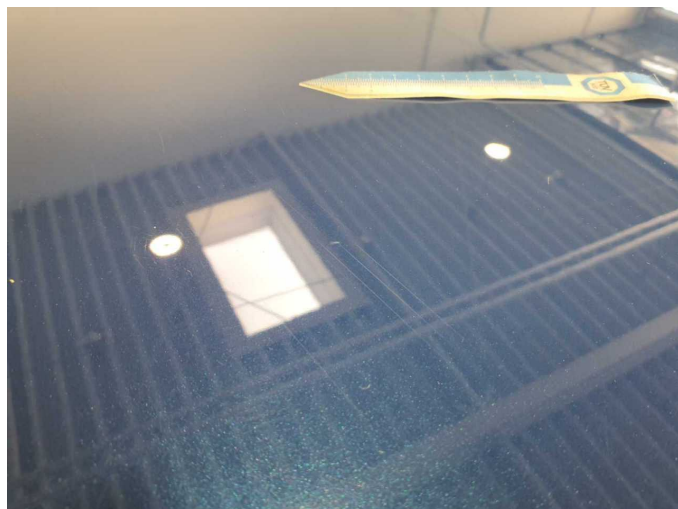
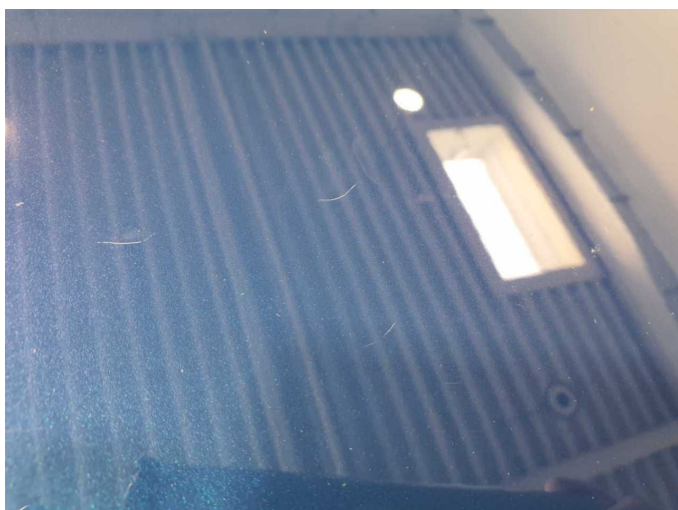
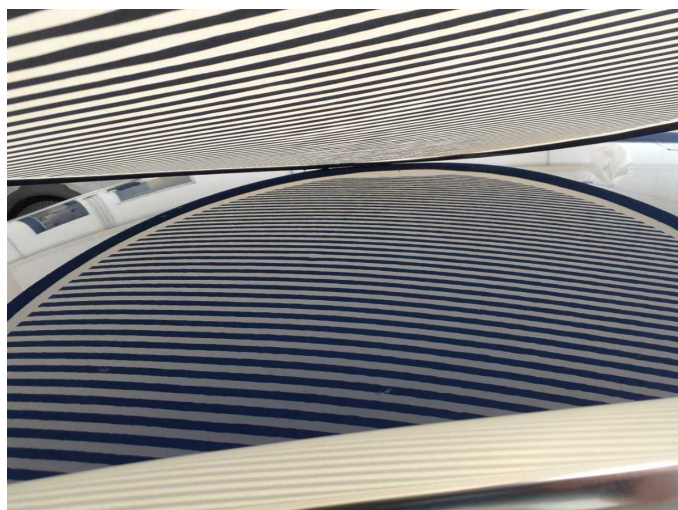
**Damage 15:** Roof: Roof (+ Kratzer) - dent(s) - Paint

| No. | Component group | Description |
|---|---|---|
| 15 | Roof | Roof (+ Kratzer) - dent(s) - Paint |
