Expertise

Manufacturer: Mercedes-Benz

Model: E 220 d T 9G-TRONIC Avantgarde

VIN: W1K2132041B091963

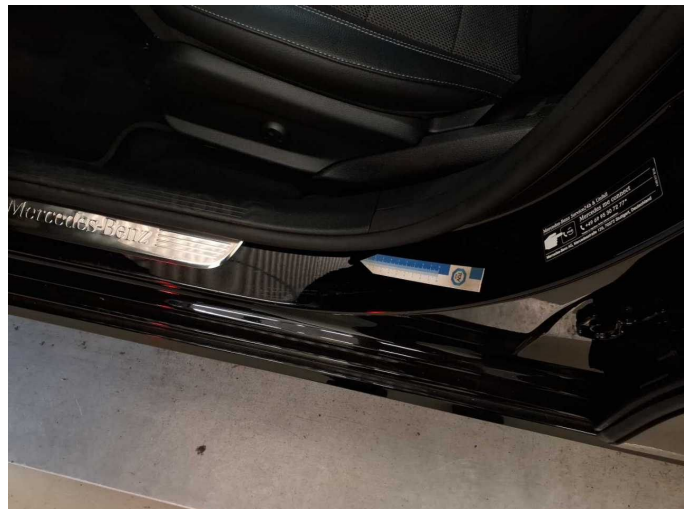
| No. | Component group | Description |
|---|---|---|
| 1 | Sill - left side | Sill - dent(s) - Smart repair |

Damage 1: Sill - left side: Sill - dent(s) - Smart repair

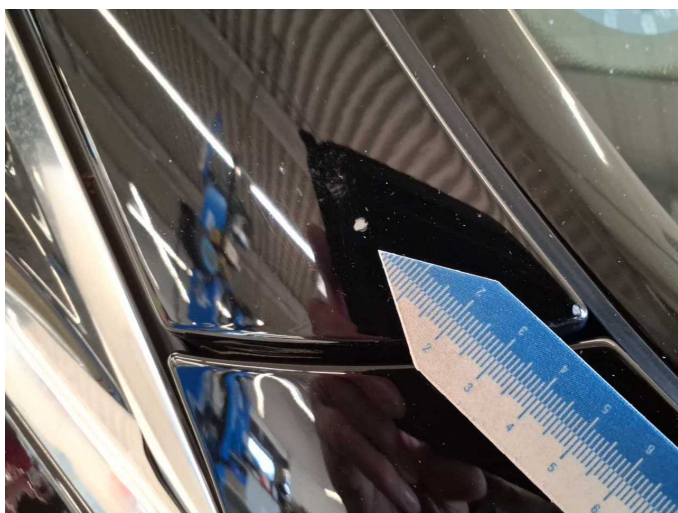
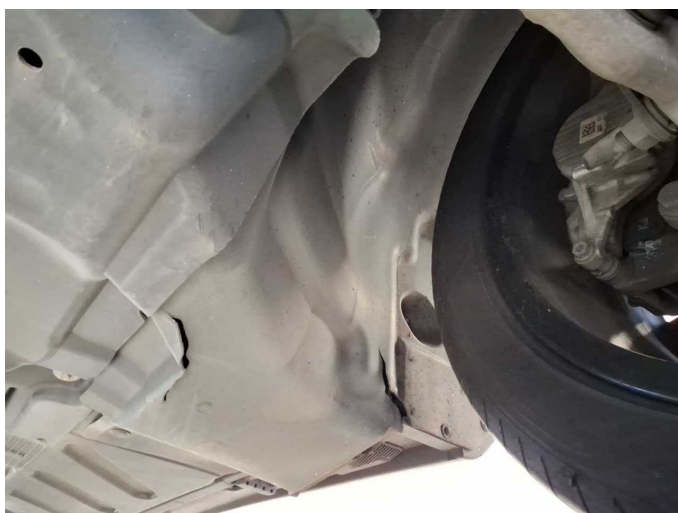
| No. | Component group | Description |
|---|---|---|
| 3 | Body | A-pillar - right side - Stone chips - Smart repair |

**Damage 3:** Body: A-pillar - right side - Stone chips - Smart repair

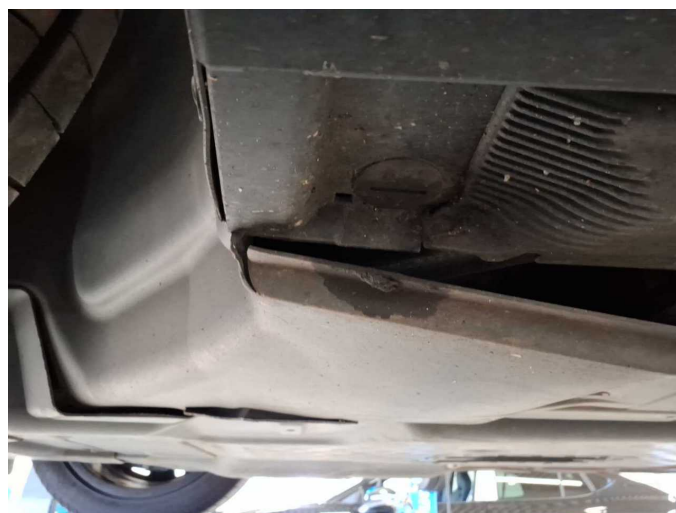
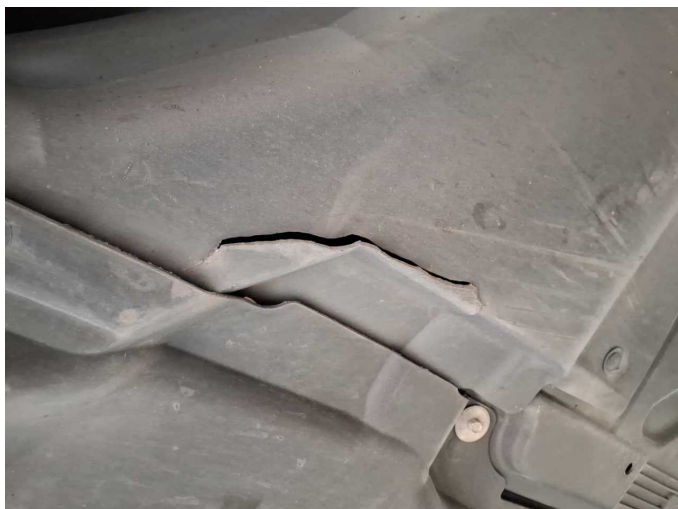
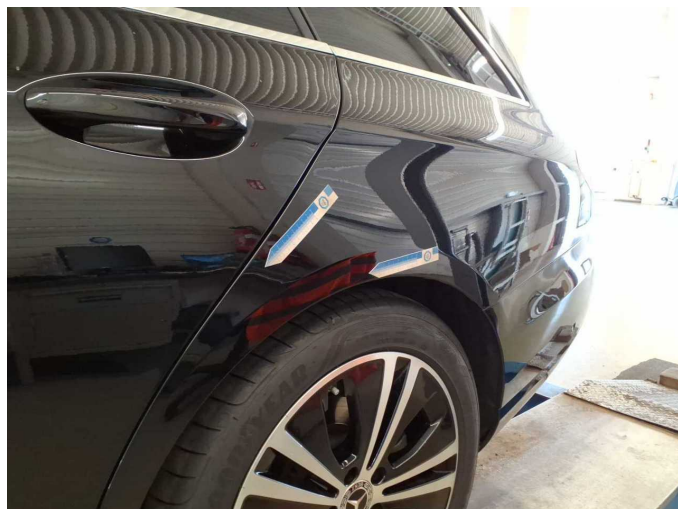
| No. | Component group | Description |
|---|---|---|
| 4 | Mudguard - left side | Inner mudguard - Broken / torn - Replace |

**Damage 4:** Mudguard - left side: Inner mudguard - Broken / torn - Replace

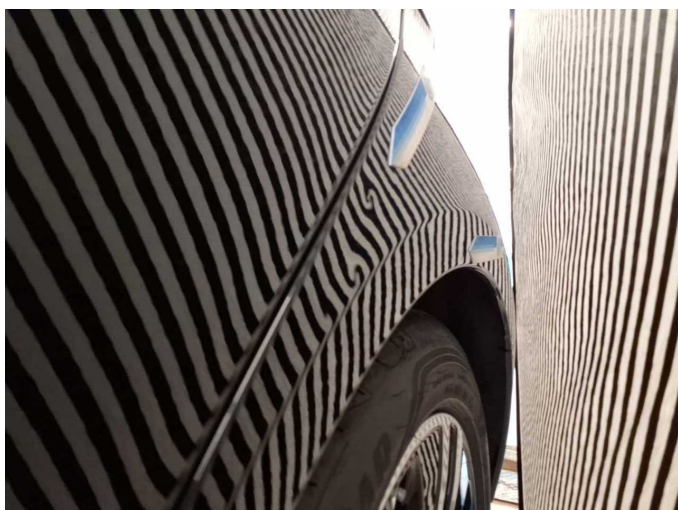
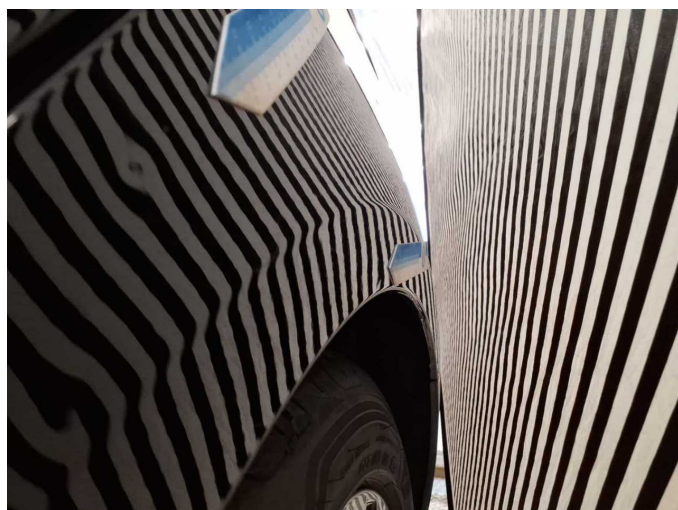
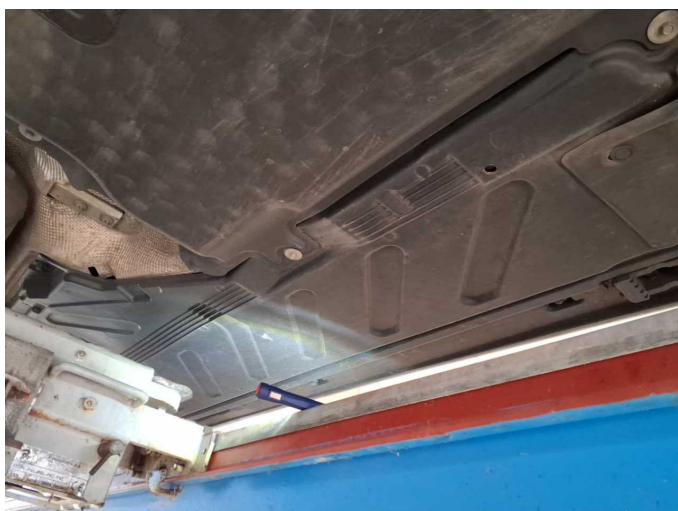
| No. | Component group | Description |
|---|---|---|
| 5 | Side panel - rear left side | Side panel - dent(s) - Smart repair |

**Damage 5:** Side panel - rear left side: Side panel - dent(s) - Smart repair

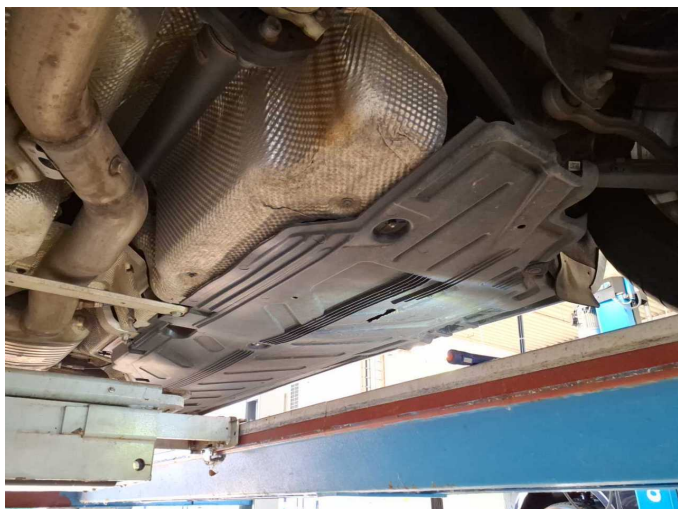
| No. | Component group | Description |
|---|---|---|
| 6 | Body | Underbody panelling (links) - Broken / torn - Replace |

**Damage 6:** Body: Underbody panelling (links) - Broken / torn - Replace

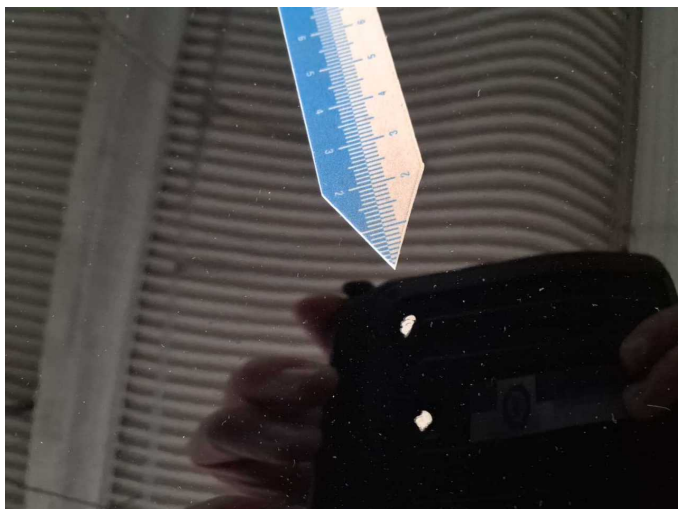
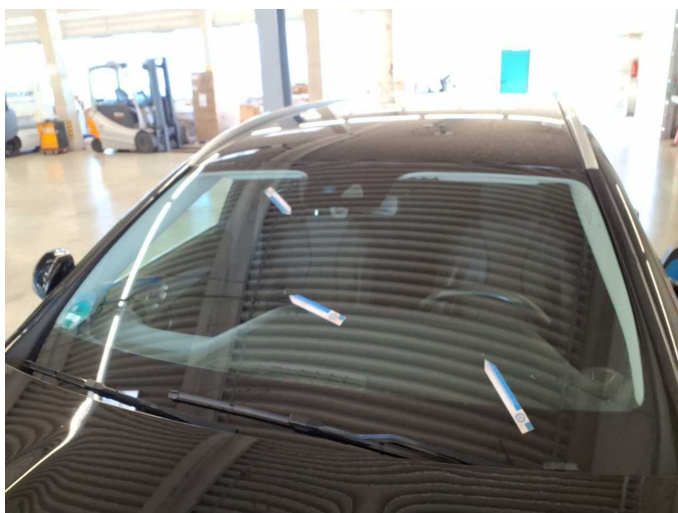
| No. | Component group | Description |
|---|---|---|
| 12 | Bonnet | Bonnet (+ Einätzungen) - Stone chips - Paint |

**Damage 12:** Bonnet: Bonnet (+ Einätzungen) - Stone chips - Paint

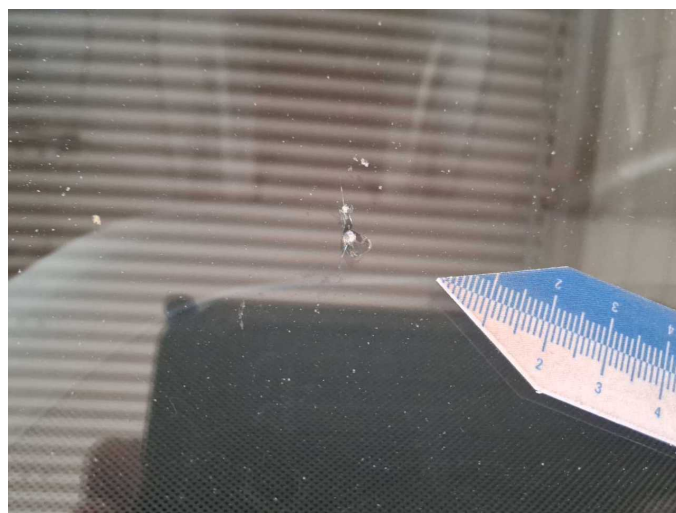
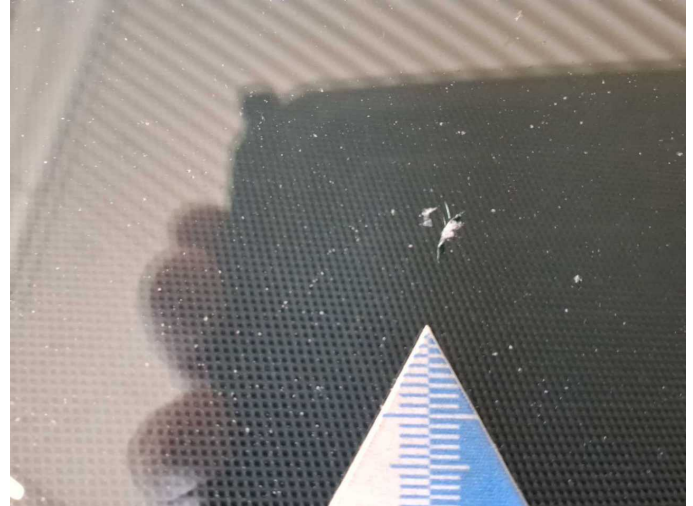
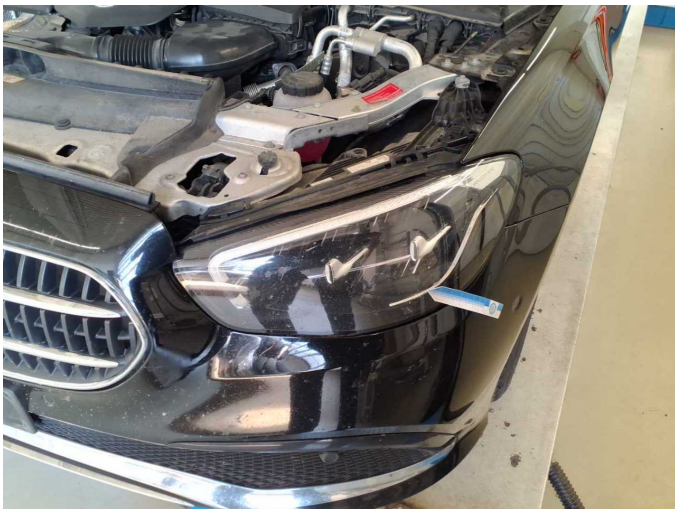
| No. | Component group | Description |
|---|---|---|
| 13 | Vehicle glazing | Windscreen with lane departure assistant - Stone chips - Replace |

**Damage 13:** Vehicle glazing: Windscreen with lane departure assistant - Stone chips - Replace

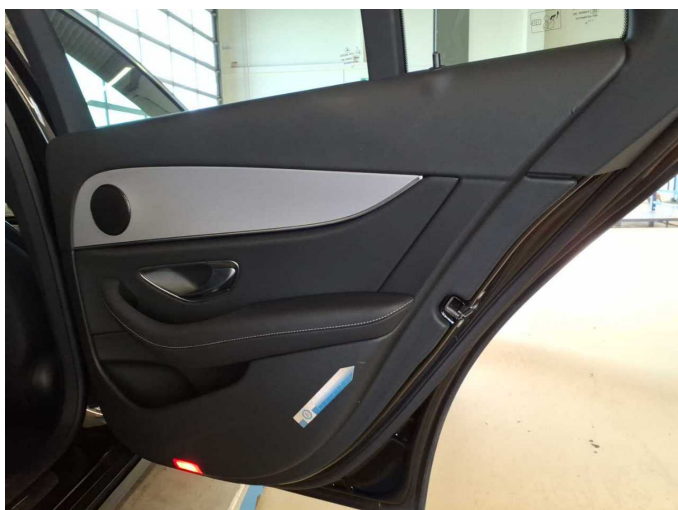
| No. | Component group | Description |
|---|---|---|
| 3 | Door - rear left side | Door - dent(s) - No deduction |

**Wear and tear 3:** Door - rear left side: Door - dent(s) - No deduction

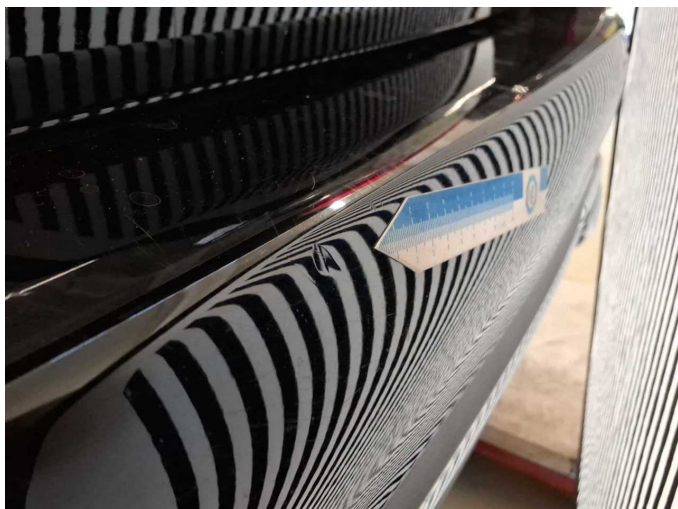
| No. | Component group | Description |
|---|---|---|
| 5 | Rear bumper | Bumper with Parktronic (Verladekante) - dent(s) - No deduction |

**Wear and tear 5:** Rear bumper: Bumper with Parktronic (Verladekante) - dent(s) - No deduction
