Expertise

Protocol number: 46851924  
Order No. / Reference: 26790220  
Inspection date: 4 Aug 2026

Manufacturer: Ford

Model: Mondeo Turnier 2.0 EcoBlue Aut. Titanium

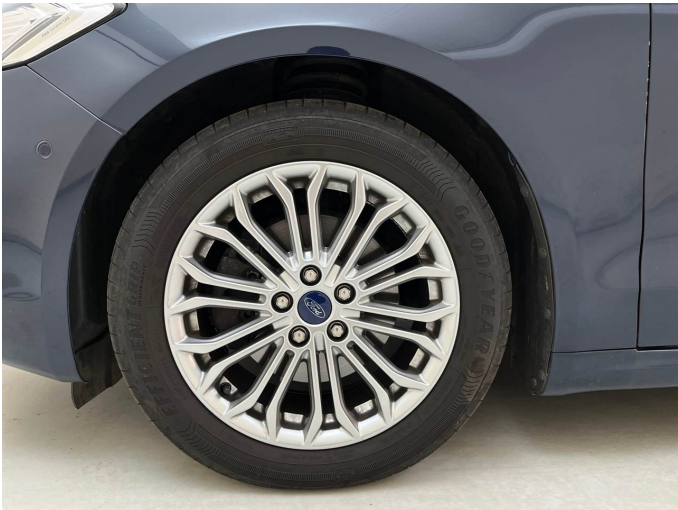
| # | Tyre size | Type of tyre | Manufacturer | Tread depth |
|---|---|---|---|---|
| 1) | 215/55 R17 98W | Summer tyres on Light alloy | Goodyear | 5mm / 5mm |
| 2) | 215/55 R17 98W | Summer tyres on Light alloy | Goodyear | 5mm / 5mm |

Figure 12: Mounted tyres

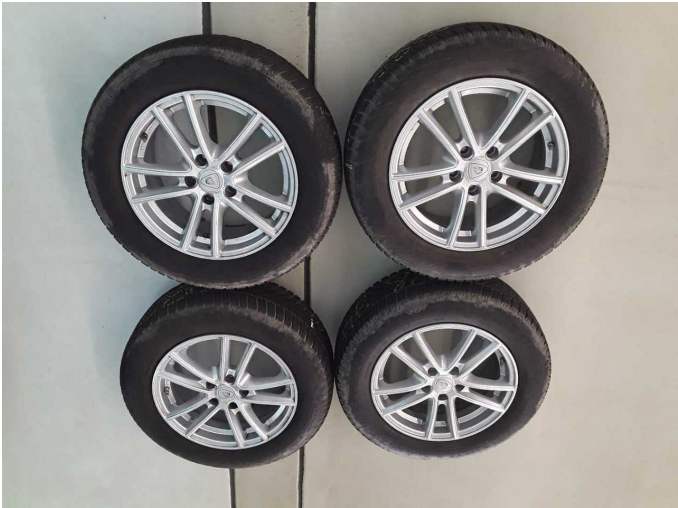
| # | Tyre size | Type of tyre | Manufacturer | Tread depth |
|---|---|---|---|---|
| 1) | 215/60 R16 99H | Winter tyres on Light alloy | Dunlop | 7mm / 6mm |
| 2) | 215/60 R16 99H | Winter tyres on Light alloy | Dunlop | 7mm / 7mm |

Figure 16: Additional tyres

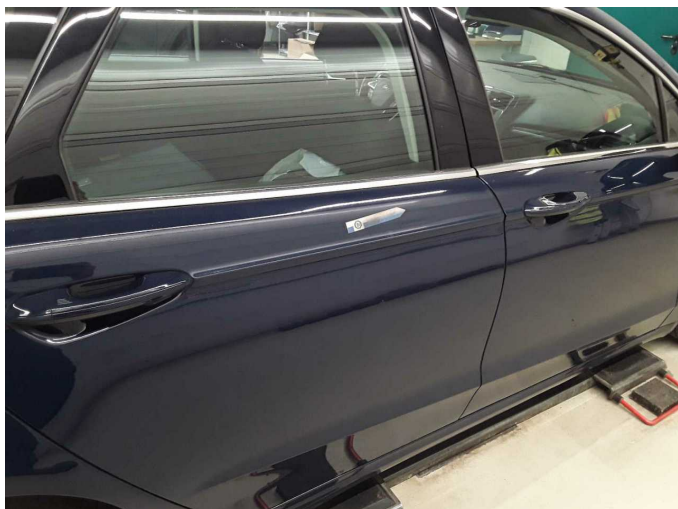
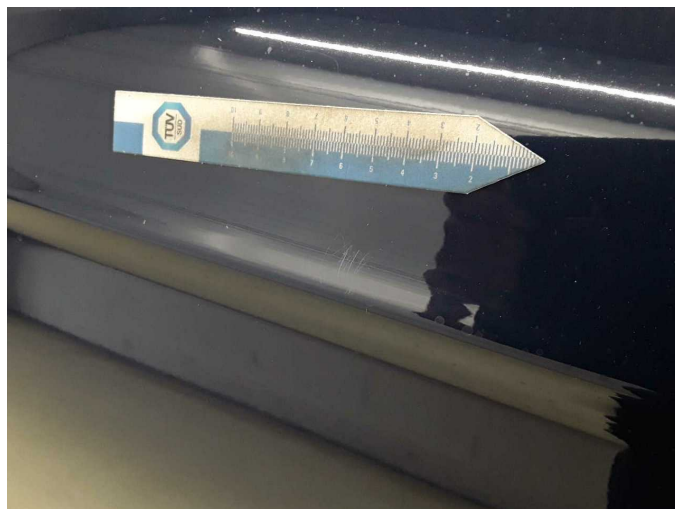
| No. | Component group | Description |
|---|---|---|
| 1 | Door - rear right side | Door - Scratch(es) - Smart repair |

**Damage 1:** Door - rear right side: Door - Scratch(es) - Smart repair

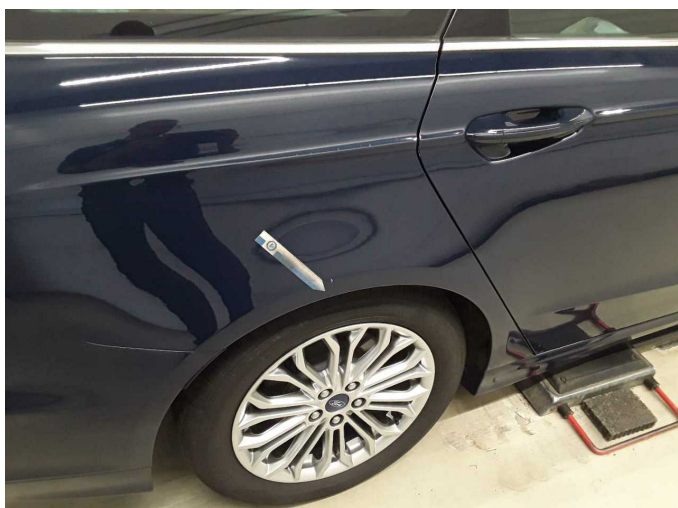
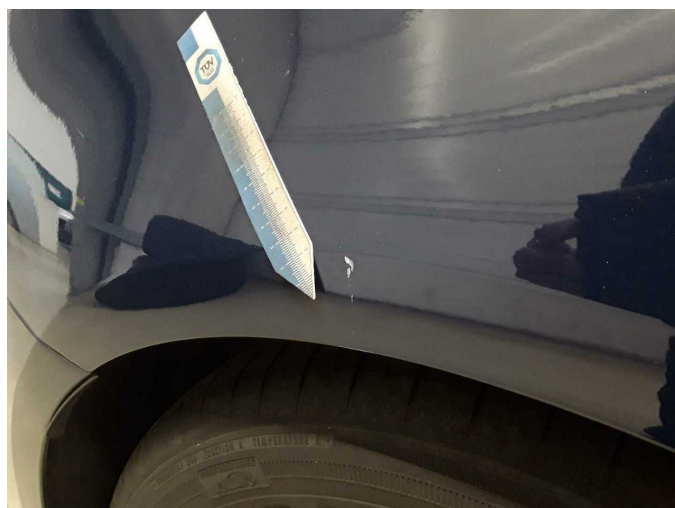
| No. | Component group | Description |
|---|---|---|
| 2 | Side panel - rear right side | Side panel - Scratch(es) - Smart repair |

**Damage 2:** Side panel - rear right side: Side panel - Scratch(es) - Smart repair

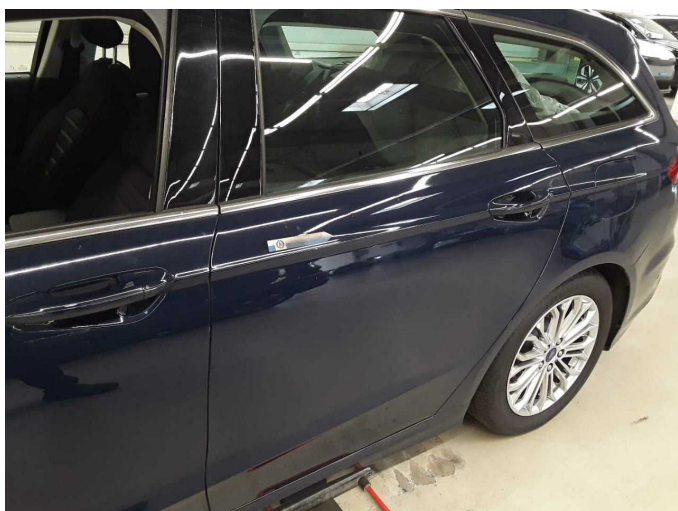
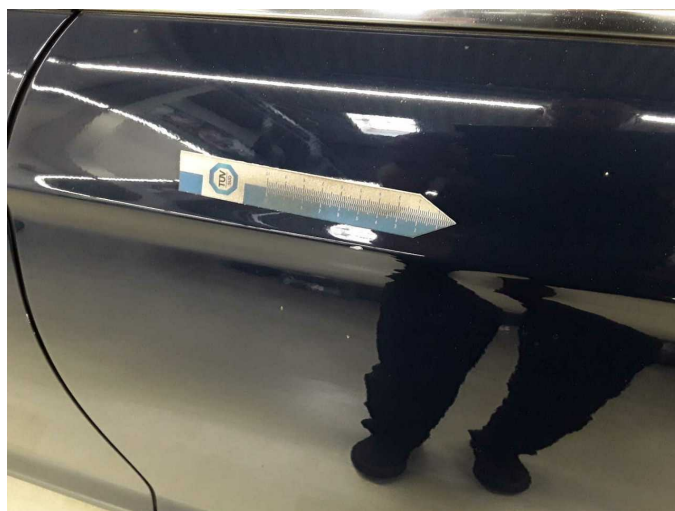
| No. | Component group | Description |
|---|---|---|
| 3 | Door - rear left side | Door - Scratch(es) - Smart repair |

**Damage 3:** Door - rear left side: Door - Scratch(es) - Smart repair

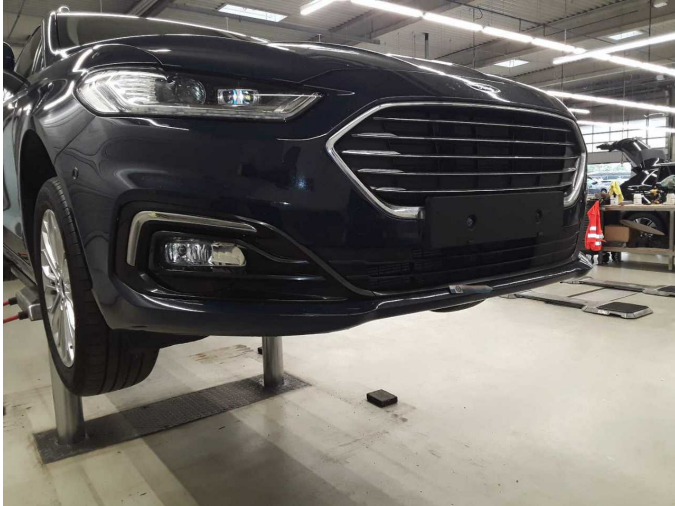
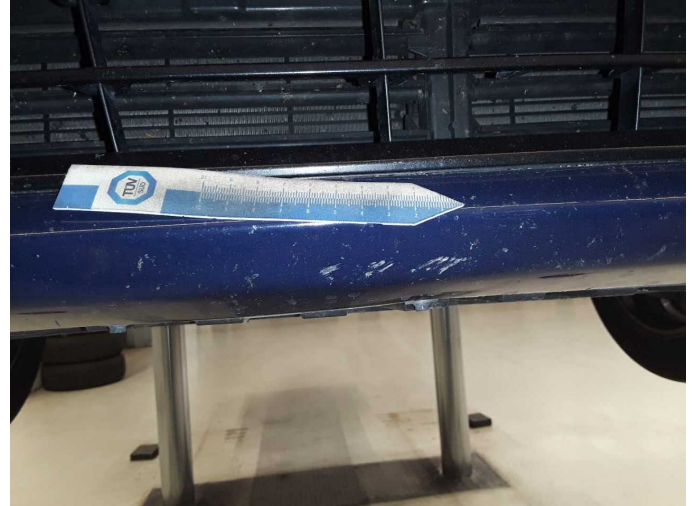
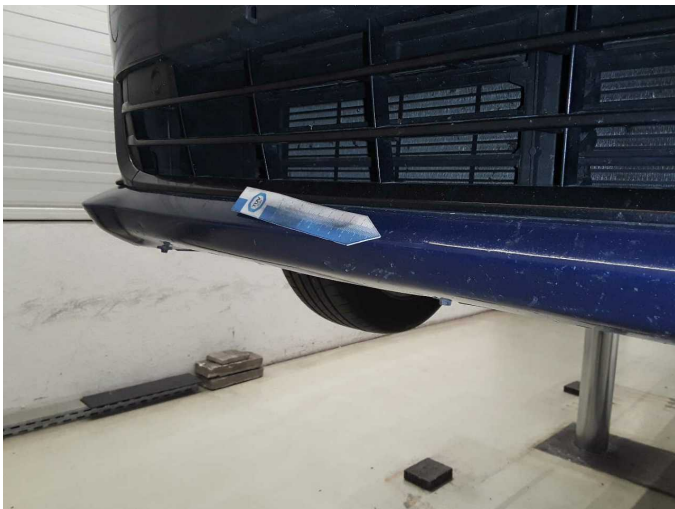
| No. | Component group | Description |
|---|---|---|
| 4 | Front bumper | Front bumper - Dent / paintcoat damage - Smart repair |

**Damage 4:** Front bumper: Front bumper - Dent / paintcoat damage - Smart repair
