Expertise

Protocol number: 46537564  
Order No. / Reference: 26597868  
Inspection date: 16 Jul 2026

Manufacturer: Audi  
VIN: WAUZZZFZ0PP022523

Model: Q4 e-tron 40

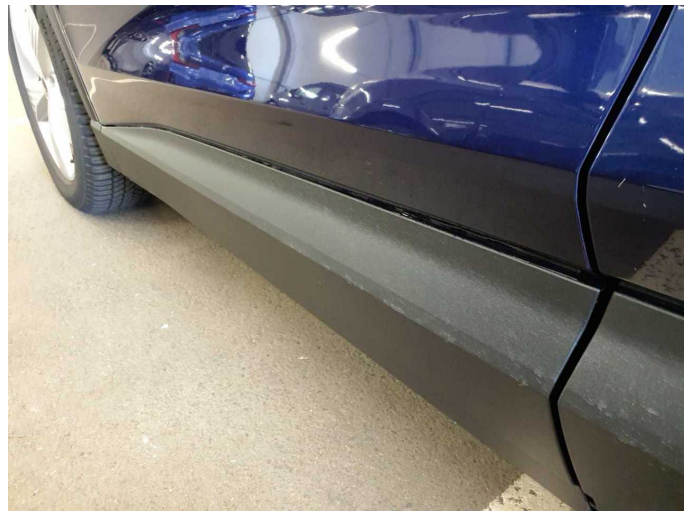
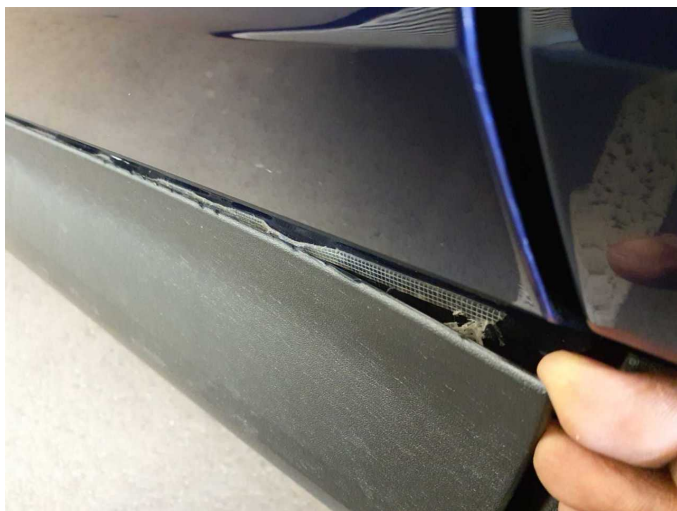
| No. | Component group | Description |
|---|---|---|
| 1 | Door - front left side | Brightware - lower - Malposition - Un- / install |

Damage 1: Door - front left side: Brightware - lower - Malposition - Un- / install

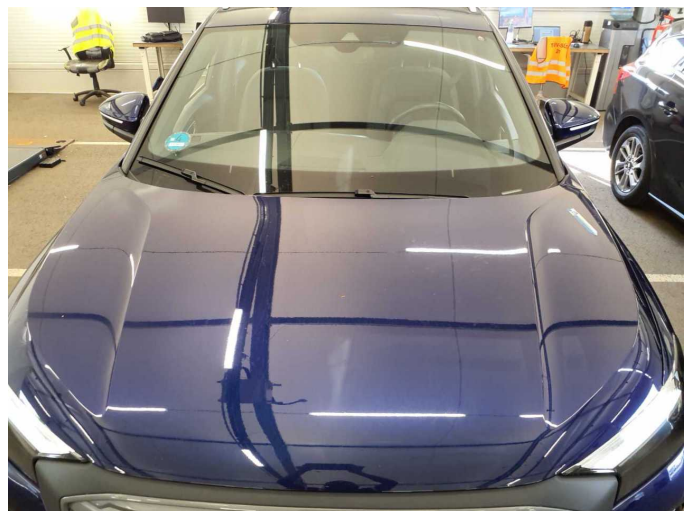
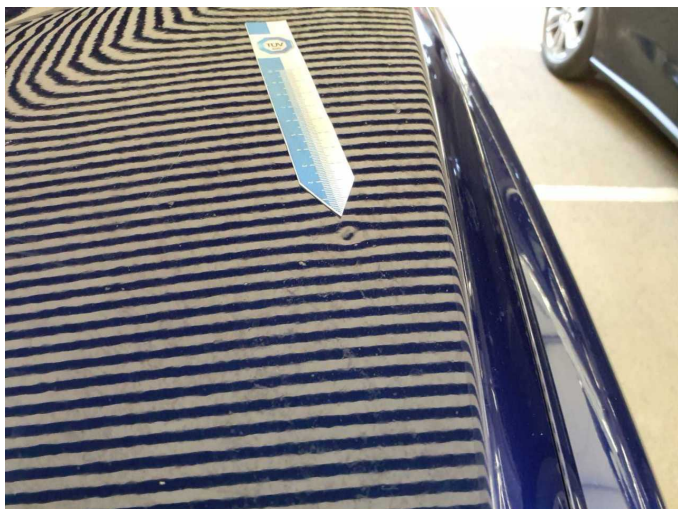
| No. | Component group | Description |
|---|---|---|
| 2 | Bonnet | Bonnet - dent(s) - Smart repair |

Damage 2: Bonnet: Bonnet - dent(s) - Smart repair

**Damage 2:** Bonnet: Bonnet - dent(s) - Smart repair

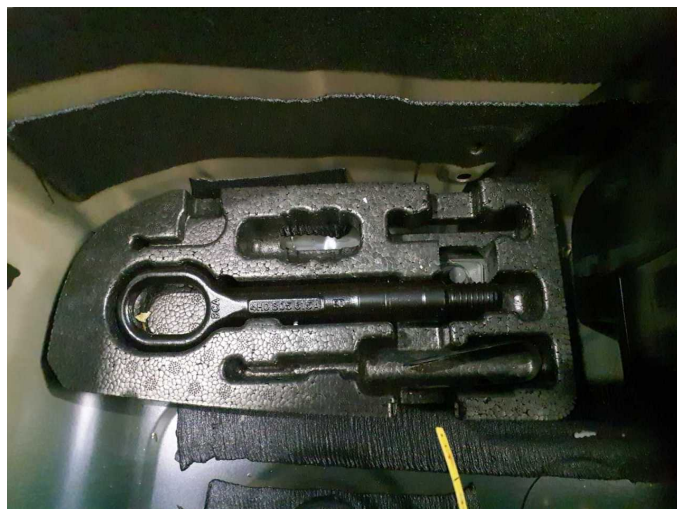
Equipment - Vehicle tool kit

**Missing part 1:** Equipment: Vehicle tool kit - Missing - Replace

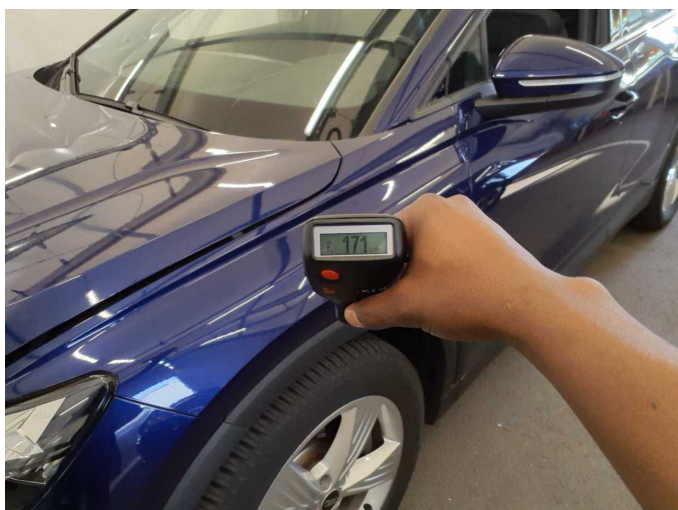
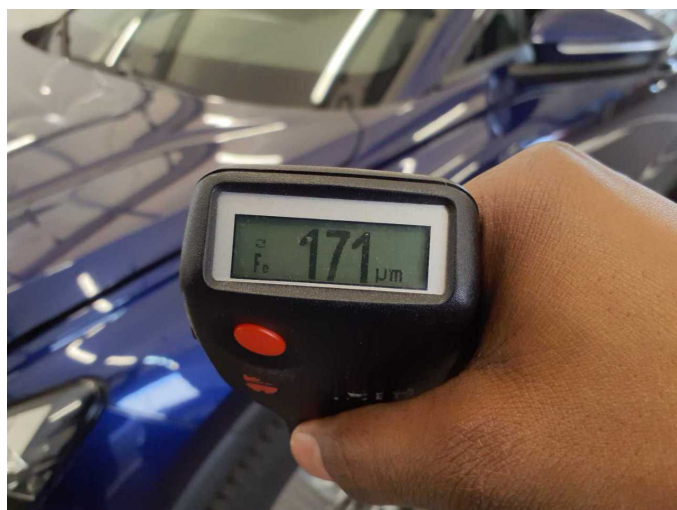
- 1 Mudguard - left side, Professionally carried out, Invoice of repair done Non-existent
- 2 Door - front left side, Professionally carried out, Invoice of repair done Non-existent

| Mudguard - left side | 171 µm | Door - front left side | 236 µm |

**Repainting 1:** Mudguard - left side

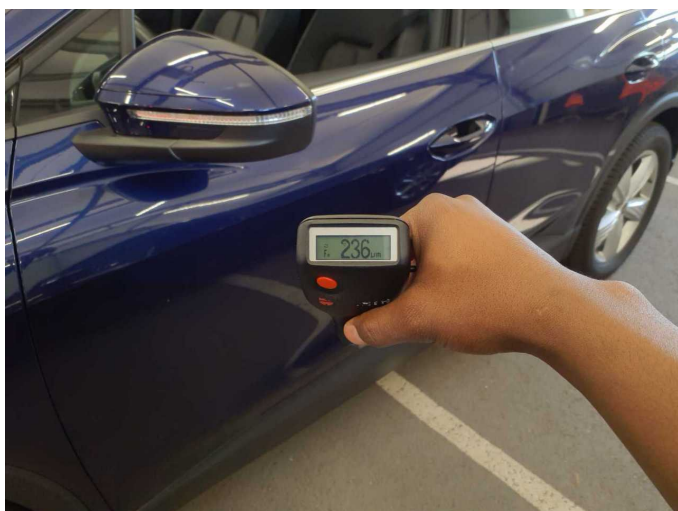
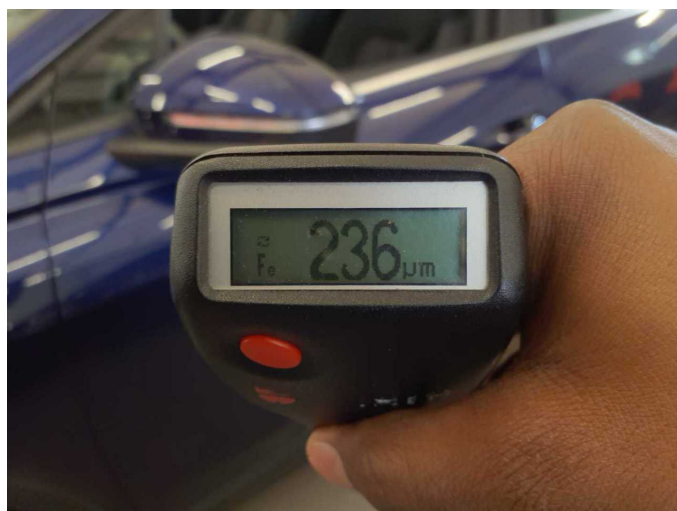
**Repainting 2:** Door - front left side
