Expertise

Protocol number: 46594836  
Order No. / Reference: 26726437  
Inspection date: 14 Jul 2026

Manufacturer: Audi  
VIN: WAUZZZF32R1016434

Model: Q3 35 TDI quattro S tronic advanced

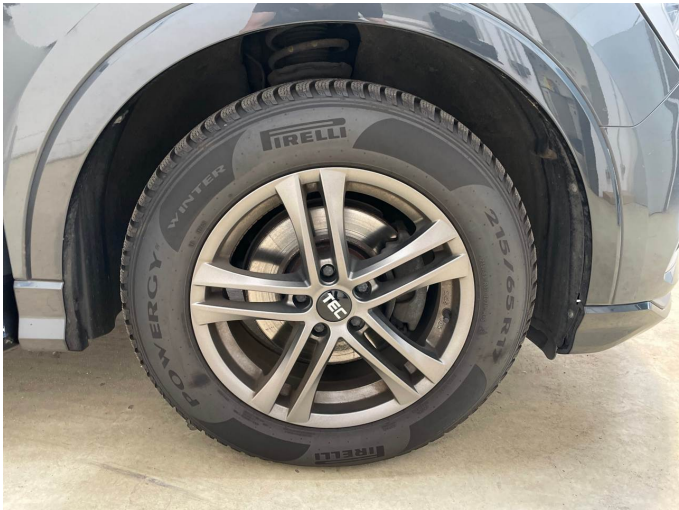
Figure 12: Mounted tyres

| # | Tyre size | Type of tyre | Manufacturer | Tread depth |
|---|---|---|---|---|
| 1) | 215/65 R17 103H | Winter tyres on Light alloy | Pirelli | 7mm / 7mm |
| 2) | 215/65 R17 103H | Winter tyres on Light alloy | Pirelli | 8mm / 8mm |

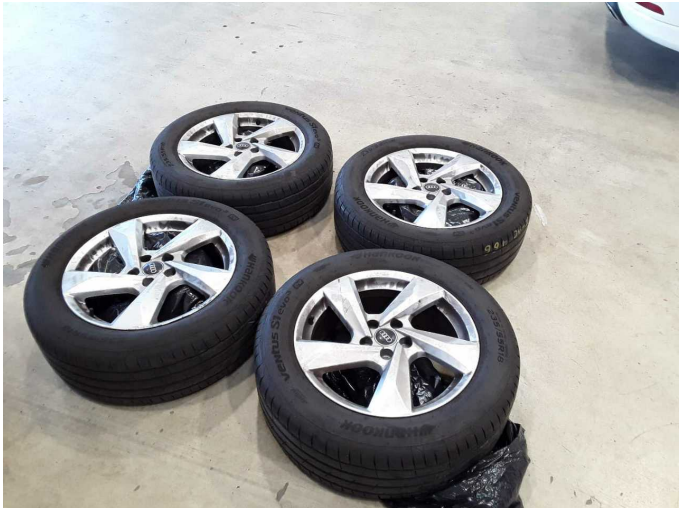
Figure 16: Additional tyres

| # | Tyre size | Type of tyre | Manufacturer | Tread depth |
|---|---|---|---|---|
| 1) | 235/55 R18 100V | Summer tyres on Light alloy | Hankook | 4mm / 4mm |
| 2) | 235/55 R18 100V | Summer tyres on Light alloy | Hankook | 5mm / 5mm |

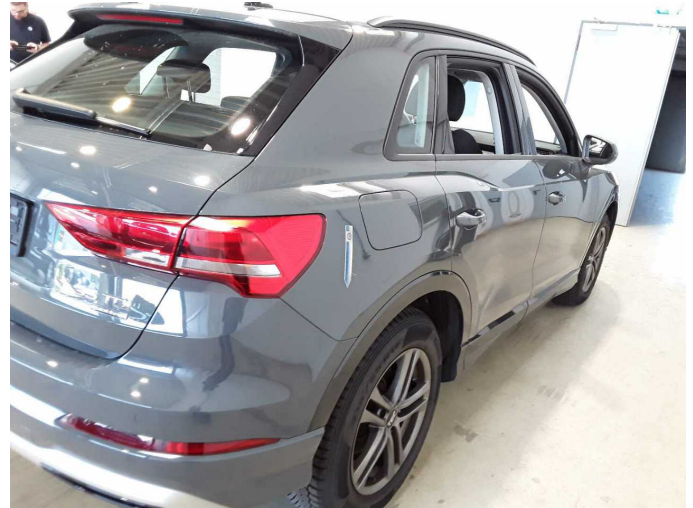
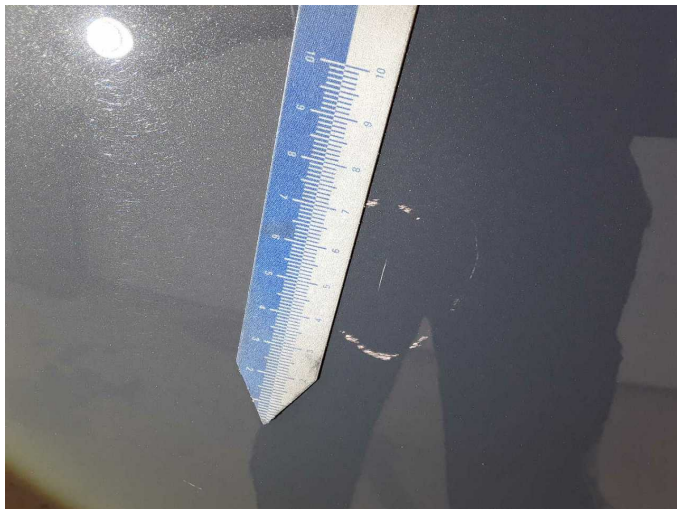
| No. | Component group | Description |
|---|---|---|
| 1 | Side panel - rear right side | Side panel - Scratch(es) - Smart repair |

**Damage 1:** Side panel - rear right side: Side panel - Scratch(es) - Smart repair

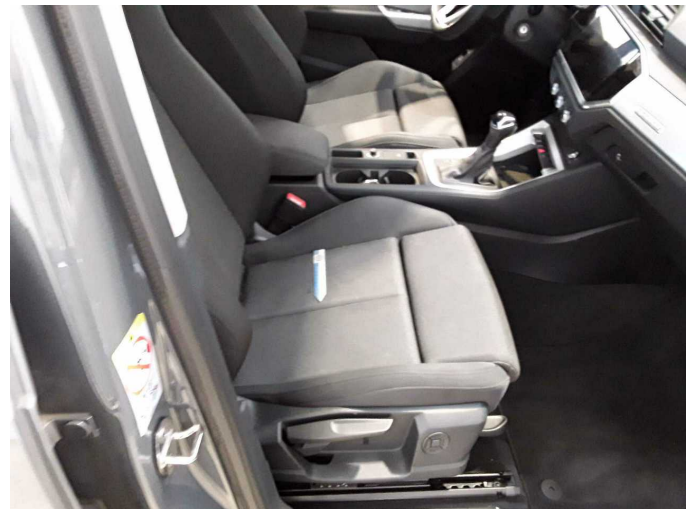
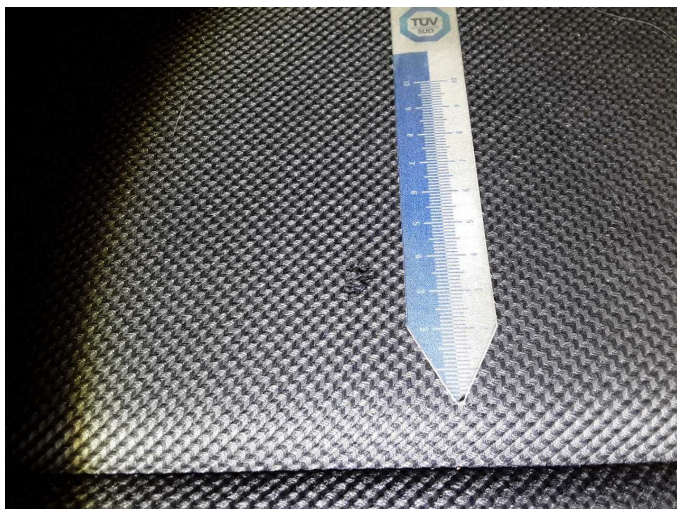
| No. | Component group | Description |
|---|---|---|
| 2 | Seat - front | Seat cover - right side - Burn hole (cigarettes) - Replace |

**Damage 2:** Seat - front: Seat cover - right side - Burn hole (cigarettes) - Replace

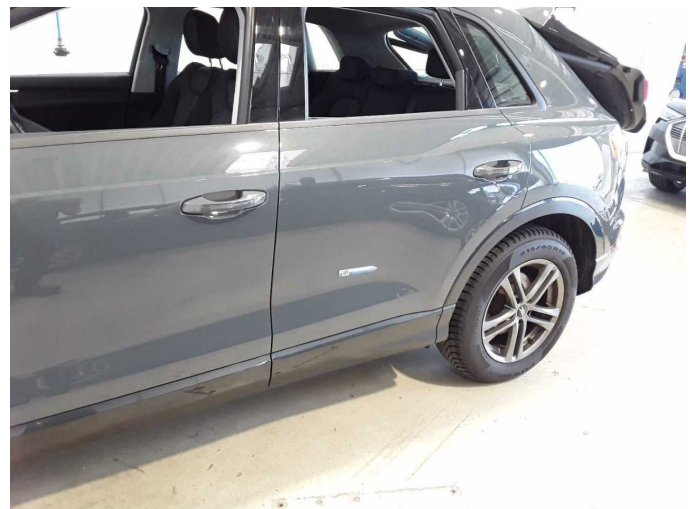
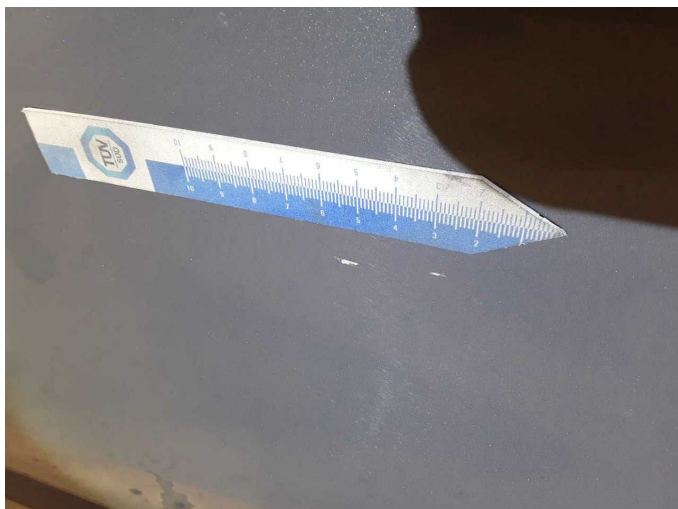
| No. | Component group | Description |
|---|---|---|
| 3 | Door - rear left side | Door - Scratch(es) - Paint |

**Damage 3:** Door - rear left side: Door - Scratch(es) - Paint

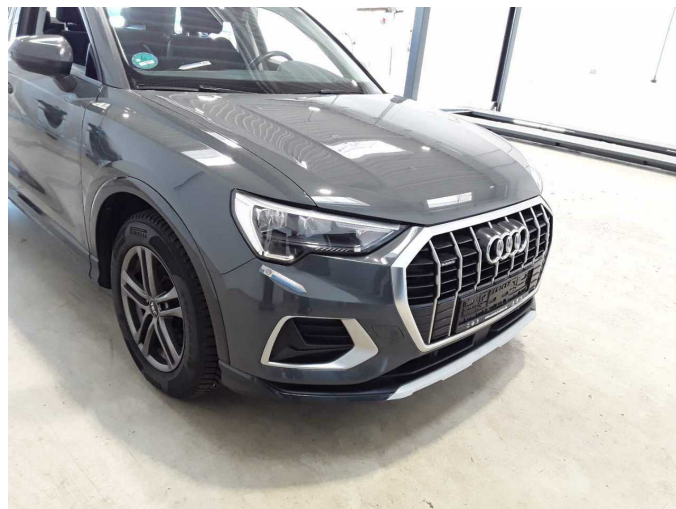
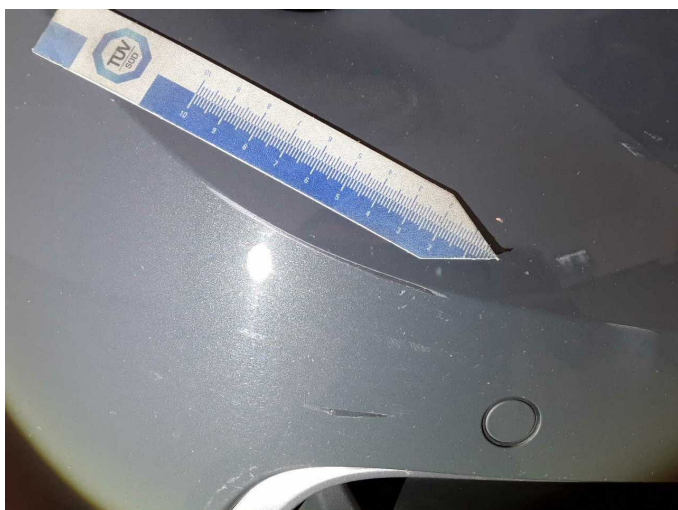
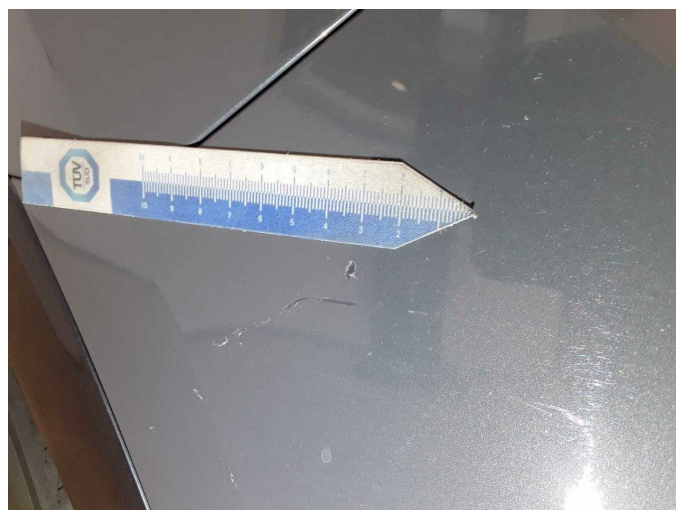
| No. | Component group | Description |
|---|---|---|
| 4 | Front bumper | Front bumper - Scratch(es) - Paint |

**Damage 4:** Front bumper: Front bumper - Scratch(es) - Paint

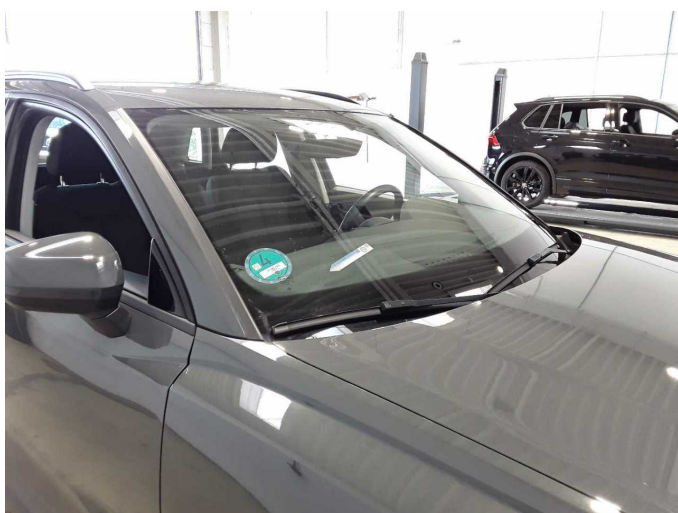
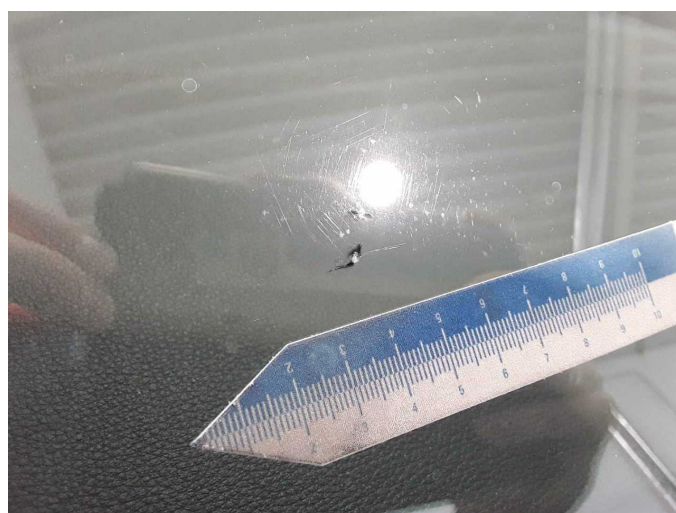
| No. | Component group | Description |
|---|---|---|
| 5 | Vehicle glazing | Windscreen (mit Riss) - Stone chips - Replace |

**Damage 5:** Vehicle glazing: Windscreen (mit Riss) - Stone chips - Replace

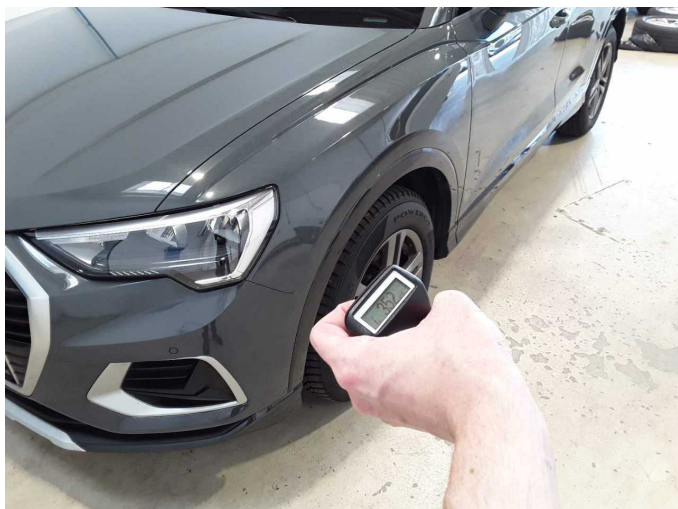
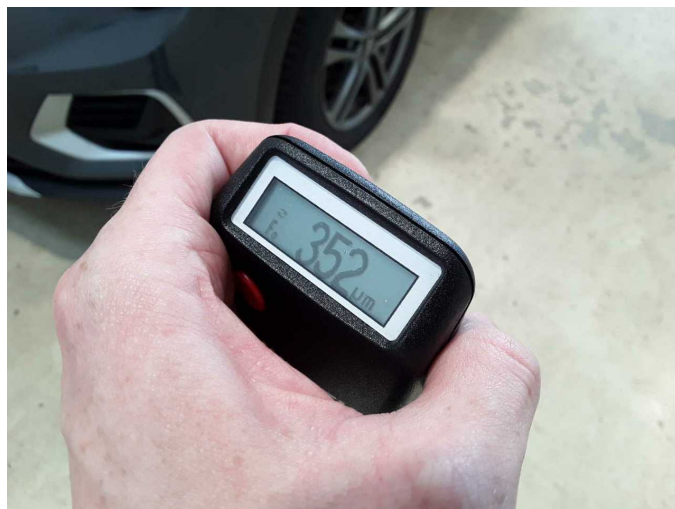
1 Mudguard - left side, Professionally carried out, Invoice of repair done Non-existent

Mudguard - left side 352 µm

**Repainting 1:** Mudguard - left side
