Expertise

Protocol number: 46145551  
Order No. / Reference: 26417688  
Inspection date: 23 Jun 2026

Manufacturer: Audi  
VIN: WAUZZZF40PA045095

Model: A4 Avant 30 TDI S tronic advanced

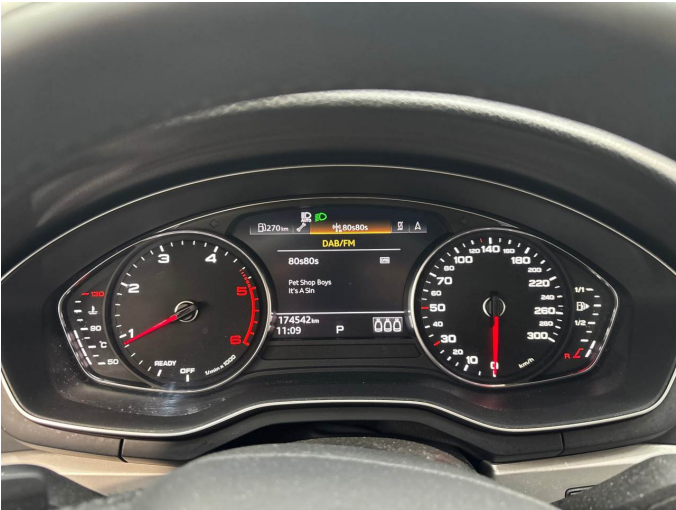
Figure 7: Instrument cluster

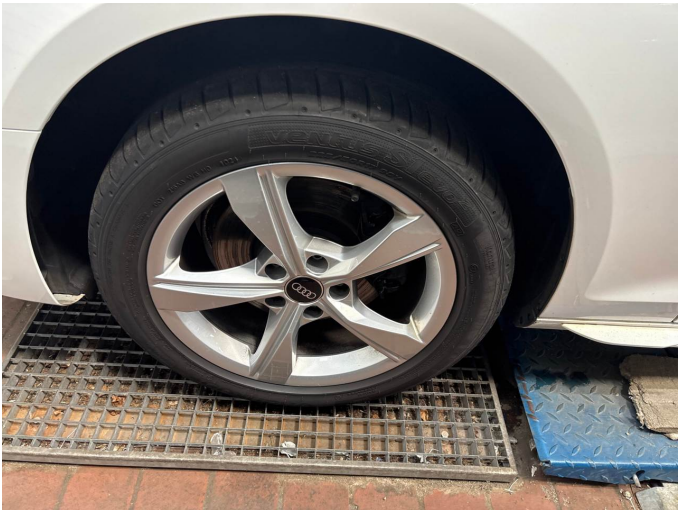
Figure 12: Mounted tyres

| No. | Component group | Description |
|---|---|---|
| 6 | Wheel / tyres | Tyre - front - Abrasion - Replace |

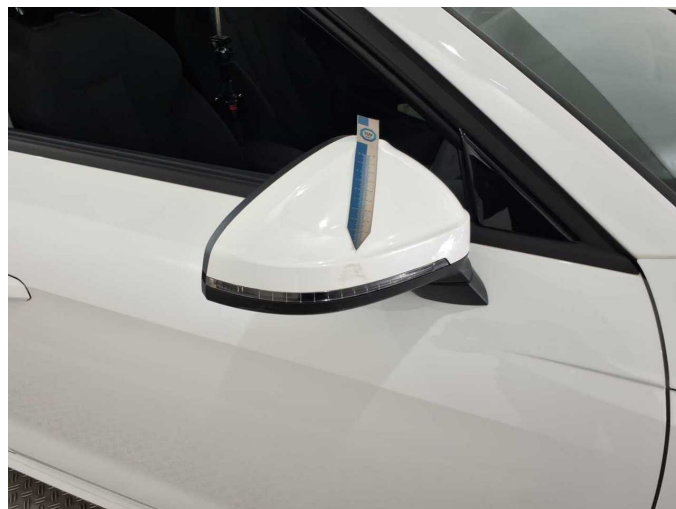
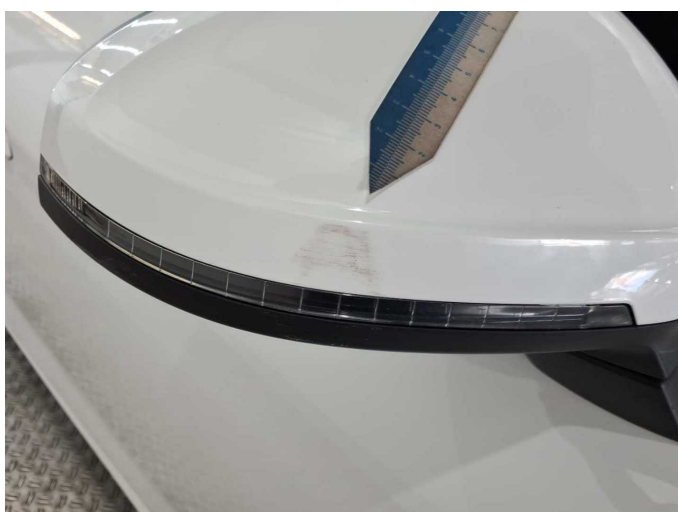
**Damage 1:** Wing mirror - right side: Cap - Scratch(es) - Smart repair

| No. | Component group | Description |
|---|---|---|
| 1 | Wing mirror - right side | Cap - Scratch(es) - Smart repair |

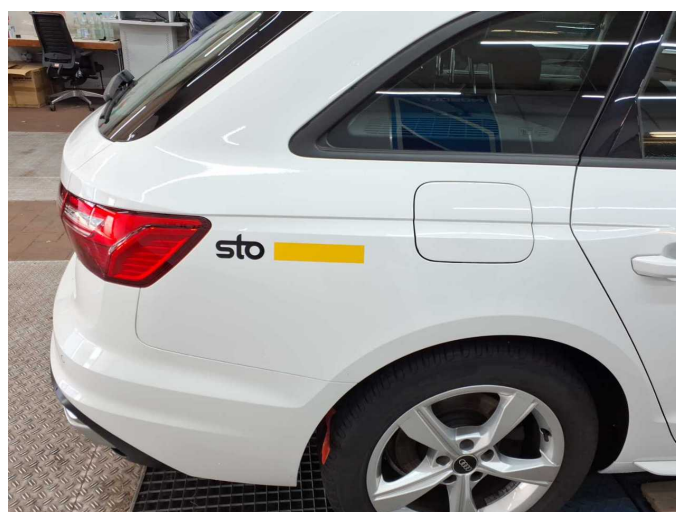
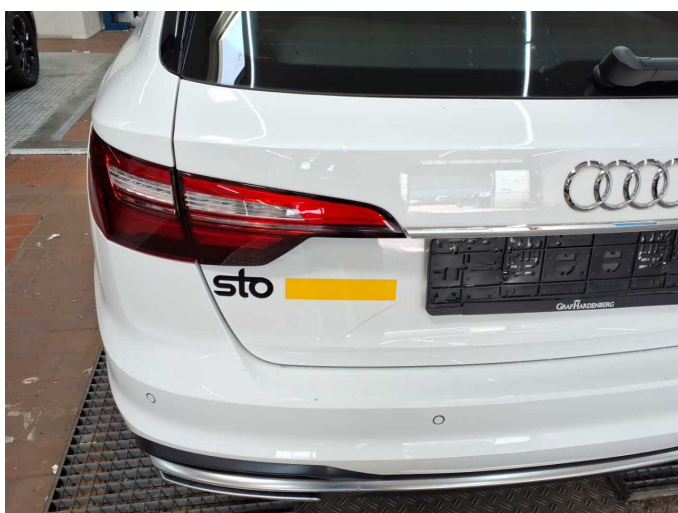
**Damage 2:** Body: Body - Glued / labelled - De-glue / neutralise

| No. | Component group | Description |
|---|---|---|
| 2 | Body | Body - Glued / labelled - De-glue / neutralise |

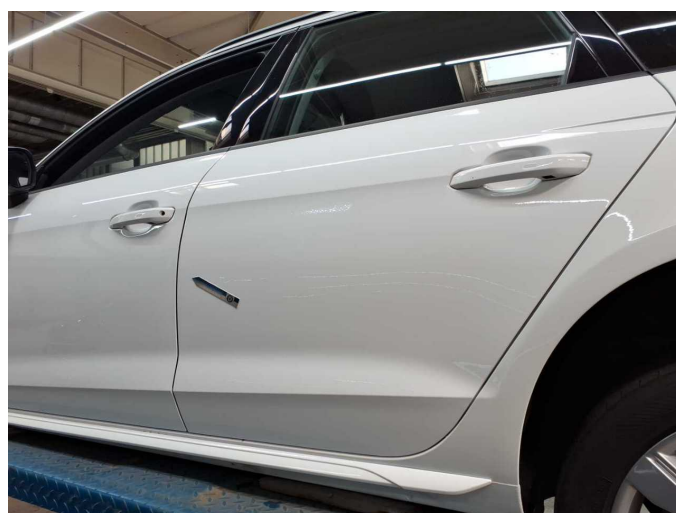
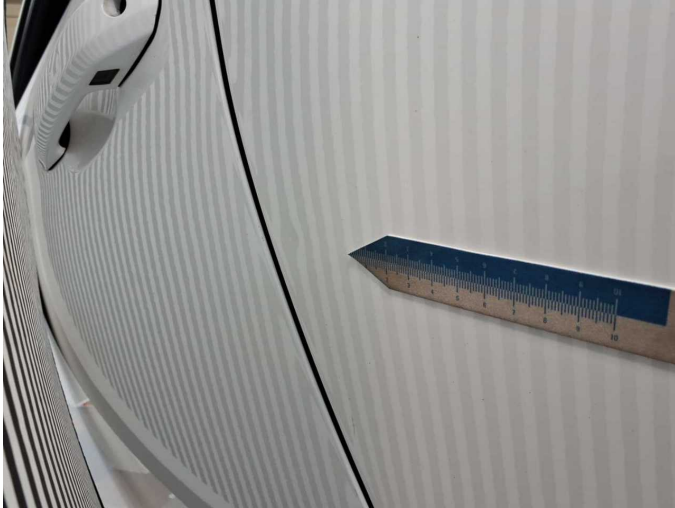
**Damage 3:** Door - rear left side: Door - dent(s) - Smooth repair work

| No. | Component group | Description |
|---|---|---|
| 3 | Door - rear left side | Door - dent(s) - Smooth repair work |

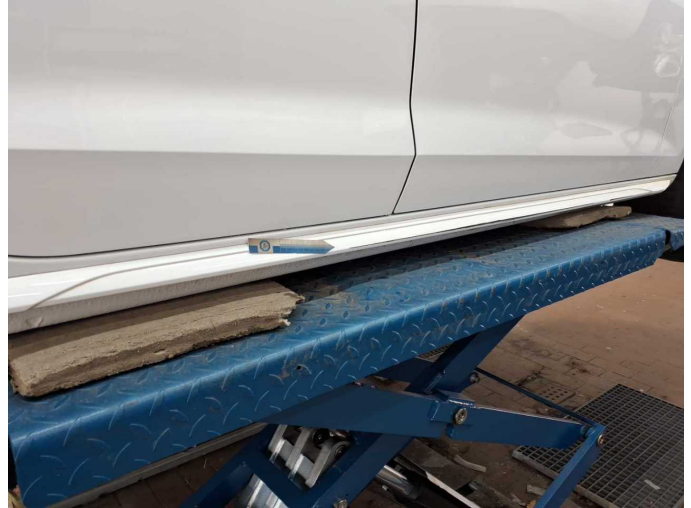
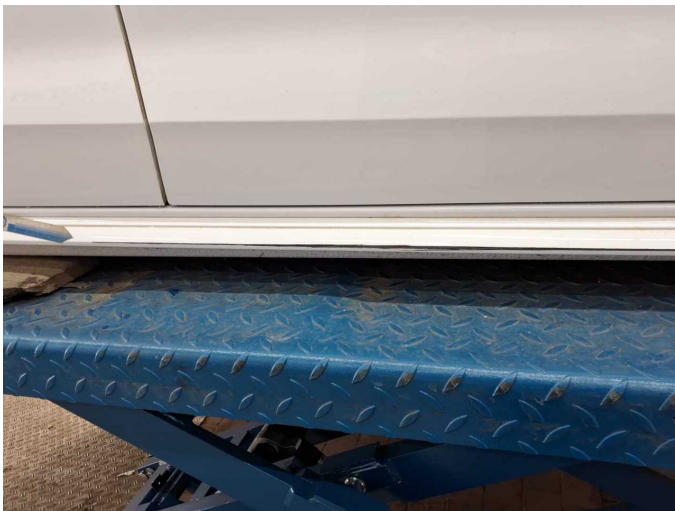
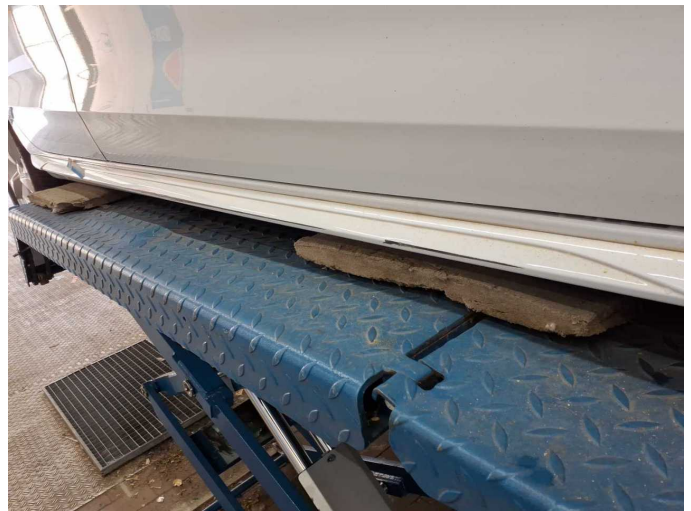
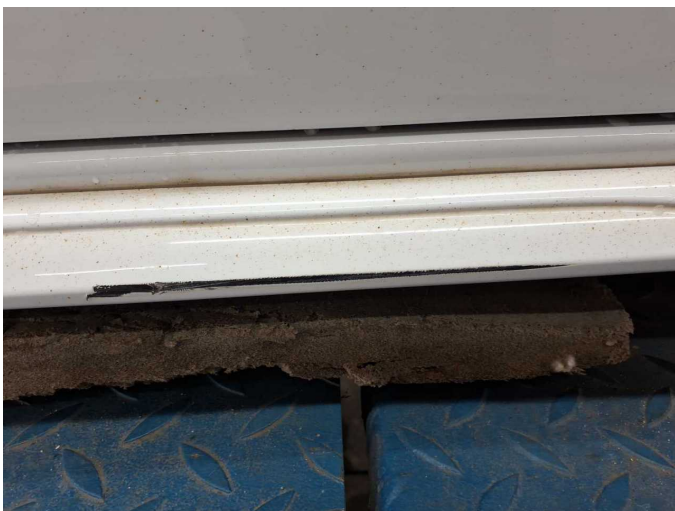
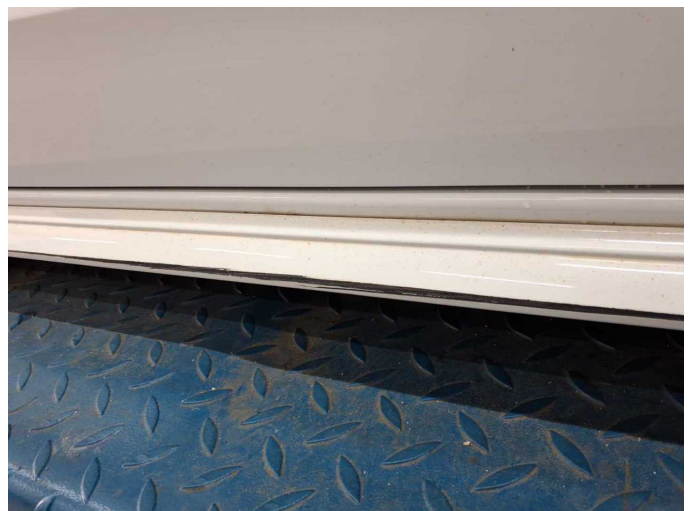
**Damage 4:** Sill - right side: Trim - Scratched - Paint

| No. | Component group | Description |
|---|---|---|
| 4 | Sill - right side | Trim - Scratched - Paint |

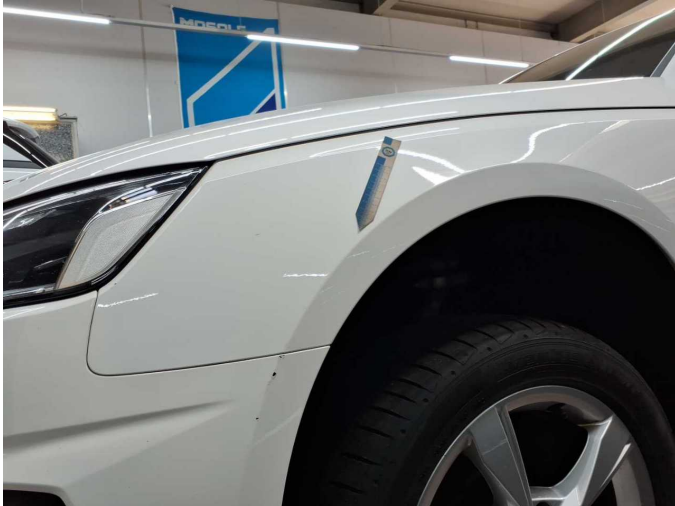
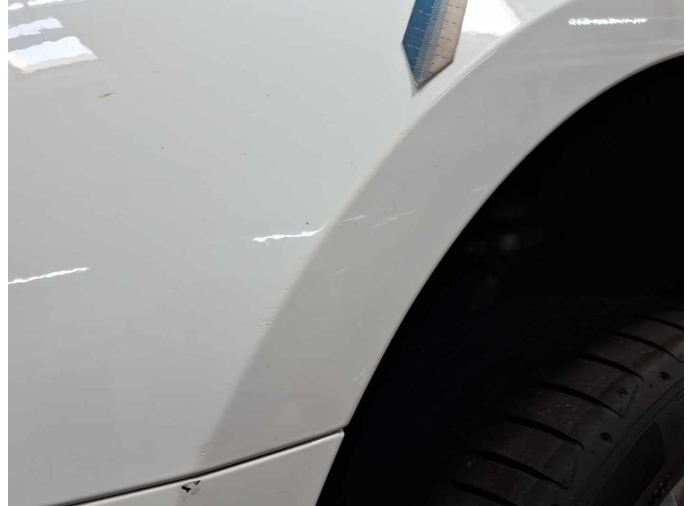
**Damage 5:** Mudguard - left side: Mudguard - left side - Scratch(es) - Smart repair

| No. | Component group | Description |
|---|---|---|
| 5 | Mudguard - left side | Mudguard - left side - Scratch(es) - Smart repair |

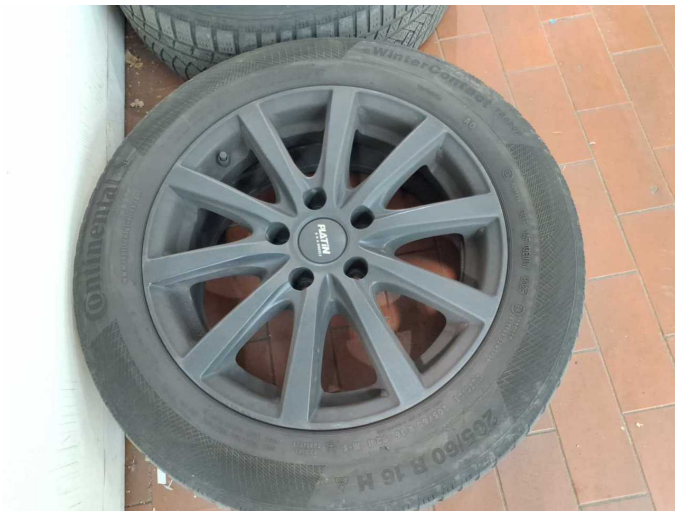
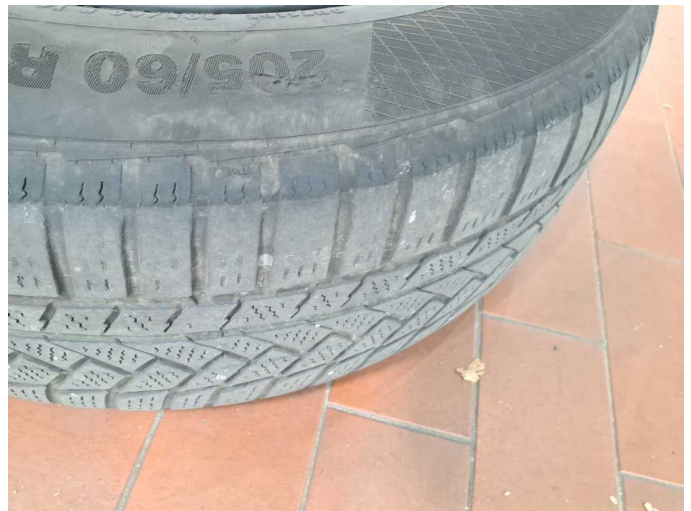
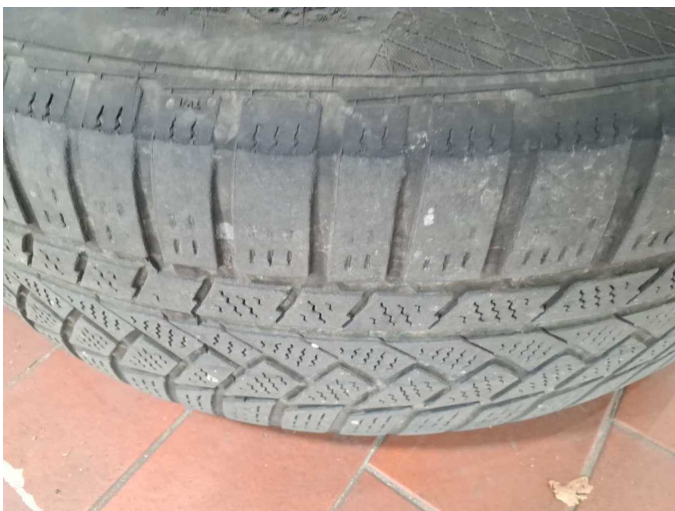
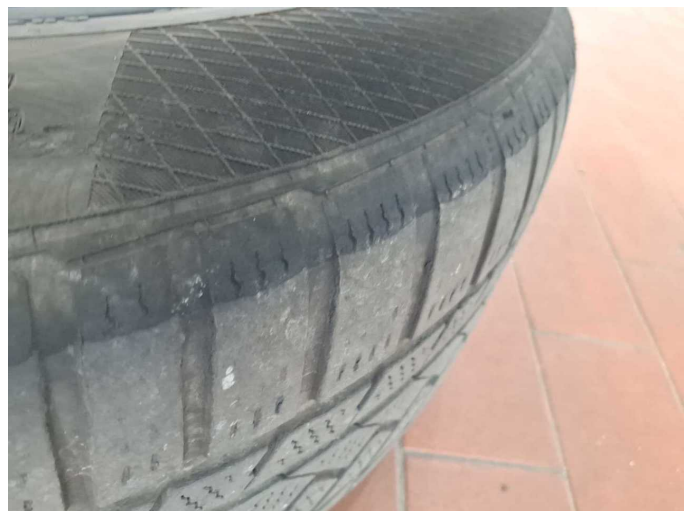
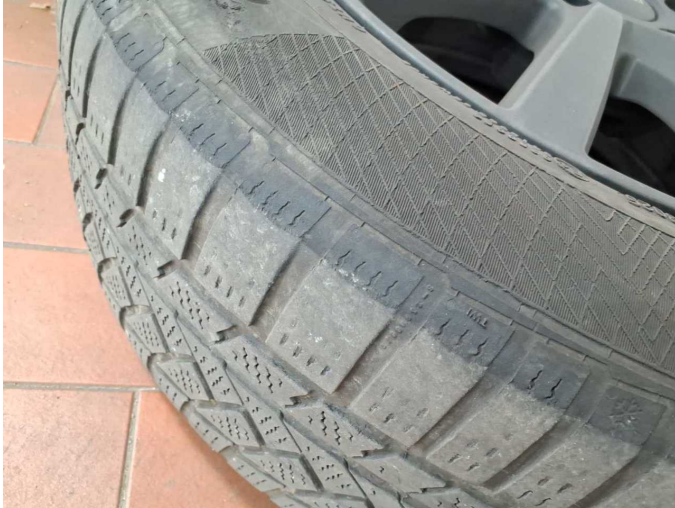
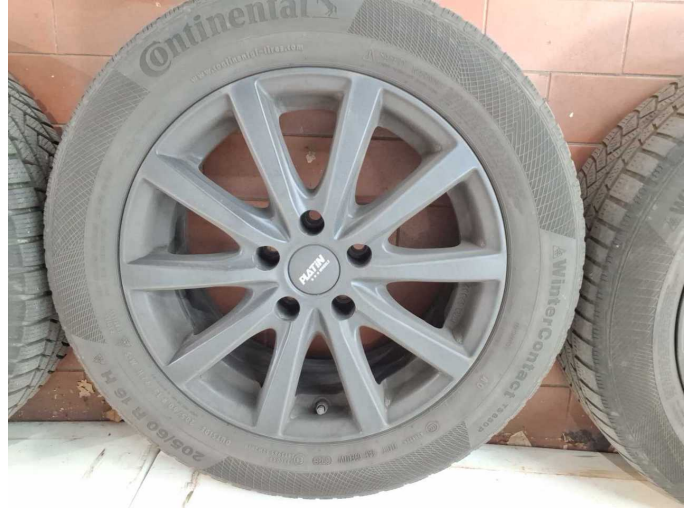
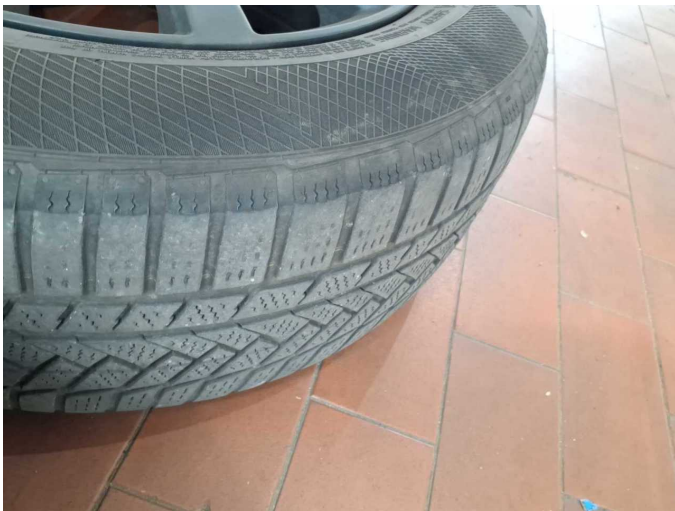
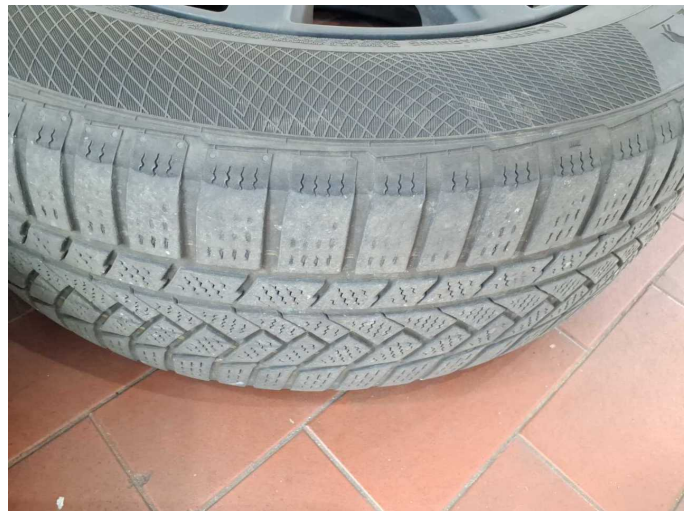
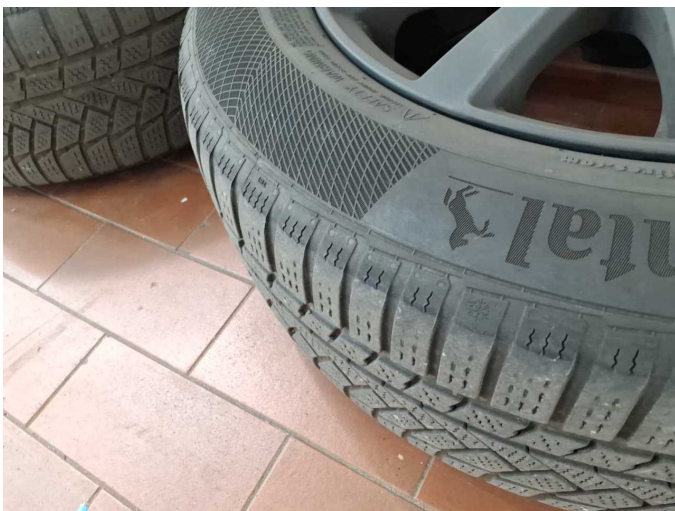
**Damage 6:** Wheel / tyres: Tyre - front - Abrasion - Replace

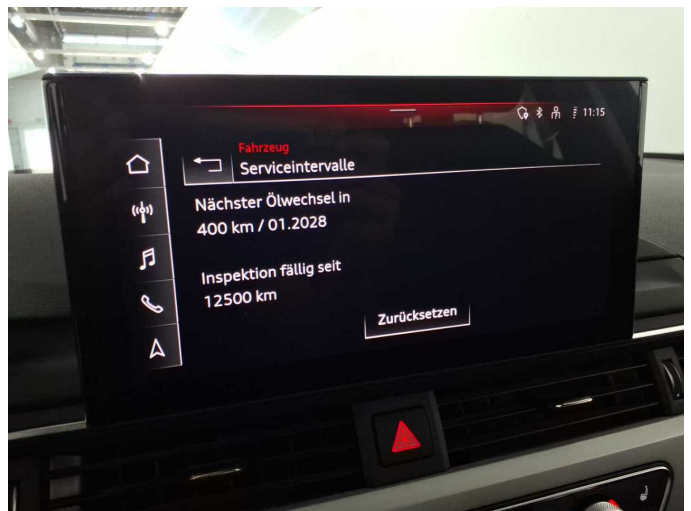
**Damage 7:** Misc.: Inspection / maintenance - Due - Replace

| No. | Component group | Description |
|---|---|---|
| 7 | Misc. | Inspection / maintenance - Due - Replace |

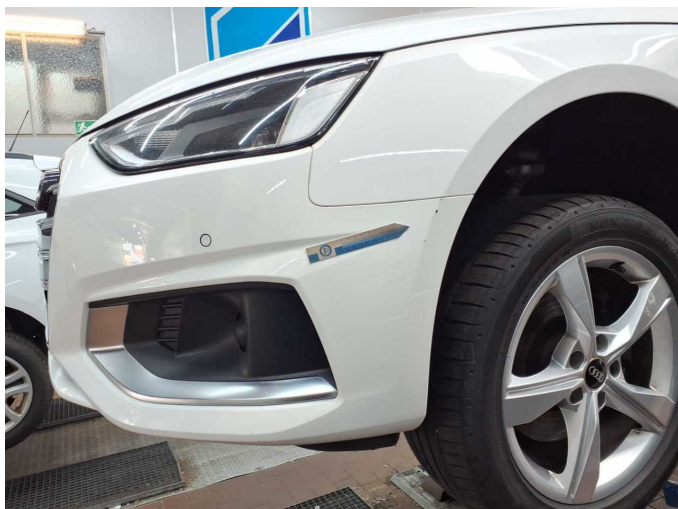
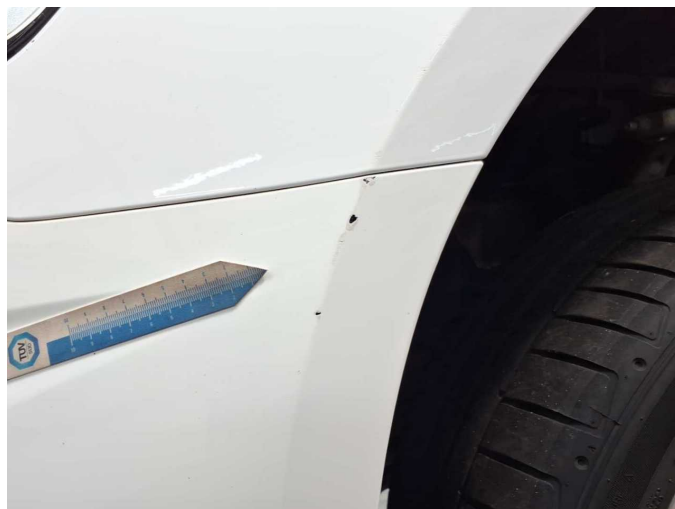
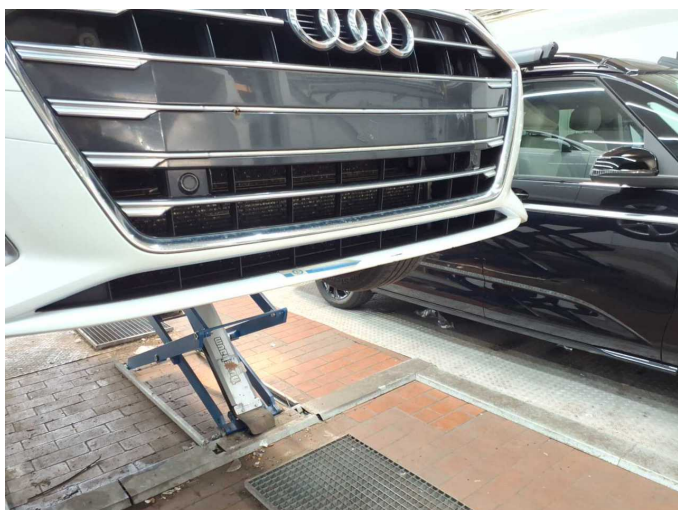
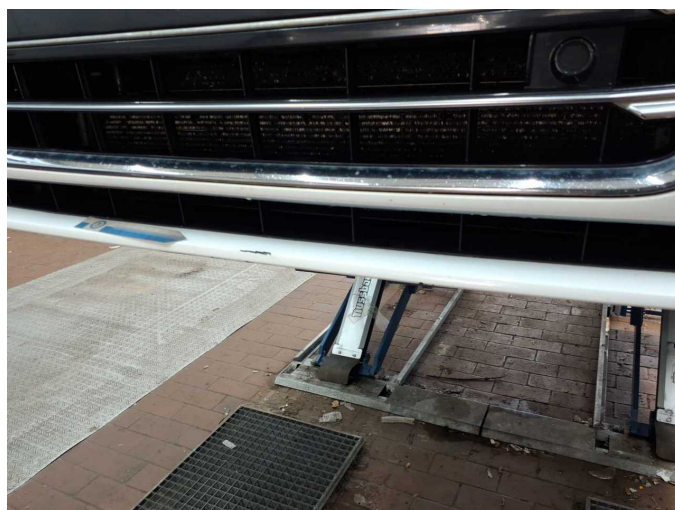
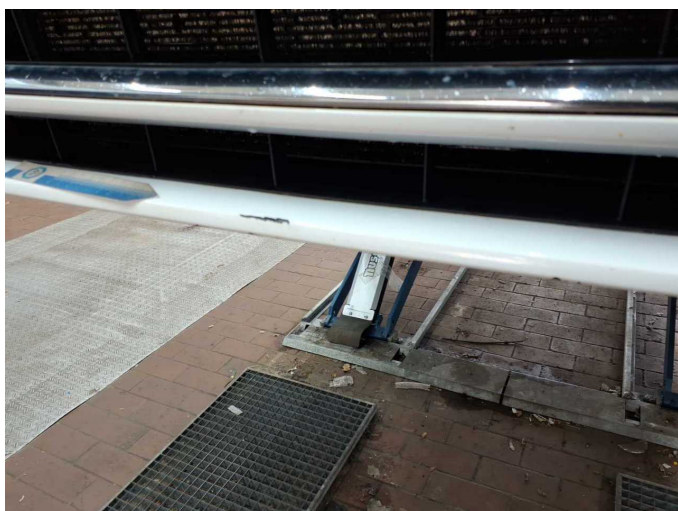
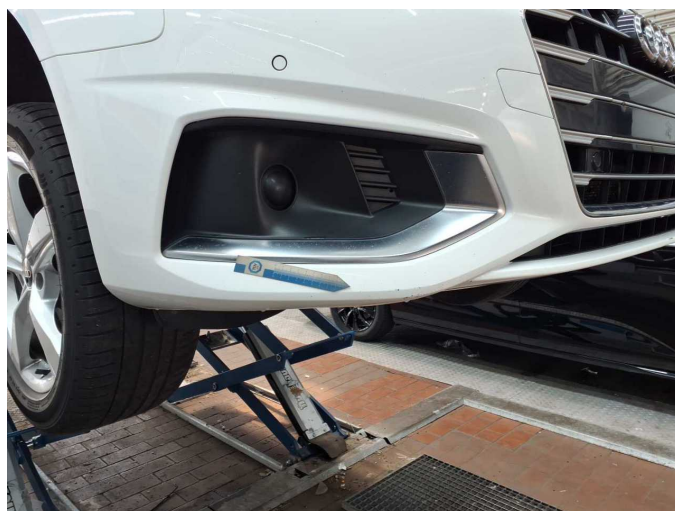
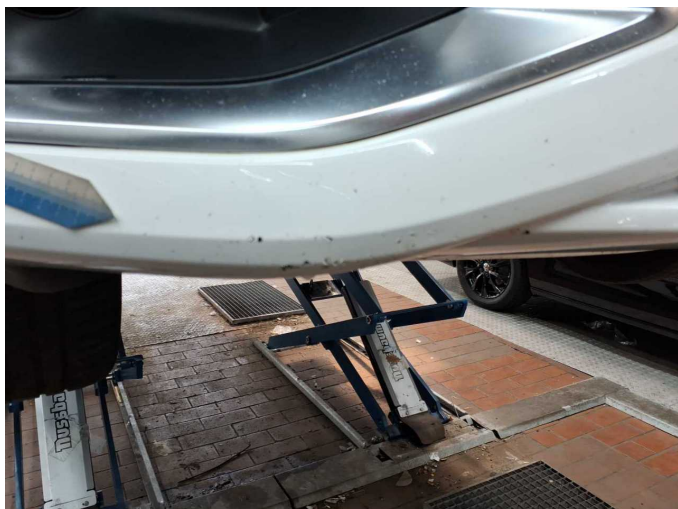
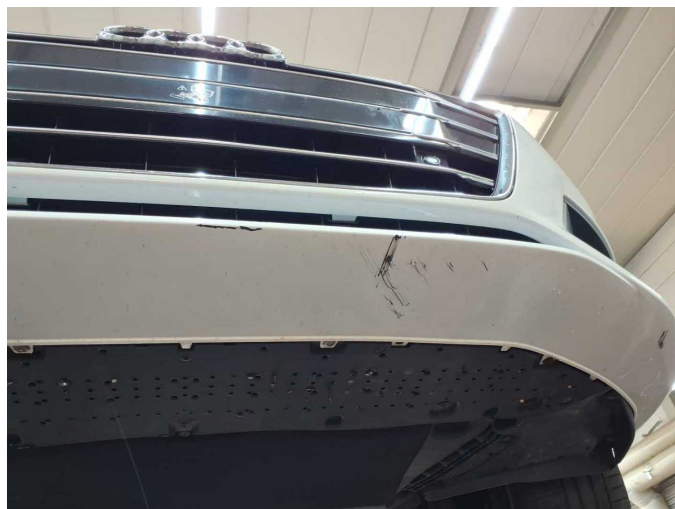
**Damage 8:** Front bumper: Front bumper - Scratched - Paint

| No. | Component group | Description |
|---|---|---|
| 8 | Front bumper | Front bumper - Scratched - Paint |

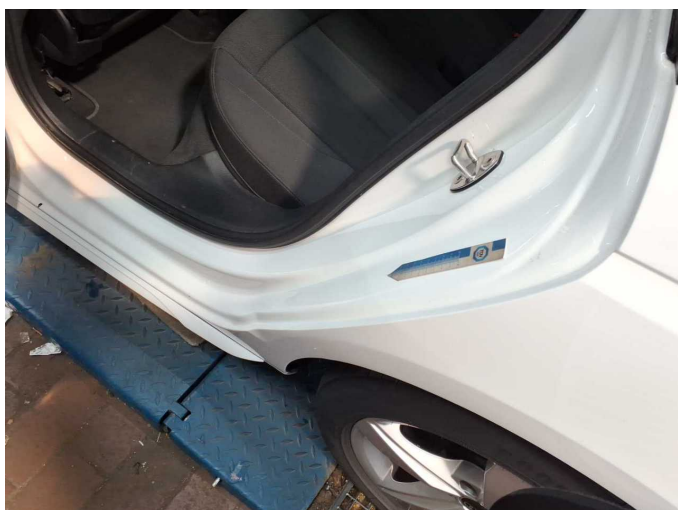
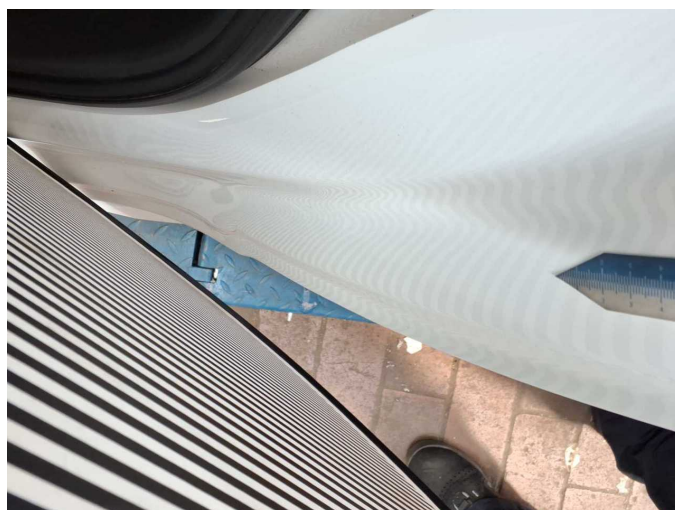
| No. | Component group | Description |
|---|---|---|
| 1 | Side panel - rear left side | Sill - dent(s) - No deduction |

**Wear and tear 1:** Side panel - rear left side: Sill - dent(s) - No deduction

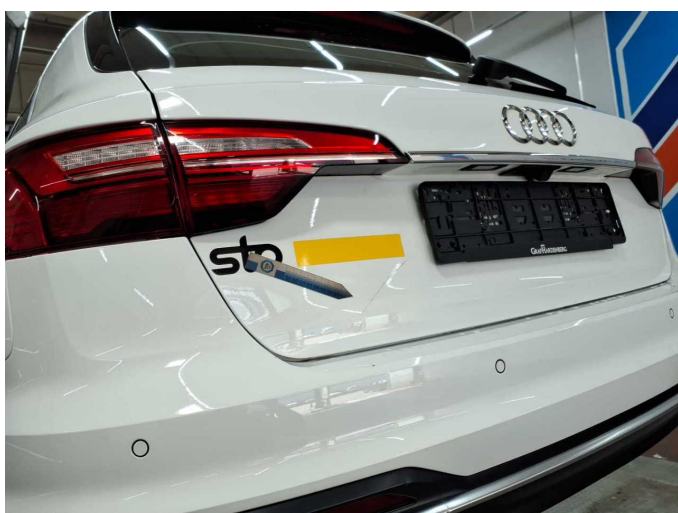
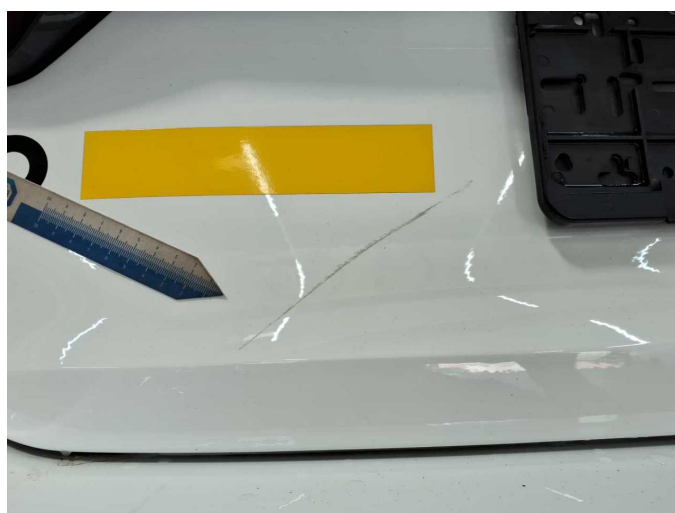
| No. | Component group | Description |
|---|---|---|
| 3 | Boot lid / rear door | Boot lid (Polieren) - Scratch(es) - No deduction |

**Wear and tear 3:** Boot lid / rear door: Boot lid (Polieren) - Scratch(es) - No deduction

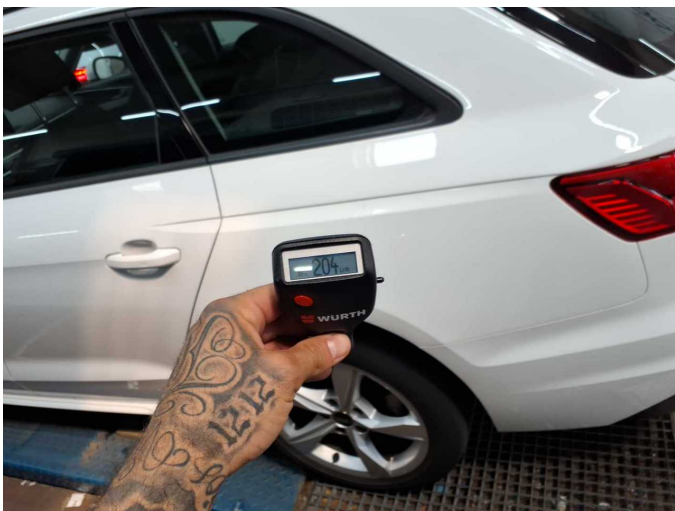
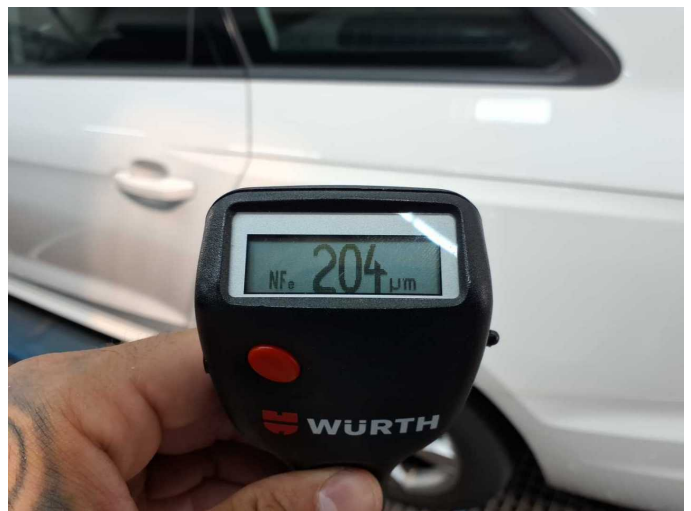
| No. | Repainting |
|---|---|
| 1 | Side panel - rear left side, Professionally carried out |

**Repainting 1:** Side panel - rear left side
