Expertise

Protocol number: 44892126
Order No. / Reference: 26121334
Inspection date: 9 Apr 2026

Model: A4 35 TDI S tronic

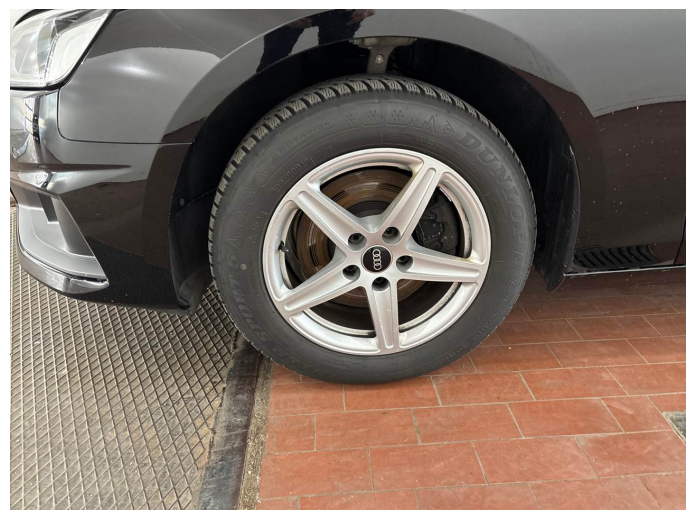
#	Tyre size	Type of tyre	Manufacturer	Tread depth
1)	205/60 R16 92H	Winter tyres on Light alloy	Dunlop	5mm / 5mm
2)	205/60 R16 92H	Winter tyres on Light alloy	Dunlop	8mm / 8mm

Figure 12: Mounted tyres

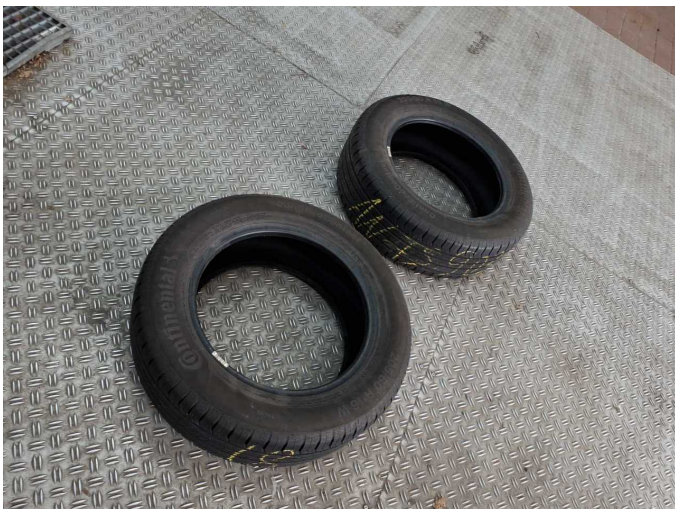
#	Tyre size	Type of tyre	Manufacturer	Tread depth
1)	205/60 R16 92W	Summer tyres (Without wheel rim)	Continental	5mm / 5mm

Figure 17: Additional tyres

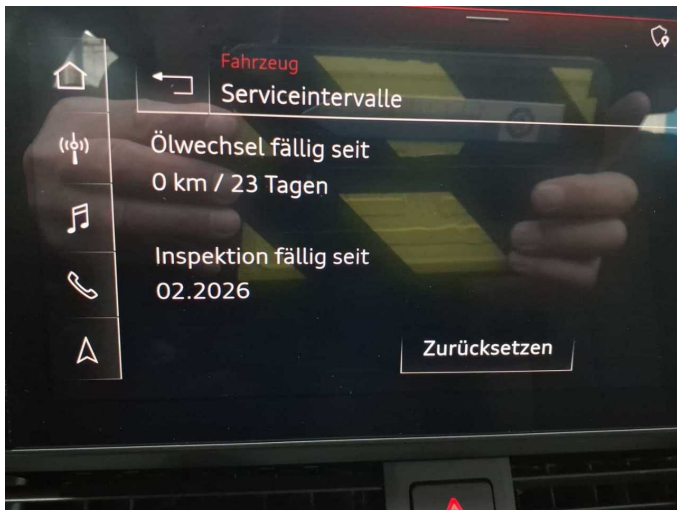
No.	Component group	Description
1	Misc.	Inspection / maintenance - Expired - Replace
2	Side panel - rear right side	Elbow (Kante) - dent(s) - Paint

Damage 1: Misc.: Inspection / maintenance - Expired - Replace

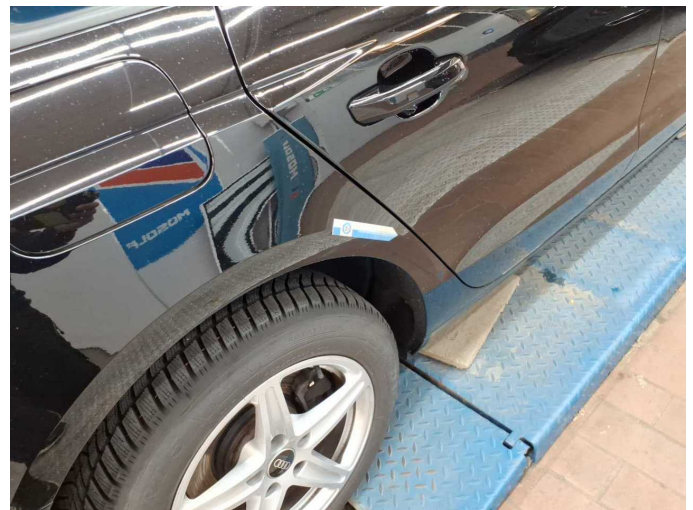
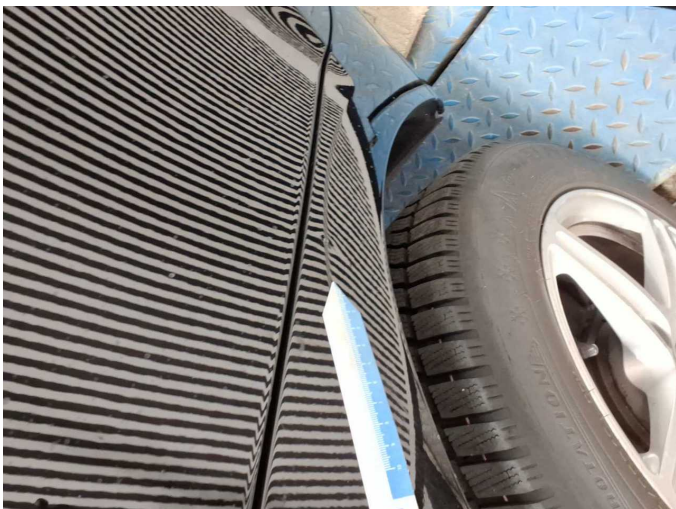
Damage 2: Side panel - rear right side: Elbow (Kante) - dent(s) - Paint

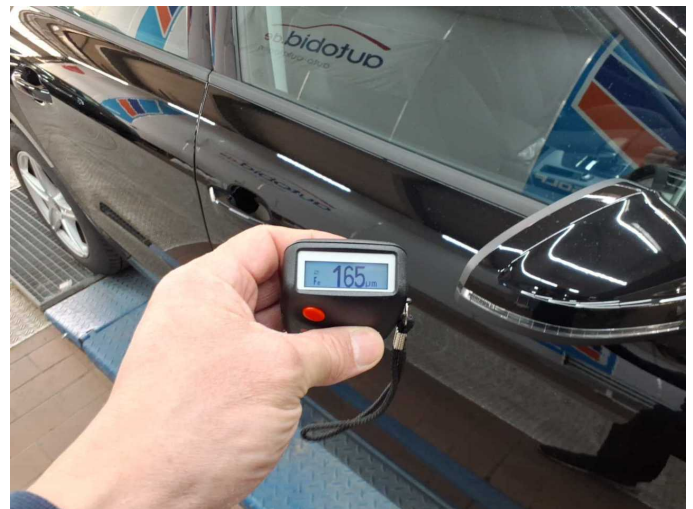
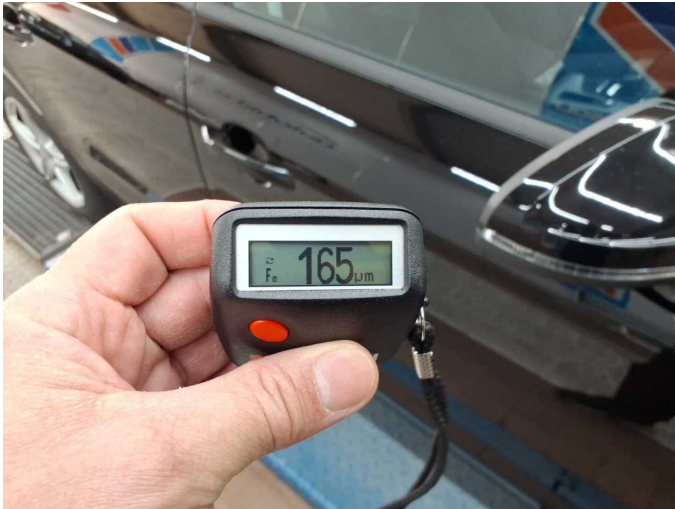
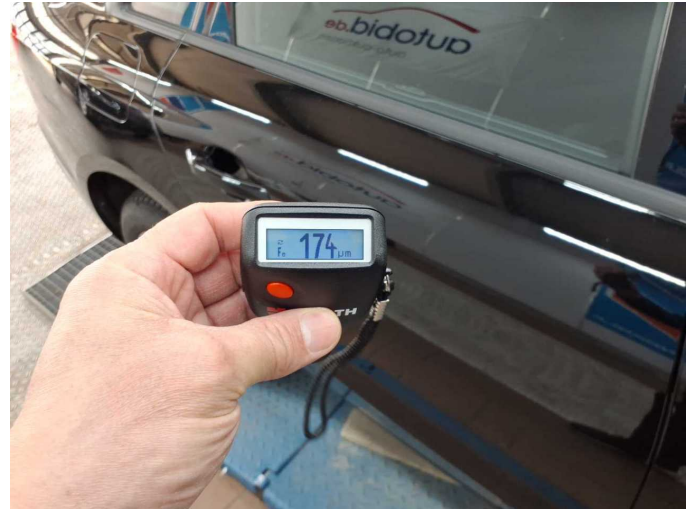
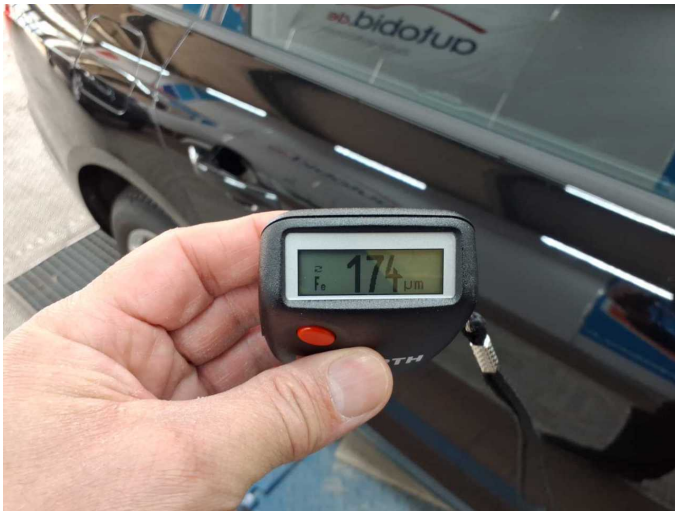
No.	Repainting
1	Door - rear right side, Door - front right side, Professionally carried out, Invoice of repair done Non-existent

Door - rear right side	174 µm	Door - front right side	165 µm
------------------------	--------	-------------------------	--------

Repainting 1: Door - rear right side, Door - front right side
